OAKLAND PARK BOULEVARD CORRIDOR SUMMARY

OAKLAND PARK BOULEVARD DEMONSTRATION CORRIDOR REVIEW

From NW 84th Avenue to Atrium West | Sunrise

The following review describes the results of the corridor safety review and general observations of the corridor. A field review was conducted on Tuesday, July 12th, 2016 from 2:00 PM to 6:00 PM and a night time field review was completed on Tuesday, July 12th, 2016 from 8:30 to 9:30 PM.

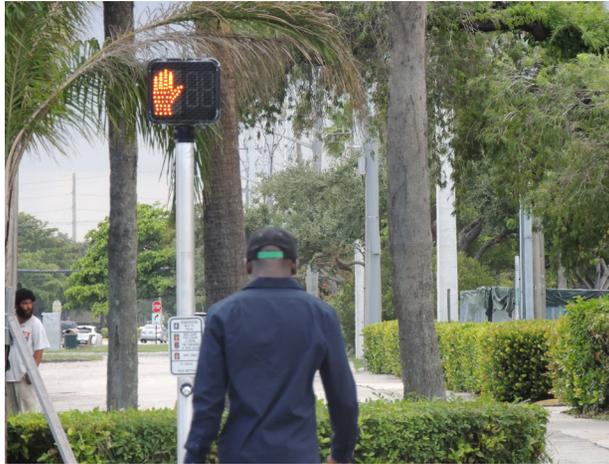
- Mid-block crossings observed at bus stops and where there are destinations on either side of the street.
- The distances between signalized crossings is very long in most locations.
- The signal times are long, which can discourage people from waiting for the signal to cross.
- In some locations, “Do Not Cross” signs have been installed, however they do not seem to have much of an impact based on field observations.
- The City of Sunrise Police Department has been implementing a High Visibility Enforcement campaign focused on pedestrian and bicyclist issues over the past year. This strategy utilizes a progressive enforcement approach, where officers educate, warn, and finally ticket pedestrians, bicyclists, and drivers. The focus is heavy on pedestrian interaction, with police officers making contact with over 1,000 pedestrians, 50 motorists, and 27 bicyclists.

Pedestrian crossing against the signal.

- Explore locations for safe mid-block crossings and consider bi-directional median opening crosswalks and TWLTL median refuge islands.
- Install thick shrubs in the median to physically prevent pedestrians from crossing medians mid-block.
- Consider relocating bus stops closer to crossings to create incentive for crossing at signals.
- Evaluate the effects of the High Visibility Enforcement campaign to determine if this kind of specialized focus worked in the study area. If so, continue the a progressive enforcement campaign where officers educate, warn, and finally ticket pedestrians who cross mid-block.

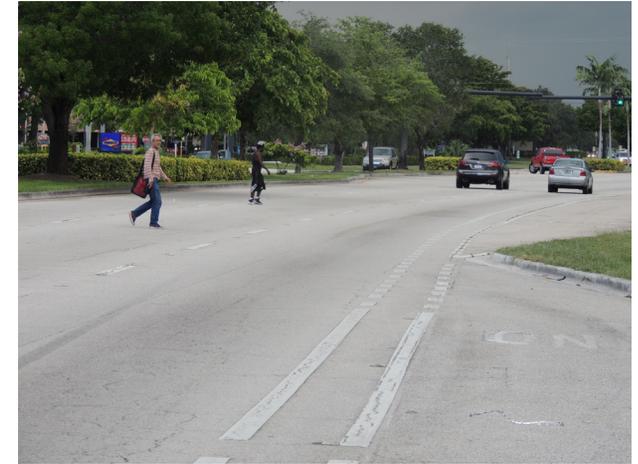
Pedestrians crossing mid-block at a gap in the shrubs.

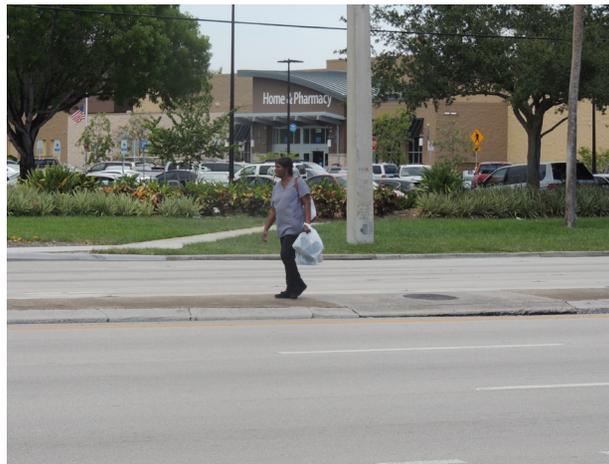
Pedestrian crossing mid-block.

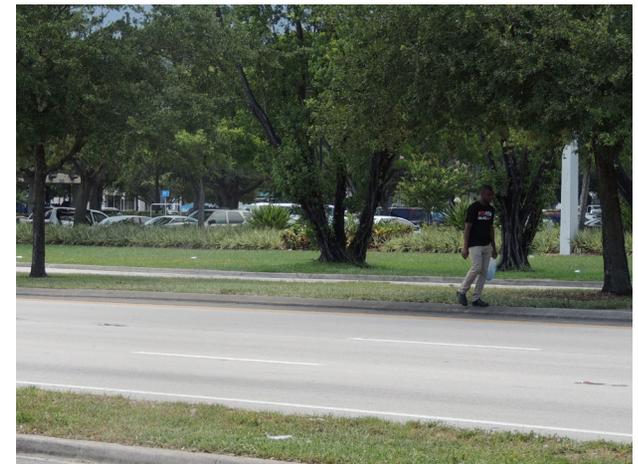
Pedestrians using the median as a refuge.

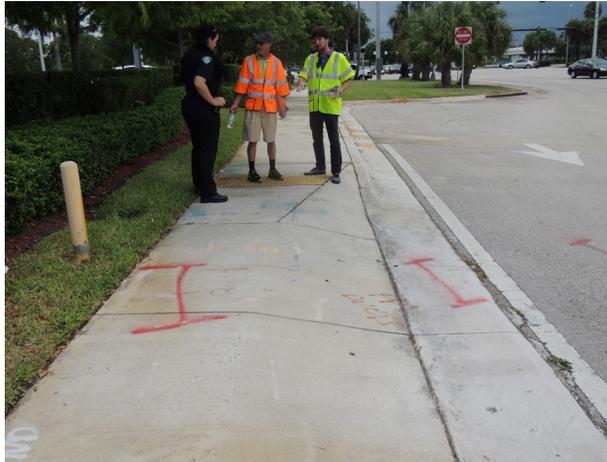
- Fixed objects are mounted within the sidewalks,
- Sidewalk ramps do not comply with ADA requirements at every intersection along the corridor.
- In general, the truncated domes are missing, worn, or misaligned.
- In several areas, accessible sidewalk connections are not present between the sidewalk and driveways or private parking lots.
- In several locations, the pedestrian signal push buttons are located far from the crosswalk ramps or too close to each other.
- Some worn paths have been made where sidewalks do not exist.

Improperly placed detectable warning surfaces and unnecessary ramp.

- Update all ADA ramps along corridor to meet requirements.
- Relocate pedestrian signal push buttons to achieve proper separation and proximity to crosswalks.
- Expand sidewalk network to connect sidewalks with safe driveway crossings.

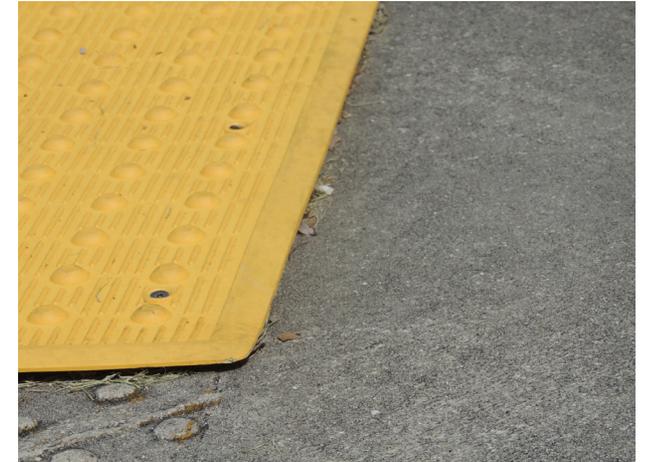
Improperly secured detectable warning surfaces.

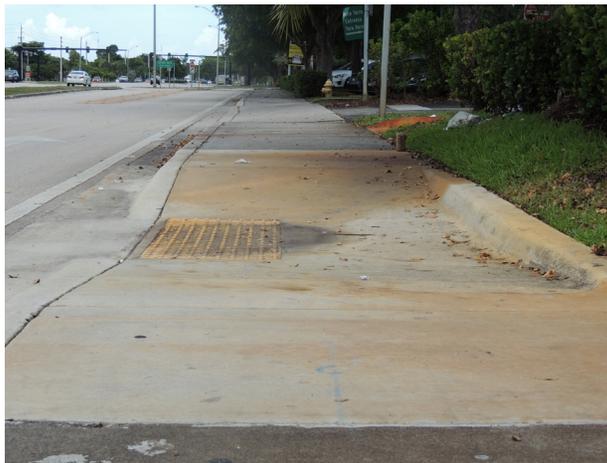
Ramp to nowhere.

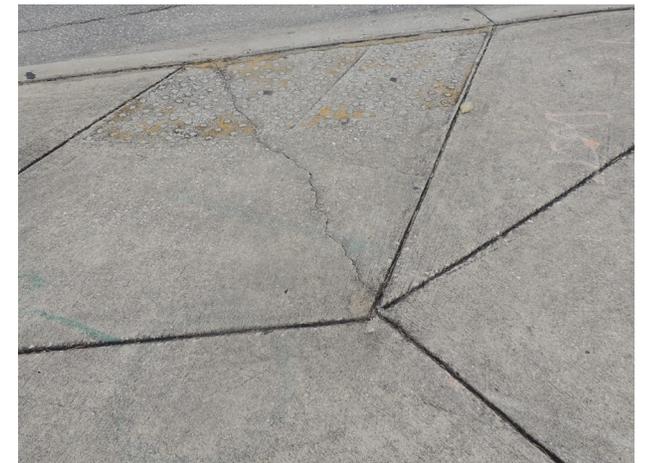
Cracked sidewalk.

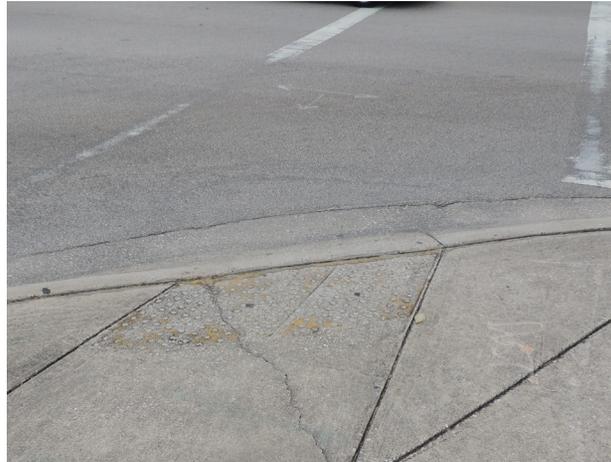
- Many of the crosswalks are faded, worn, uneven, or difficult to discern from other pavement markings.
- Crosswalks are not present for all legs of all intersections.
- The pedestrian crossing signal time is too short for slower pedestrians in some locations and crossing distances are long at some intersections.

Faded crosswalk.

- Due to the high transit ridership along the corridor, add crosswalks across all intersection legs where possible.
- Review signal timing plans for corridor and extend pedestrian crossing times to meet minimum recommendations of 3.5 feet per second.
- Consider creating pedestrian bump outs and refuge islands to reduce pedestrian crossing distances.

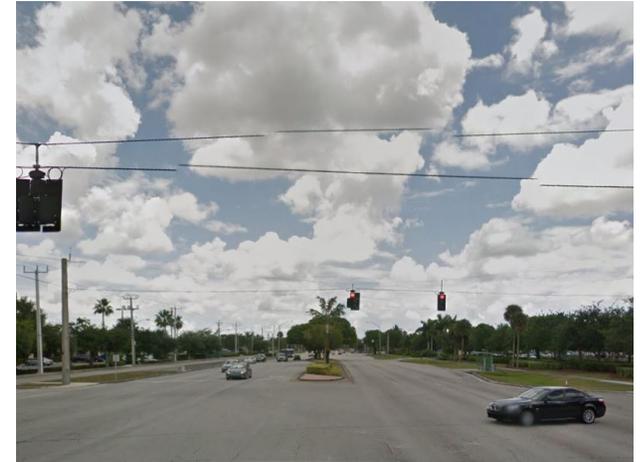
Missing crosswalk on west leg of NW 48th Terr.

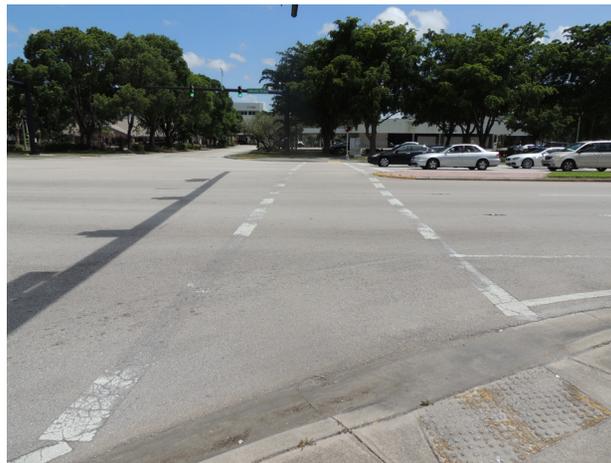
Faded crosswalk.

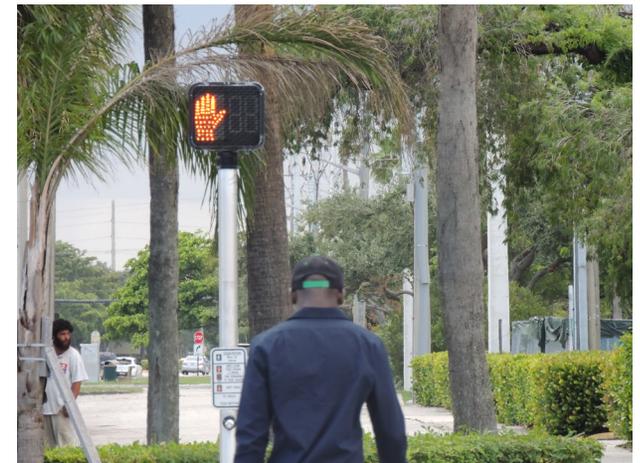
Pedestrian crossing against the signal.

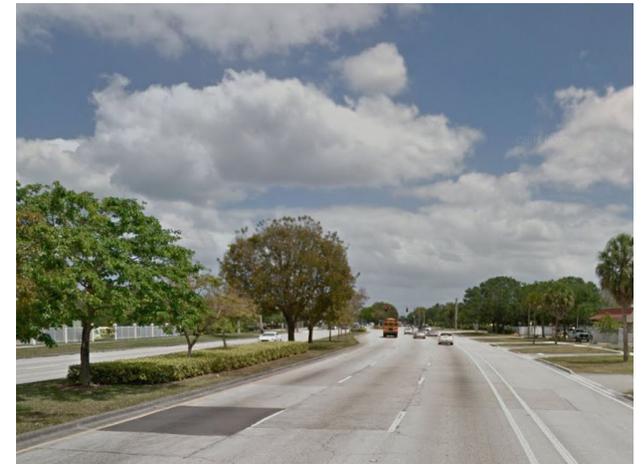
The lanes are wide enough in most places to fit buffered bike lanes with restriping.

- Evaluate the addition of bike lanes throughout the corridor. Ensure that the bike lanes are designed to have sufficient width to safely separate bikes from the high-speed and high-volume vehicular traffic in the study area in order to promote use of the bike lanes rather than the sidewalks. The high volumes and speeds suggest the need for protected or separated bike lanes to accommodate the needs of riders. This could potentially be done through restriping.

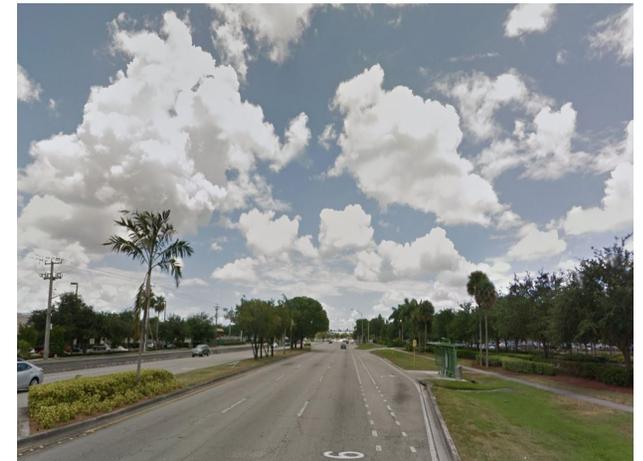
- There are no bike lanes in the study area.
- Bicyclists ride on the narrow sidewalks, creating conflicts between bicyclists and pedestrians.
- Bicyclists were also observed riding on the sidewalk in the opposite direction of vehicles.
- These conditions create safety issues for bicyclists, especially at intersection and driveway crossings.
- The City of Sunrise Police Department has been implementing a High Visibility Enforcement campaign focused on pedestrian and bicyclist issues over the past year. This strategy utilizes a progressive enforcement approach, where officers educate, warn, and finally ticket pedestrians, bicyclists, and drivers. The focus is heavy on pedestrian interaction, with police officers making contact with over 1,000 pedestrians, 50 motorists, and 27 bicyclists.

There are no bike lanes, however there is a shoulder.

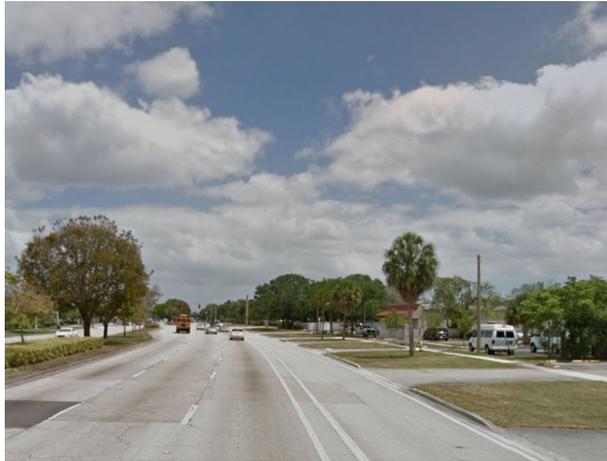
- There are a number of driveways between intersections in the study area. Many of these driveways have poorly marked crosswalks.
- Many driveways along the corridor are very wide and allow drivers to turn in and out without slowing down. Some also have right turn lanes that allow for this.
- Many drivers were observed turning out of driveways without looking for or yielding to pedestrians.
- The stop bar at some driveways is set back far from the street. Drivers pull past the stop bar and in to the crosswalk for a better view of traffic, which causes conflicts with bicyclists and pedestrians.

There are frequent driveways along the corridor.

- Refresh pavement markings to emphasize crosswalks across driveways.
- Create an outreach campaign to alert bicyclists of the dangers of riding on the sidewalks and to alert drivers of the need to look for bicyclists when turning in to and out of driveways.
- Encourage cross access agreements between developments to limit the number of driveways approved along the corridor.
- Consider narrowing driveways where possible and ensure that driveway width is considered in development review for new developments.
- Consider whether right turn lanes are needed at every development. If not, consider where they might be able to be removed.
- Install warning signs at intersections and driveways, such as "Stop Here on Red".
- Consider redesigning the location of the stop bar and crosswalk.

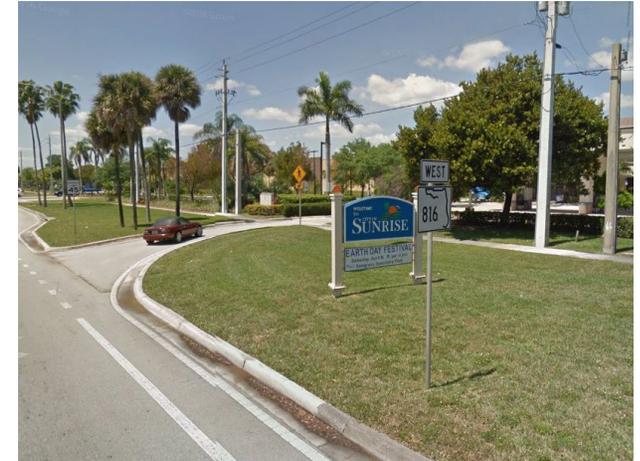
High speed turn lanes into driveways are common.

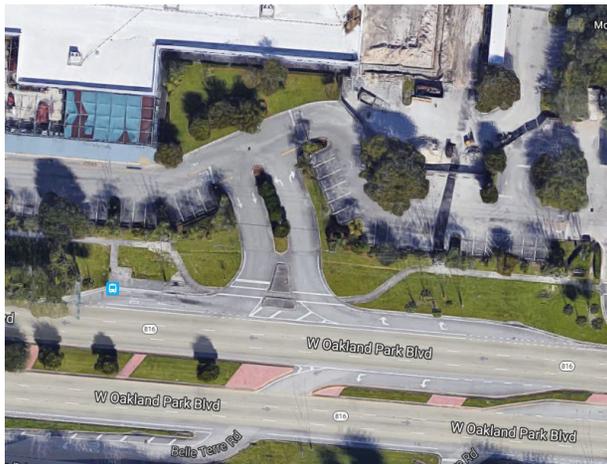
Wide, channelized driveways allow cars to turn into parking lots without slowing down.

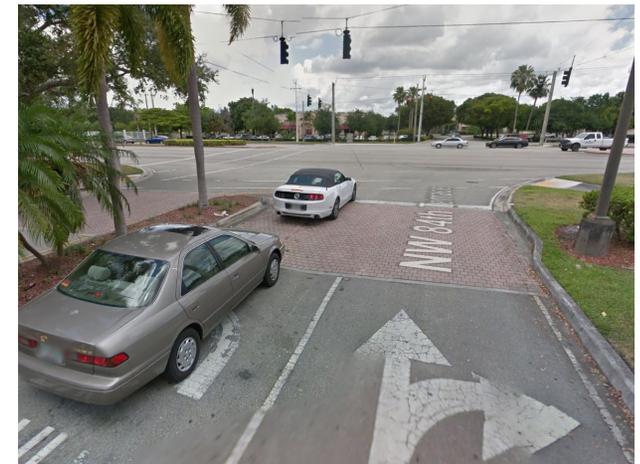
Stop bar is set far back from the road and cars pull through it for a better view of traffic.

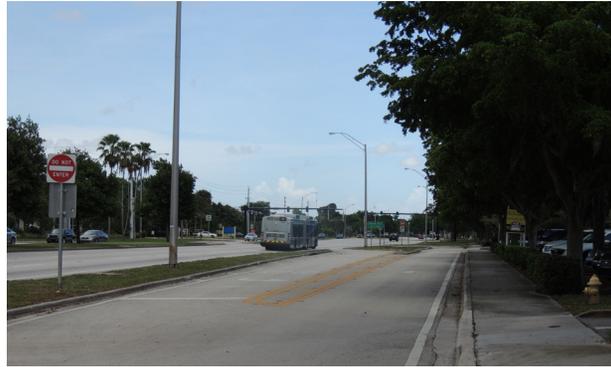
- Many intersections have excessive pavement widths. This is confusing to vehicles operating the intersection - especially with poorly maintained pavement markings - and yields long crossing distances for pedestrians.

Frontage road with markings that cause motorist confusion.

- Evaluate the need for separate turn lanes and consider road diets where possible.
- Utilize excess space to incorporate bump outs, bike lanes, and other improvements to the bicycle and pedestrian realm.

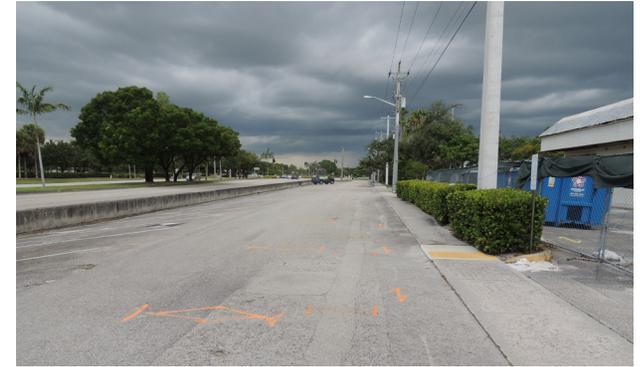
Excess pavement.

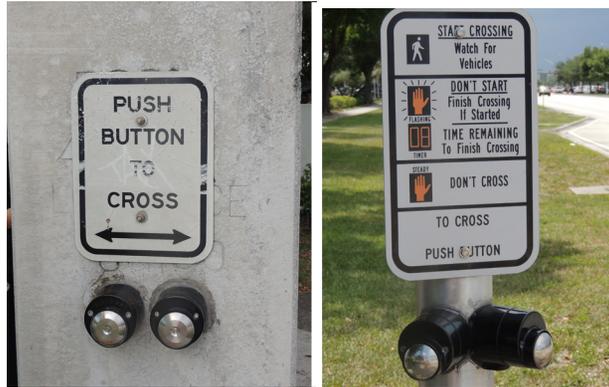
- Pedestrian signals are not functioning or the countdown signal is not working at multiple intersections.
- Many of the pedestrian signal push button signs do not provide the street names or signs with directions on how to properly use pedestrian signal heads.

Signs are out of date and either do not state which street they are referring to do not have instructions.

- Replace or fix pedestrian signals/controllers.
- Update pedestrian signal push button signs as necessary to meet standards.

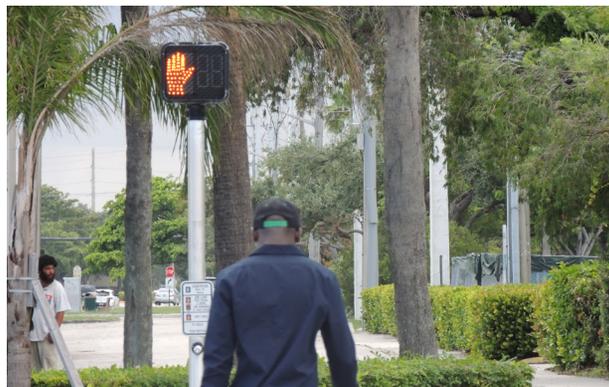
- Signal times are long, which causes long wait times for pedestrians when crossing the street at intersections.
- It was observed that pedestrians cross the street against the signal even in crosswalks instead of waiting for the Walk signals.

Pedestrian crossing against the signal.

- Consider retiming signals with a focus on pedestrian and bicycle mobility.

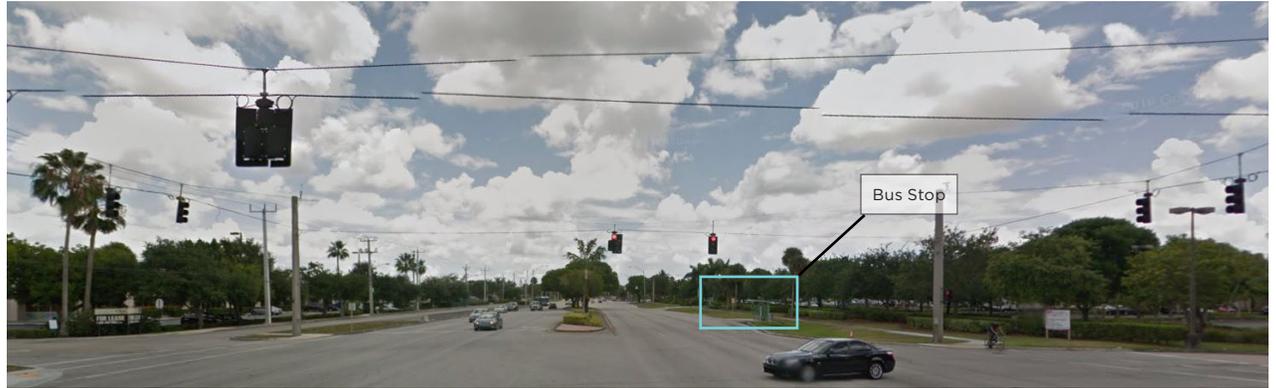
- Mid-block pedestrian crossing is a critical safety concern throughout the corridor. Many, but not all, of the observed illegal mid-block crossings result from bus stops that are not conveniently located near existing crosswalks. Alternatively, crosswalks are not conveniently located near the bus stops.

There is no crosswalk on the side of the intersection where the bus stop is located on the west leg of NW 48th Terr.

- Evaluate the bus stop locations and potential mid-block crosswalk locations.
- Design mid-block crosswalks with enhanced visibility features, such as Rectangular Rapid Flash Beacons (RRFBs), to encourage use and to improve safety.

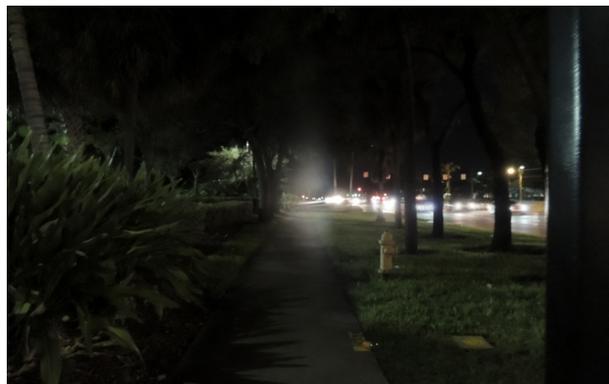
- Lighting is poor outside of the intersection of Oakland Park Boulevard and University Drive. That intersection was updated recently. The transition between lower and higher lighting levels is difficult at night.
- Lighting is present on only one side of the roadway between intersections.

Lighting is poor outside of signalized intersections and present only on one side of the street.

- Complete a lighting study with a focus on pedestrian lighting.
- Create an outreach campaign to alert pedestrians and bicyclists of the need to wear bright clothing at night and to use lighting.

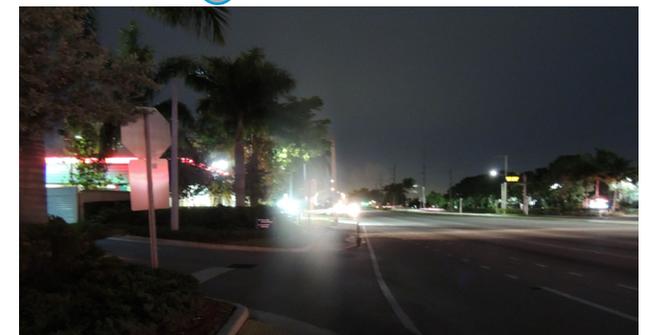
Lighting is poor outside of signalized intersections and present only on one side of the street.
