*SR 7 MULTIMODAL IMPROVEMENTS CORRIDOR STUDY*

# TECHNICAL APPENDIX C: HOT SPOT PRELIMINARY SAFETY AND TRAFFIC OPERATIONS REVIEWS

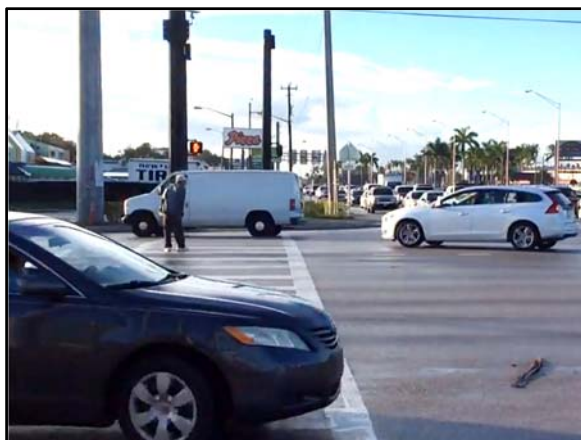
Pedestrians were observed crossing during the “DO NOT WALK” pedestrian phase. Enforcement of pedestrians who do not obey pedestrian signals should be increased. The old pedestrian signals should be upgraded to countdown signals, provide separated pedestrian push buttons, and relocate the push buttons closer to the curb ramps for easier access.

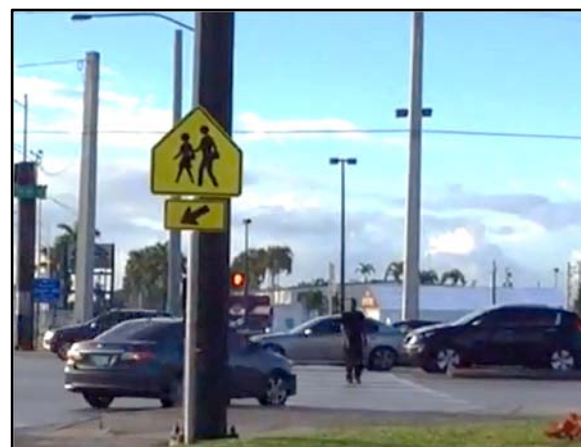
Southbound right turning vehicles were observed not yielding to pedestrians. Consider installing a “YIELD TO PEDESTRIANS” (R10-15R) sign with a four-section flashing yellow (or red) right-turn arrow, which would display a flashing yellow

(or red) arrow when pedestrians are crossing to encourage drivers to yield to pedestrians.

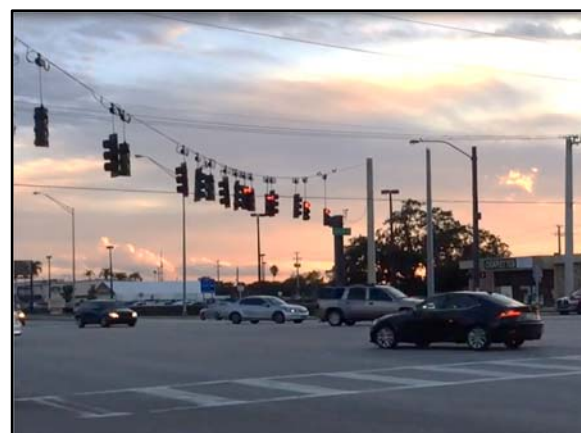
Left-turn phase failures were observed for southbound and eastbound approaches. Both southbound and eastbound left-turning vehicles were observed running the red light. Signal timings should be reviewed to extend the left-turn timings.

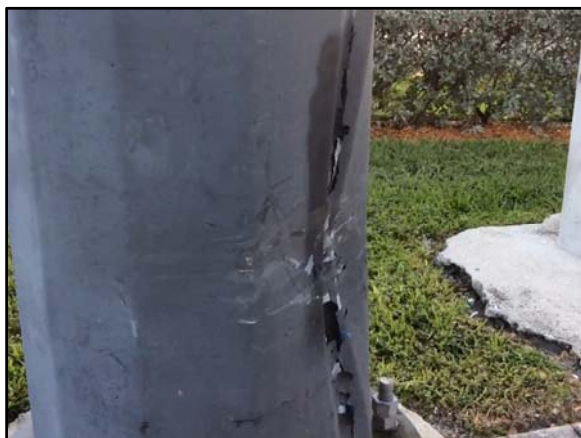
The old unused signal pole in the southwest corner is damaged and appears to have been hit by a vehicle. The pole should be removed as it is no longer used.

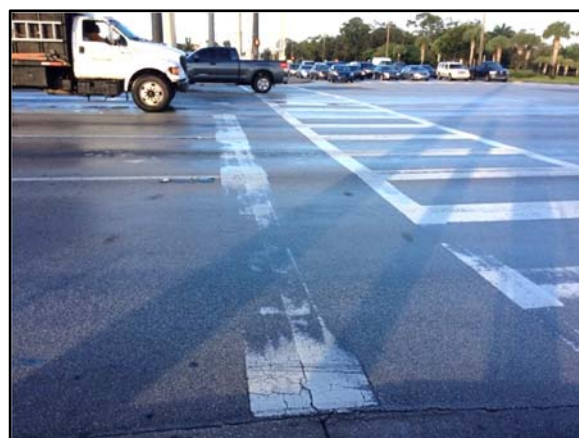
Poor pavement markings were observed throughout the intersection. The intersection should be restriped with new pavement markings.

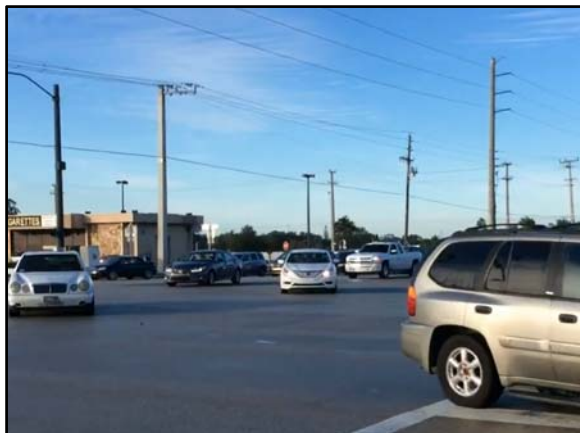
Outside left turning vehicles were observed turning widely while the inside turn lanes were observed taking sharper turns as the left-turn skip striping for each approach is worn and poorly visible. A few conflicts were observed between left turning vehicles, and several crash reports involved sideswipes within the left-turn lanes. The left-turn skip striping should be restriped.

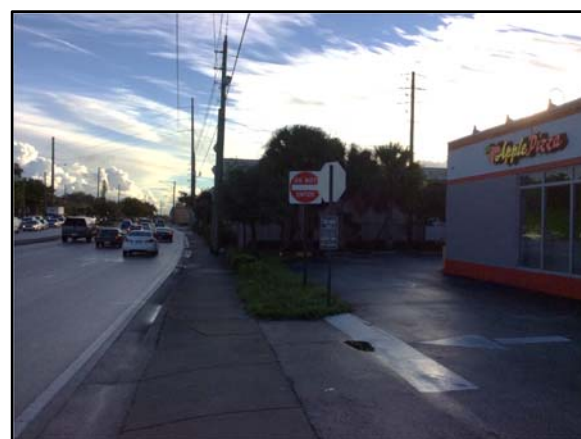
The “SPEED LIMIT 45” sign (R2-1) is covered by overgrown vegetation. The vegetation should be trimmed to allow for better visibility of the sign.

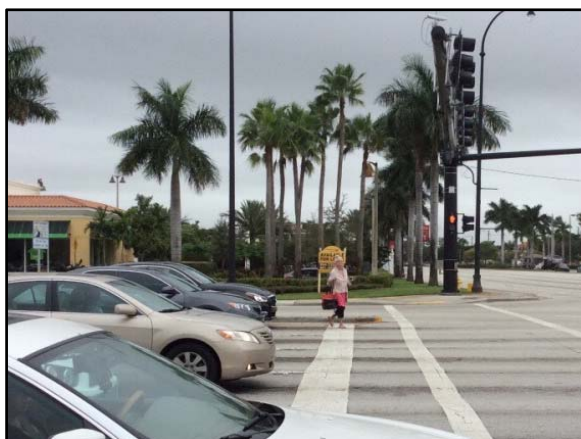
Pedestrians were observed crossing during the “DO NOT WALK” pedestrian phase. Enforcement of pedestrians who do not obey pedestrian signals should be increased. Crosswalks should also be upgraded to special emphasis or ladder style crosswalks for better visibility. Pedestrian push buttons also should be separated and relocated closer to the curb ramps.

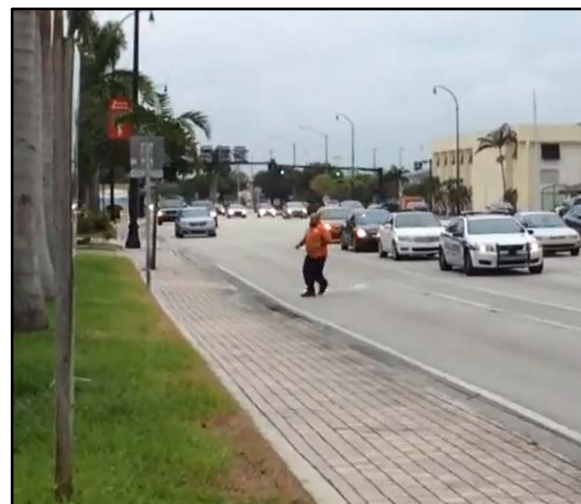
Pedestrians were observed crossing midblock along both SR 7 and Broward Boulevard. Consider installing “NO PEDESTRIAN CROSSING” sign (R9-3) with “USE CROSSWALK” (R9-3b) within the median of each approach.

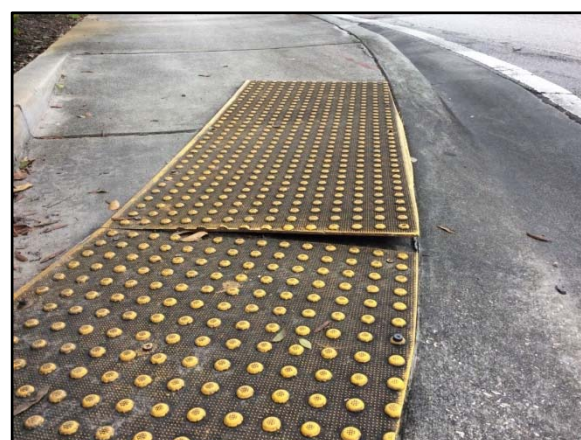
Detectable warning surfaces along the sidewalk of SR 7 are damaged at the driveway to Grove East Rental Apartments, which is just south of Broward Boulevard. The detectable warning surfaces should be replaced or removed at this location as it is currently a tripping hazard to pedestrians and not ADA-compliant.

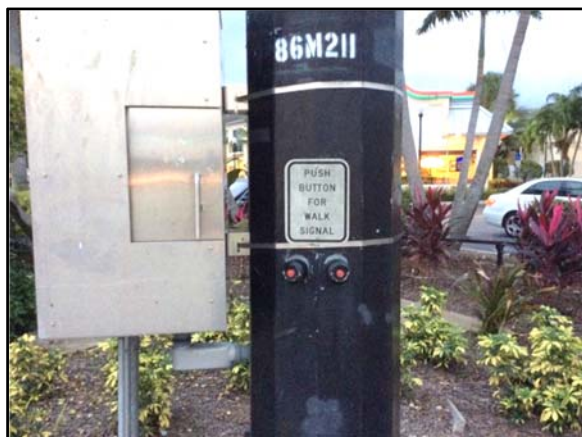
The pedestrian push buttons share the mast arm poles at each corner and some are further than 10 feet from the curb ramp. Separate push buttons for each corner and relocating each push button closer than 10 feet to the curb ramp would enhance accessibility.

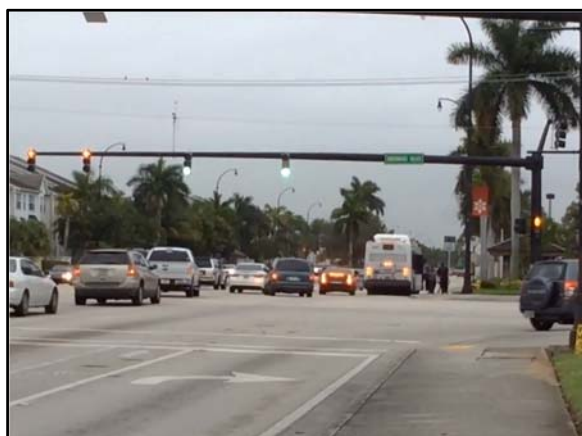
Vehicular conflicts were observed just south of Broward Boulevard as southbound vehicles were observed cutting off other southbound vehicles to avoid waiting behind the bus at the bus stop.

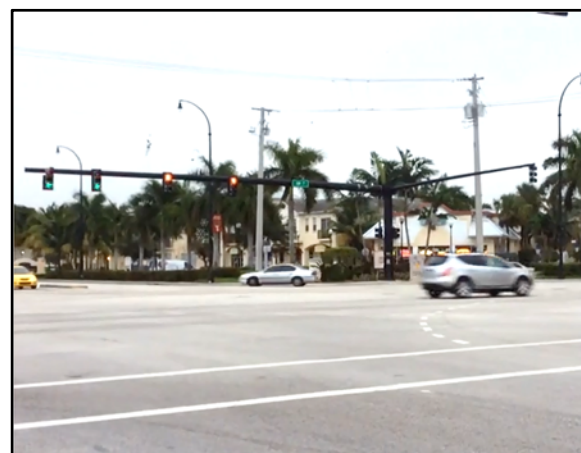
A southbound vehicle was observed speeding and running the red light. The vehicle did not clear the intersection prior to the start of the eastbound left-turn phase.

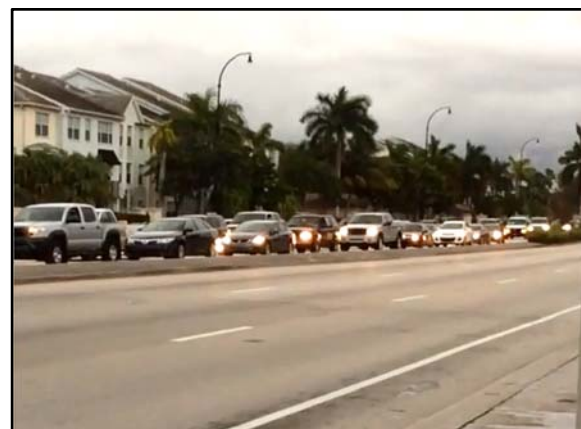
Northbound left-turn phase failures were observed during both the AM and PM peak periods and long queues were observed. All movements appeared to have high volumes during the PM peak hour.

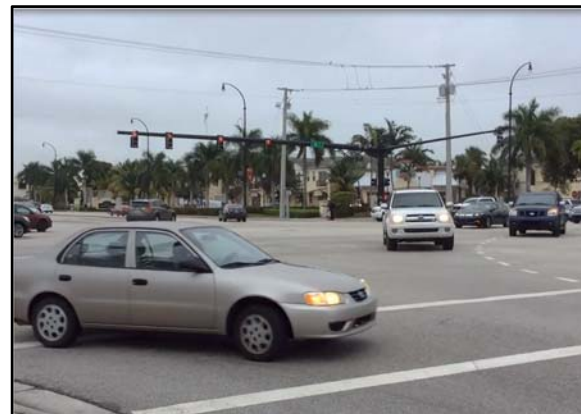
The eastbound right-turn movement had 485 vph during turning movement counts. During field observations, the vehicle movement was heavy making it difficult for pedestrians to cross the southern and western crosswalks. Consider a right-turn overlap with the left-turn movement by installing a four-section right-turn arrow to display a green arrow during the left-turn phase and a flashing yellow (or red) right-turn arrow during the pedestrian phase to encourage drivers to yield to pedestrians. This improvement would require prohibiting the U-turn movement.

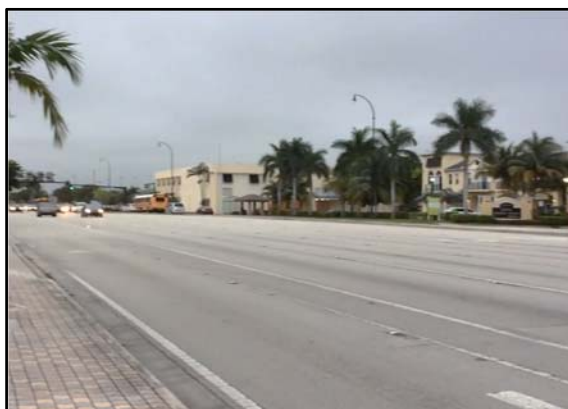
Poor pavement markings were observed throughout the intersection. The intersection should be restriped with new pavement markings.

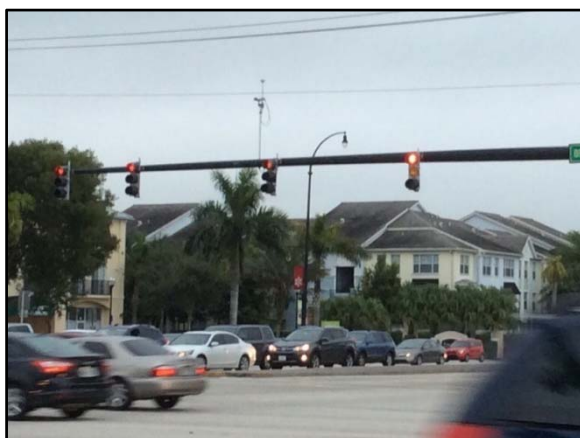
The southbound signal head is missing a signal visor. Consider replacing the visor and also consider installing one signal head per lane with yellow backplates for each approach.

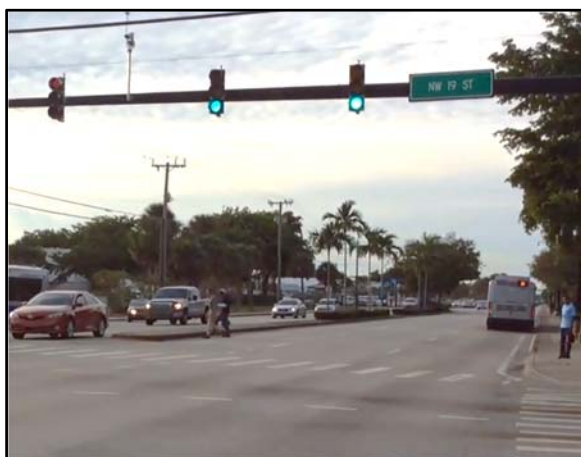
Pedestrians were observed crossing during the “DO NOT WALK” pedestrian phase. Enforcement of pedestrians who do not obey pedestrian signals should be increased. Separate push buttons for each corner and relocating the push buttons closer to the curb ramps would provide better accessibility. Installing “NO PEDESTRIAN CROSSING” sign (R9-3) with “USE CROSSWALK” (R9-3b) within the median for each approach could help deter unsafe mid-block crossings.

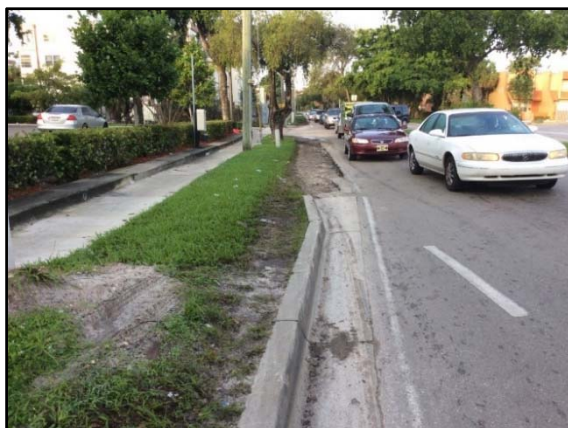
The eastbound approach was observed having large queues during the AM and PM peak hours.

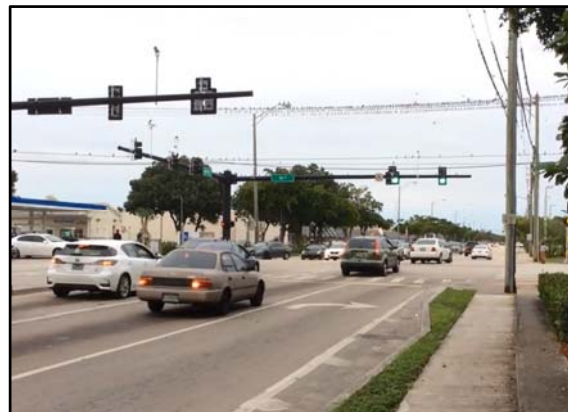
For the eastbound approach, the PM peak hour had the highest volumes with 111 vph in the left-turn lane, 314 vpd in the through lane, and 77 vpd in the right-turn lane. Aggressive driving, including speeding and red light running, was observed as phase failures occurred. To increase capacity of the eastbound movement and to reduce aggressive driving, consider modifying the eastbound right-turn lane to a shared through/right-turn lane as there are two eastbound through lanes on the opposing side of the intersection.

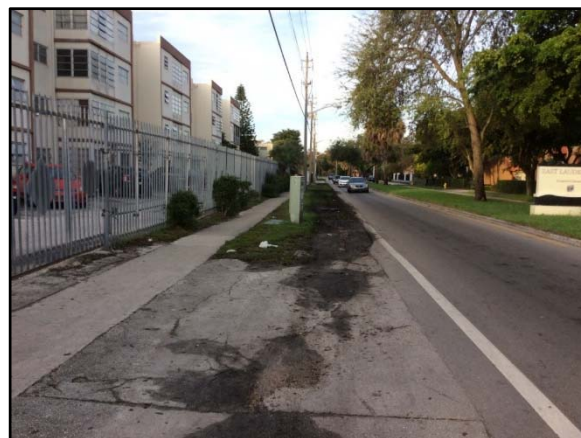
Off tracking was observed 450 feet west of the intersection. If right of way is available and construction is feasible, consider extending the proposed shared through/right-turn lane back as far possible.

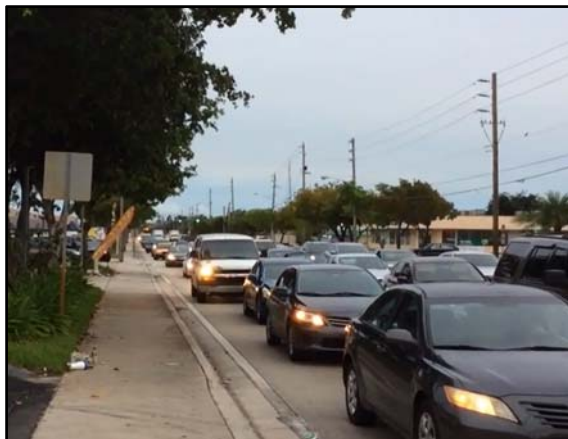
The westbound right-turn lane was observed having large queues during the PM peak hour.

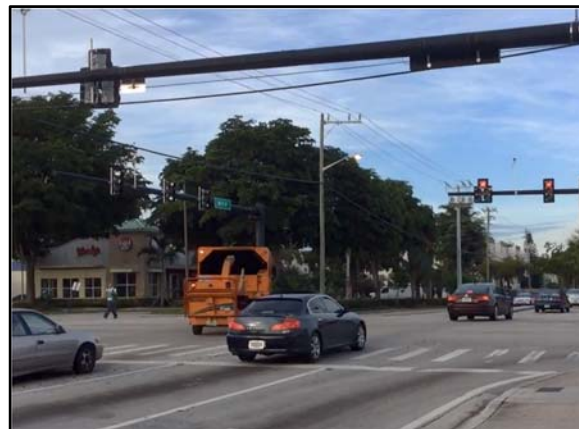
The westbound left-turn lane was also observed having large queues during the PM peak hour.

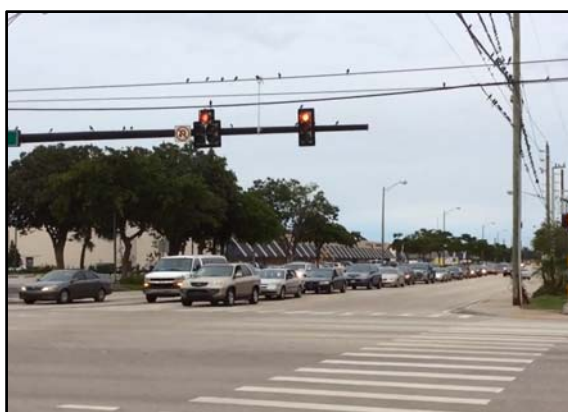
Westbound right turns were observed cutting through the driveway to the Mobil gas station to skip the long right-turn queue. If feasible, consider adding dual right-turn lanes by modifying the through lane to a shared through/right-turn lane. If this improvement is implemented, a leading pedestrian interval with a “NO RIGHT TURN” blank out sign for westbound right-turns should also be considered to provide a protected crossing for pedestrians. A more detailed analysis should be conducted prior to implementing this improvement.

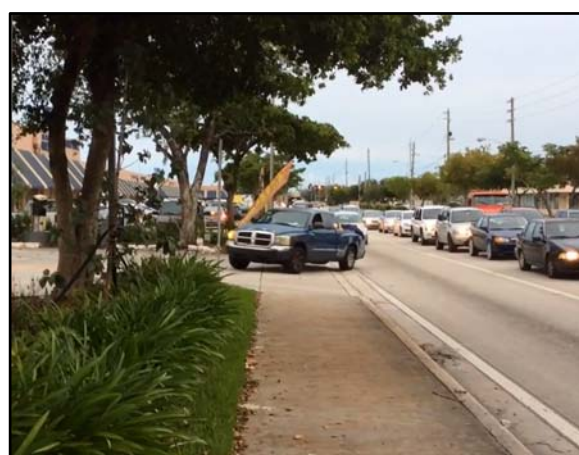
For the westbound approach, the PM peak hour had the highest volumes with 180 vph in the left-turn lane, 371 vpd in the through lane, and 452 vpd in the right-turn lane. Aggressive driving, including speeding and red light running, was observed as phase failures occurred. To reduce aggressive driving, consider reviewing the signal timings to allow additional time for NW 19<sup>th</sup> Street.

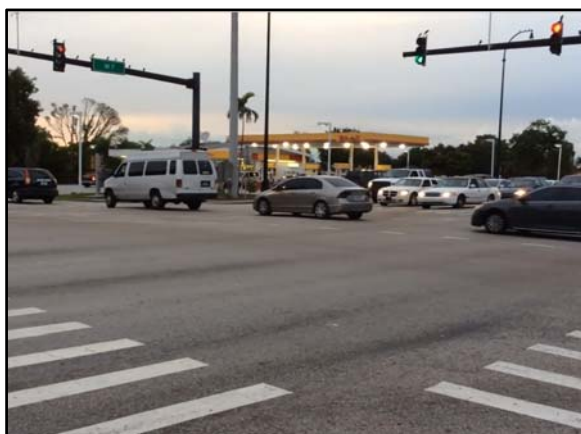
The median opening 250 feet west of SR 7 should be closed as westbound left turning vehicles block westbound through traffic.

During observations, two left-turning vehicles at this location were observed waiting to turn left within the westbound through lane. The vehicles were unable to turn left until after the eastbound phase turned red and an eastbound vehicle allowed them to turn. This resulted in westbound vehicles to queue and block the intersection. Consider closing the median to not allow this movement. This improvement would also allow the eastbound left-turn lane to be extended 140 feet west.

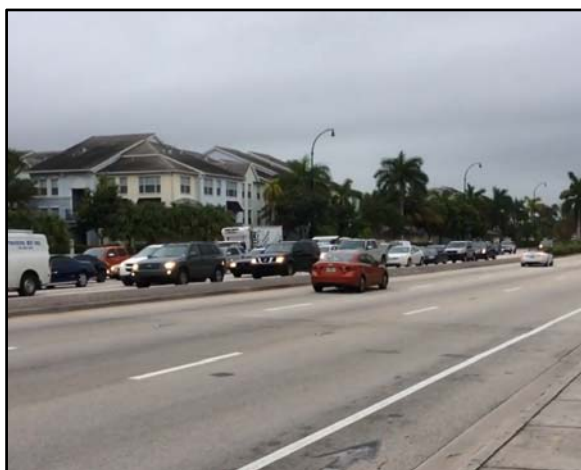
The northbound left-turn lane was observed having large queues during the PM peak hour.

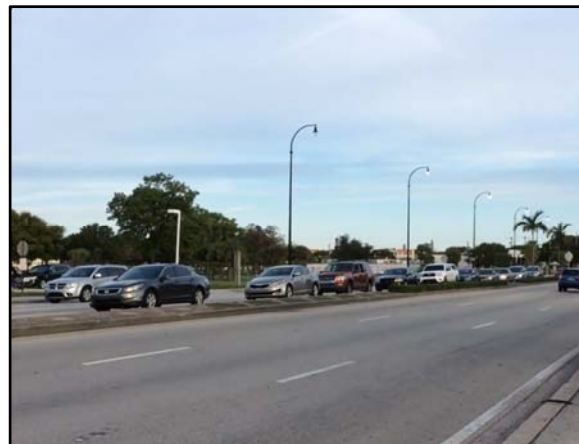
The southbound left-turn lane was observed having large queues during the AM and PM peak hours.

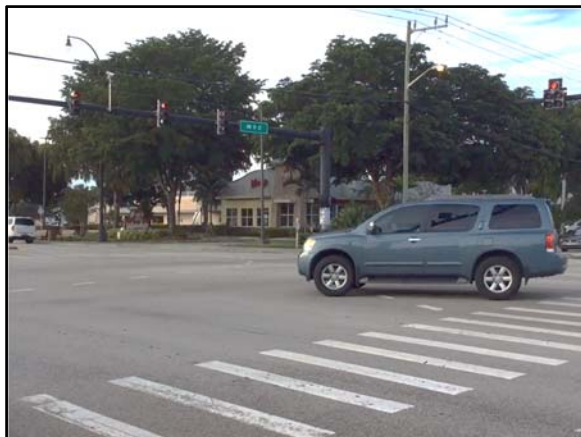
The southbound left-turn lane had 252 vph during the AM peak hour and 230 vph during the PM peak hour. During the field reviews many southbound left-turn phase failures occurred. Many drivers were observed driving aggressively such as speeding and running the red light. To reduce aggressive driving, signal timings should be reviewed to allow more time for the southbound left-turn movement. During nonpeak hours, consider installing a four-section left-turn arrow to display a flashing yellow (or red) during the northbound/southbound through movements as gaps were available in traffic that left-turns could utilize.

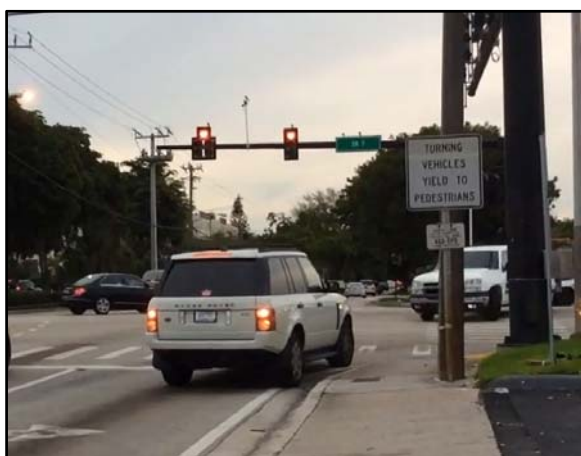
A conflict was observed between a westbound right turning vehicle and a southbound U-turning vehicle. Consider prohibiting the southbound U-turn movement as U-turns are permitted at NW 21<sup>st</sup> Street which is 780 feet north of the intersection. Also, consider a right-turn overlap with the left-turn movement by installing a four-section right-turn arrow to display a green arrow during the left-turn phase.

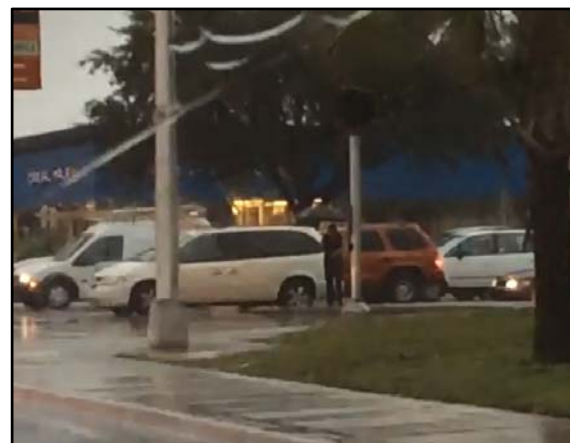
Pedestrians were observed crossing during the “DO NOT WALK” pedestrian phase during the AM peak hour and while it was raining in the PM peak hour. Enforcement of pedestrians who do not obey pedestrian signals should be increased. Upgrading the crosswalks to special emphasis or ladder style crosswalks would provide better visibility. Separating the pedestrian push buttons and relocating the push buttons closer than 10 feet of the curb ramps would provide better accessibility.

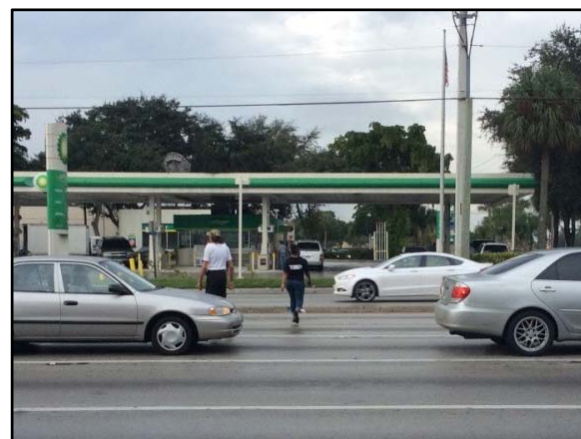
Pedestrians were observed crossing midblock along both SR 7 and Oakland Park Boulevard. Consider installing “NO PEDESTRIAN CROSSING” sign (R9-3) with “USE CROSSWALK” (R9-3b) within the median for each approach that currently does not have these signs to direct pedestrians to use the crosswalks.

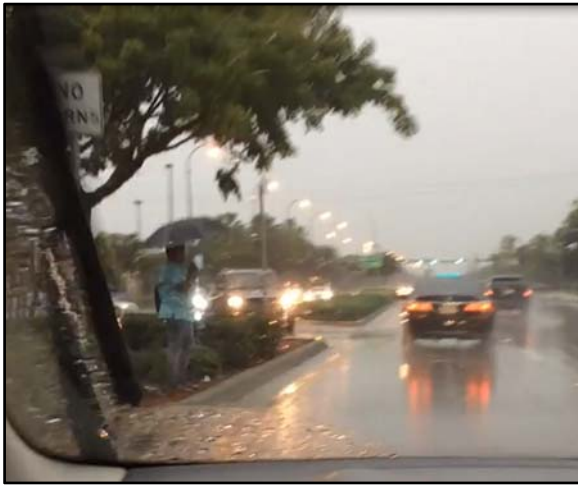
A pedestrian was observed waiting in the median to cross SR 7 while it was raining.

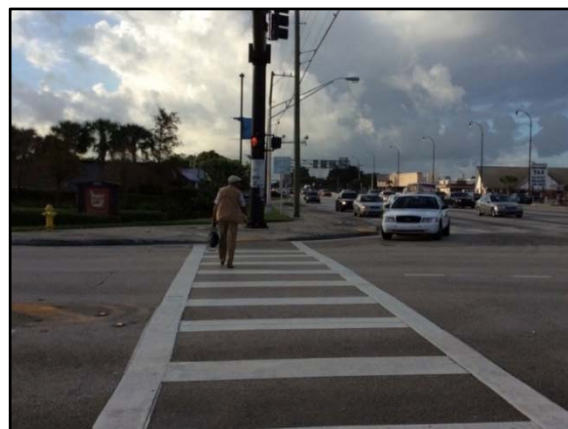
Pedestrians were observed crossing during the “DO NOT WALK” pedestrian phase. Enforcement of pedestrians who do not obey pedestrian signals should be increased. The pedestrian push buttons should be separated and relocated closer to the curb ramps for better accessibility.

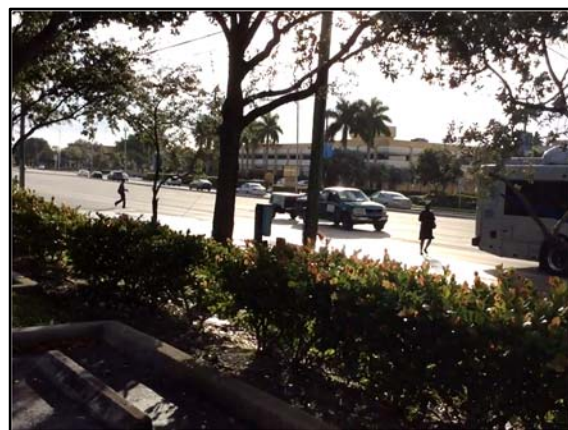
Pedestrians were observed crossing midblock to reach the bus stops along both SR 7 and Commercial Boulevard. Enforcement of pedestrians who do not use the crosswalks.

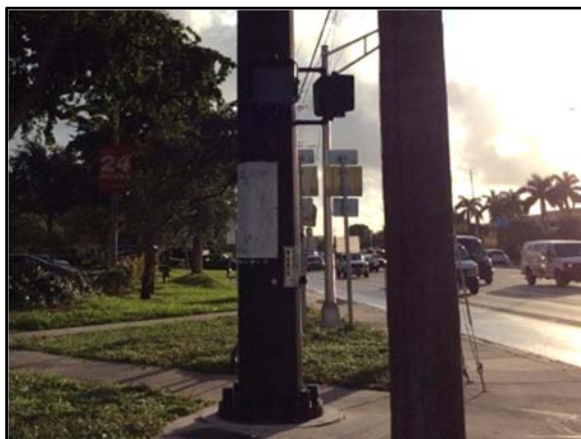
All of the pedestrian signals were audible and all appear to have countdowns. However not all countdowns were utilized and the “WALK” signal for eastbound pedestrians for the north crosswalk was broken and was not displaying. The broken pedestrian signal should be fixed and all pedestrian signals modified to display countdowns

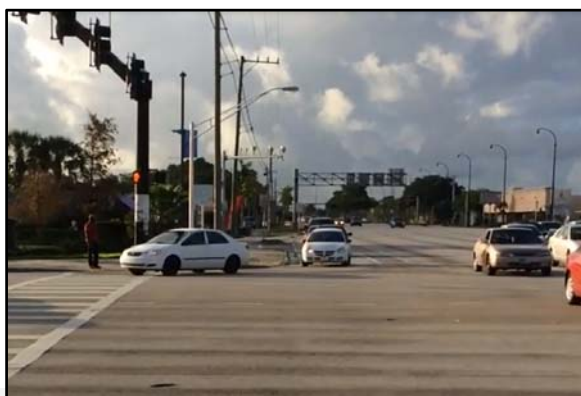
Northbound right turning vehicles were observed not yielding to pedestrians. Consider supplementing the “YIELD TO PEDESTRIANS” (R10-15R) sign with a four-section flashing yellow (or red) right-turn arrow which would display a flashing yellow (or red) arrow when pedestrians are crossing to encourage drivers to yield to pedestrians.

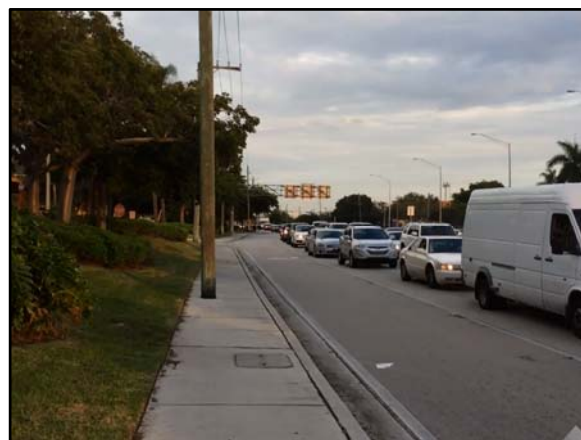
The westbound approach was observed having large queues during the AM and PM peak hours. The striping for the westbound approach is in poor condition and should be replaced.

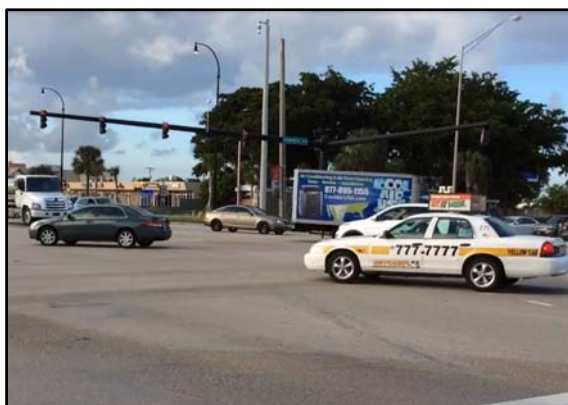
During the PM peak hour the eastbound, westbound, and northbound left-turn movements had phase failures and long queues. Red light cameras are along the northbound, southbound, and westbound approaches. Despite the cameras, vehicles were observed running the red light and driving aggressively. To increase capacity, consider right-turn overlaps with the left-turn movements by installing a four-section right-turn arrow to display a green arrow during the left-turn phase and a flashing yellow (or red) right-turn arrow during the pedestrian phase to encourage drivers to yield to pedestrians. This improvement would require prohibiting the U-turn movements.

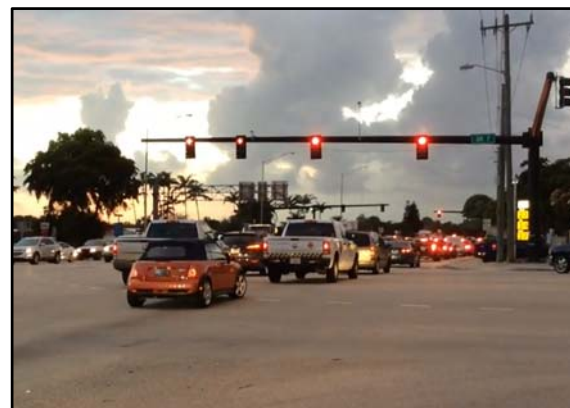
Commercial Boulevard had failures to the west of the intersection due to the Turnpike and/or the signal at Mainland Drive. Westbound traffic could not clear the intersection by the end of the phase and would block northbound left-turns and the southbound movement.

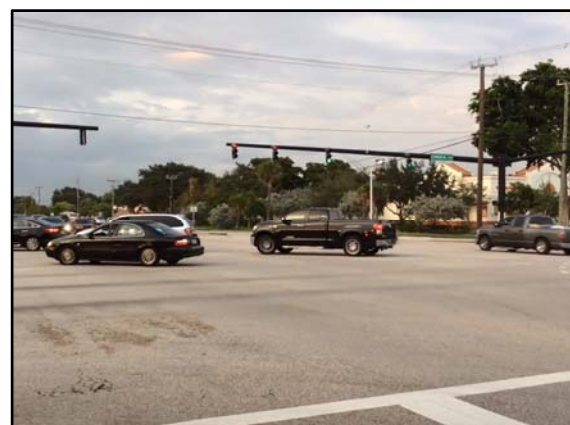
Northbound left-turn phase failures were observed and left-turning vehicles were not able to clear the intersection.

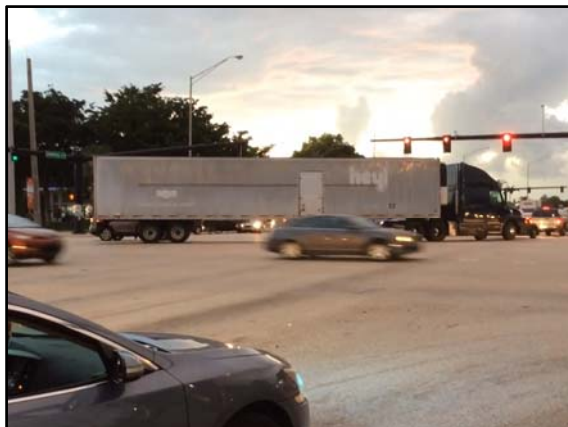
A northbound left-turning semi was observed stuck in the intersection as westbound Commercial Boulevard was too congested. Southbound vehicles had a green signal and could not move as the semi was blocking their route. The Turnpike and/or the signal at Mainland Drive may be causing the congestion. A more detailed study may be needed to review Commercial Boulevard just west of SR 7.

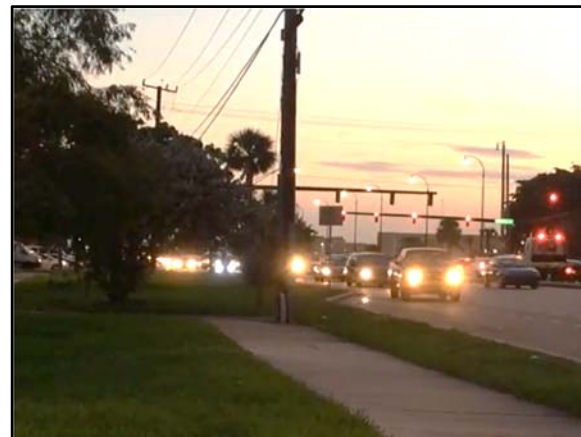
Sight distance is limited at the CVS driveway just north of Commercial Boulevard as vegetation is blocking visibility of northbound SR 7 traffic. Vegetation should be trimmed to provide better visibility.

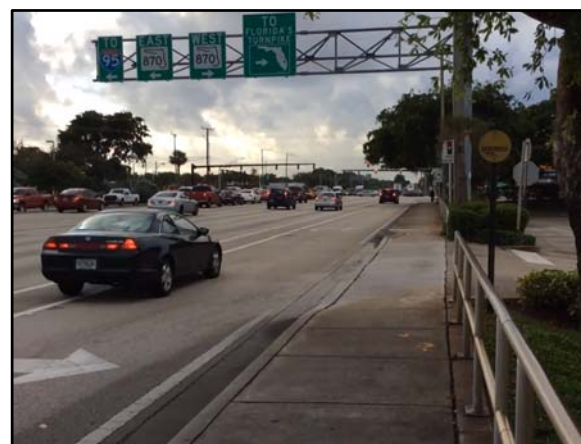
The southbound right-turn lane on SR 7 is approximately 650 feet long and a driveway for the Sunshine Plaza is 415 feet north of the intersection. Southbound vehicles were observed entering the right-turn lane near the shopping plaza entrance but not entering the plaza. Instead vehicles would continue south to turn right at Commercial Boulevard. No conflicts were observed at this location. However, consider separating the right-turn lanes with chevrons or a concrete island to reduce any potential conflicts that could occur.
