SUNRISE BOULEVARD CORRIDOR SUMMARY

SUNRISE BOULEVARD DEMONSTRATION CORRIDOR REVIEW

From NW 13th Avenue to Middle River | Fort Lauderdale

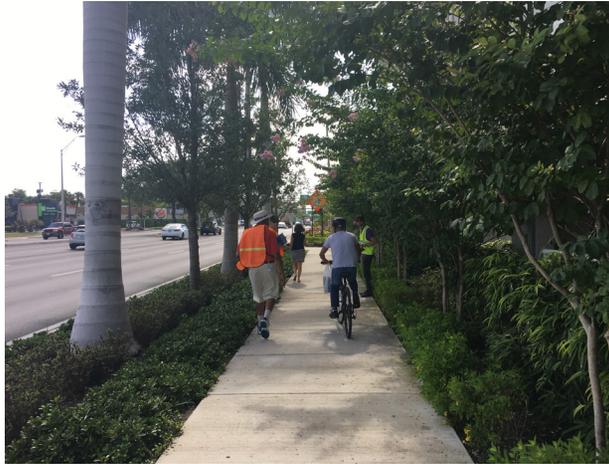
- There are no bike lanes in the corridor.
- Bicyclists ride on the narrow sidewalks, creating conflicts between bicyclists and pedestrians.
- Bicyclists were also observed riding on the sidewalk in the opposite direction of vehicles.
- These conditions create safety issues for bicyclists, especially at intersection and driveway crossings.

Bicyclists ride in the sidewalk, causing potential conflict between pedestrians and bicyclists.

- Evaluate the addition of bike lanes throughout the corridor. Ensure that the bike lanes are designed to have sufficient width to safely separate bikes from the high-speed and high-volume vehicular traffic along Sunrise Boulevard, in order to promote use of the bike lanes rather than the sidewalks. The high volumes and speeds suggest the need for protected or separated bike lanes to accommodate the needs of riders.

- Provide additional visual separation of bike lanes through buffers.
- Use green paint at intersections, driveways, or other conflict points to highlight to drivers that bicyclists may be crossing.

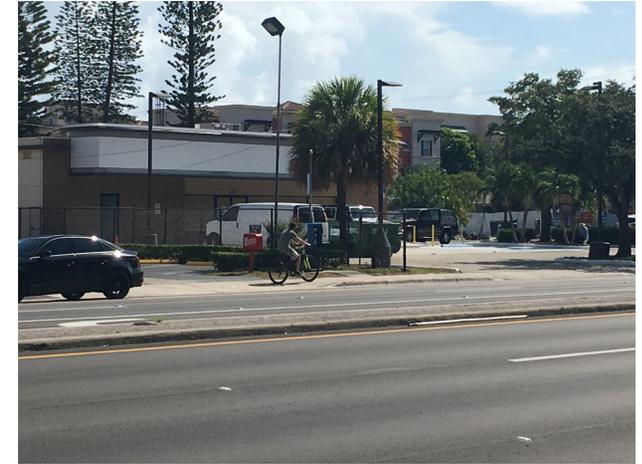
Bicyclist riding in the sidewalk.

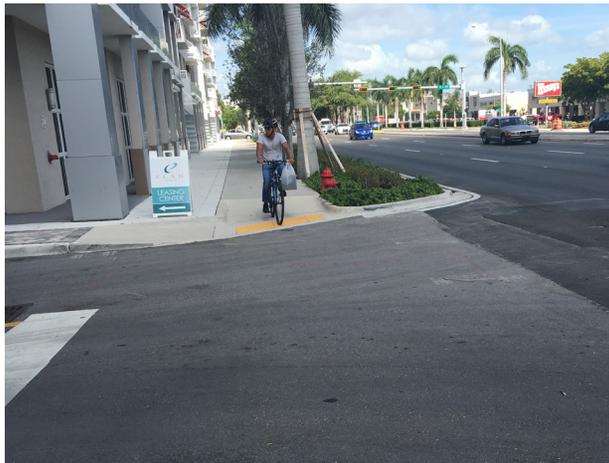
Bicyclist riding in the sidewalk.

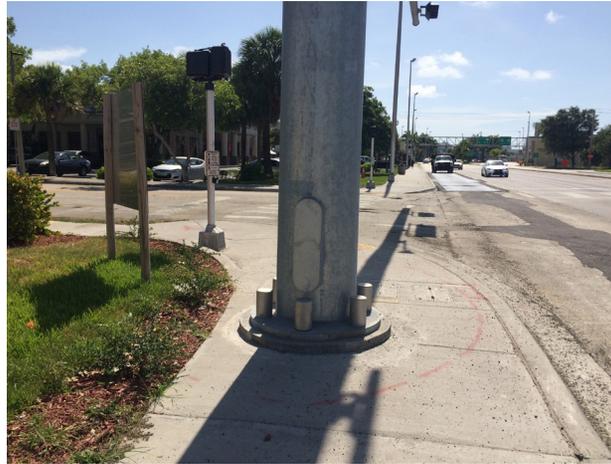
- Utility poles, signal poles, fire hydrants, and bus stop benches are mounted within the sidewalks throughout the corridor.
- Sidewalks are less than 6 feet.
- Sidewalks are directly adjacent to travel lanes without any separation from vehicles.
- Some adjacent sidewalks do not align with each other.

Poles are frequently placed in the sidewalk.

- Widen sidewalks to meet or exceed ADA standard minimum width (6 feet if at back of curb) or add landscaped buffer between sidewalk and street.
- Relocate fixed objects off of sidewalks or provide additional sidewalk width to bypass. There should be a minimum of 4-foot clearance around fixed objects in accordance with forthcoming Public Right of Way Accessibility Guidelines.

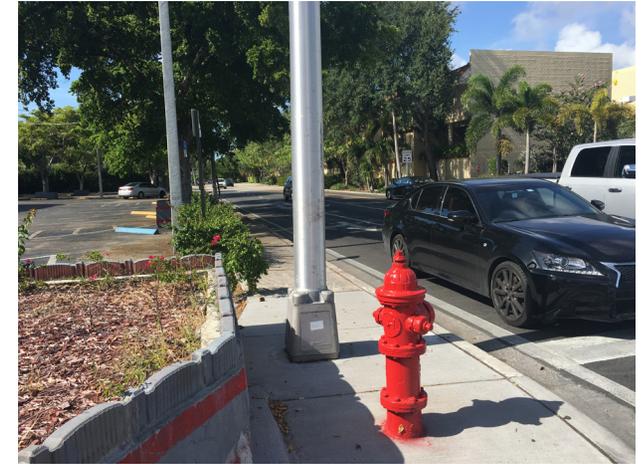
Objects in sidewalk on the SE corner of the NE 15th Avenue intersection.

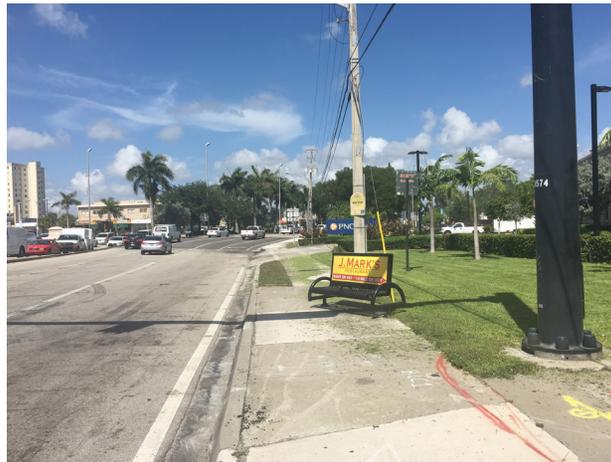
Bench placed in the sidewalk; some sidewalks are wide but still do not offer separation from the street.

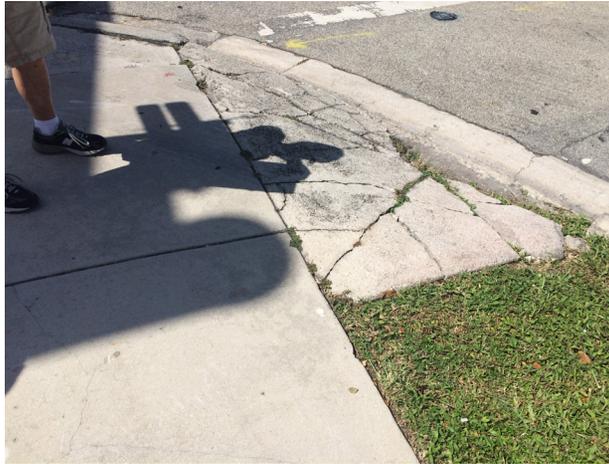
- Fixed objects are mounted within the sidewalks,
- Sidewalk ramps do not comply with ADA requirements at every intersection along the corridor.
- In general, the truncated domes are missing, worn, or misaligned.
- In several areas, accessible sidewalk connections are not present between the sidewalk and driveways or private parking lots.
- The drainage inlet on the northwest corner of NE 15th Avenue blocks the ramp.

Lack of detectable warning surfaces and broken sidewalk.

- Update all ADA ramps along corridor to meet requirements.
- Expand sidewalk network to connect sidewalks with safe driveway crossings.
- Move the drainage inlet on the northwest corner of NE 15th Avenue away from ramp.

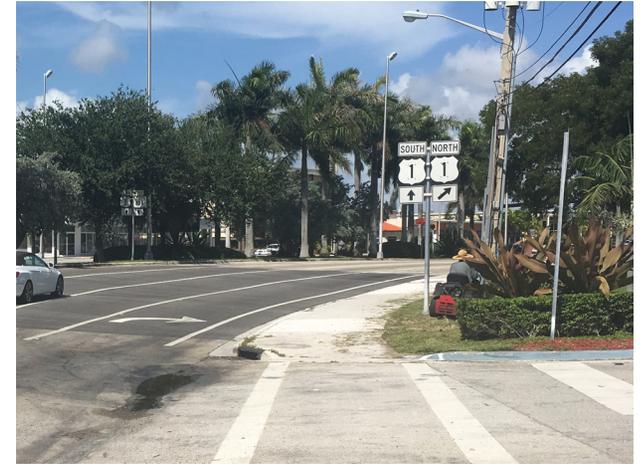
Lack of detectable warning surfaces.

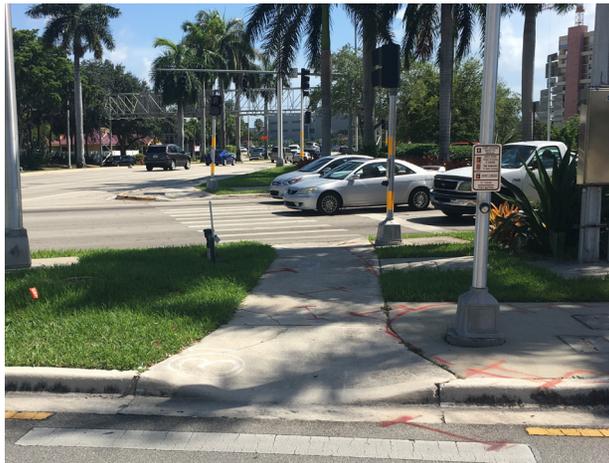
Lack of detectable warning surfaces.

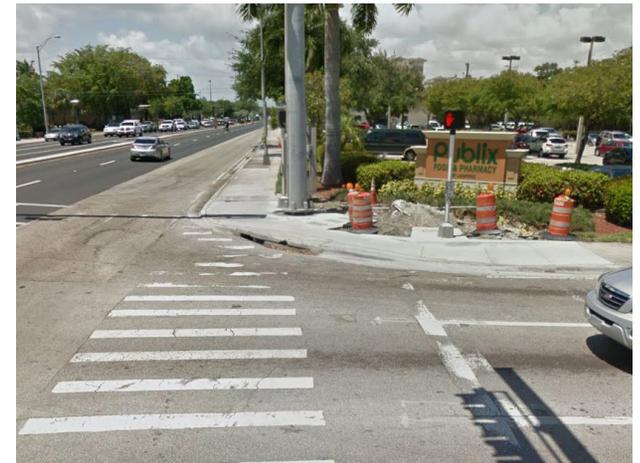
The drainage inlet on the northwest corner of NE 15th Avenue blocks the ramp.

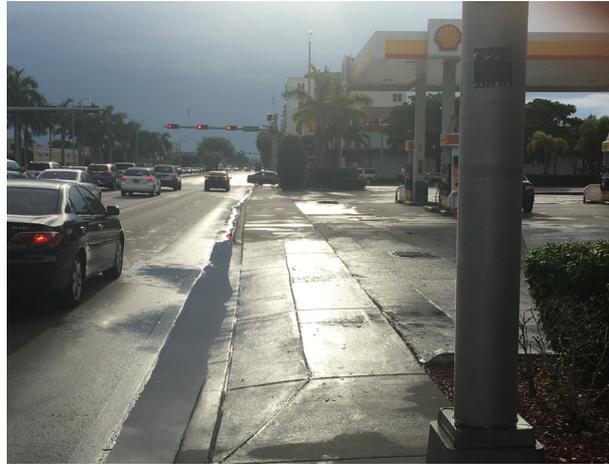
- There are a number of driveways between intersections along the corridor. Many of these driveways have poorly marked crosswalks.
- Many driveways along the corridor are very wide and allow drivers to turn in and out without slowing down.
- Many drivers were observed turning out of driveways without looking for or yielding to pedestrians.
- In section 13, almost every development has a right turn lane. These prevent new pedestrian crossings from being created and allow drivers to turn quickly in to driveways.

Wide driveways at a gas station on Sunrise Boulevard.

- Refresh pavement markings to emphasize crosswalks across driveways.
- Create an outreach campaign to alert bicyclists of the dangers of riding on the sidewalks and to alert drivers of the need to look for bicyclists when turning in to and out of driveways.
- Encourage cross access agreements between developments to limit the number of driveways approved along the corridor.
- Consider narrowing driveways where possible and ensure that driveway width is considered in development review for new developments.
- Consider whether right turn lanes are needed at every development. If not, consider where they might be able to be removed.

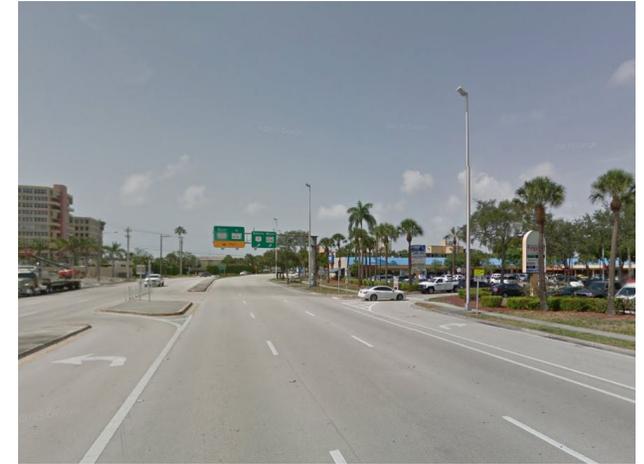
Frequent left and right turn lanes on Federal Highway.

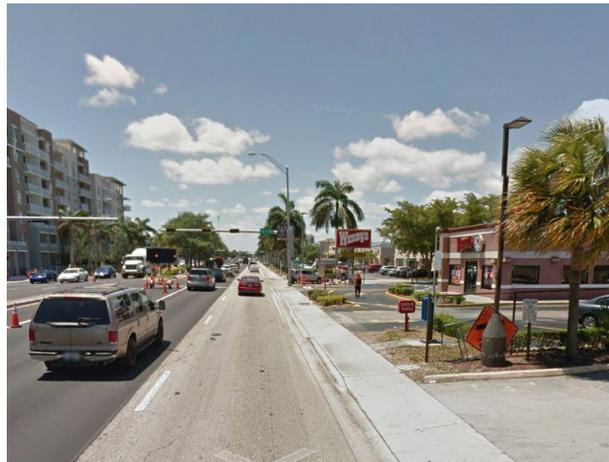
Frequent driveways on Sunrise Boulevard.

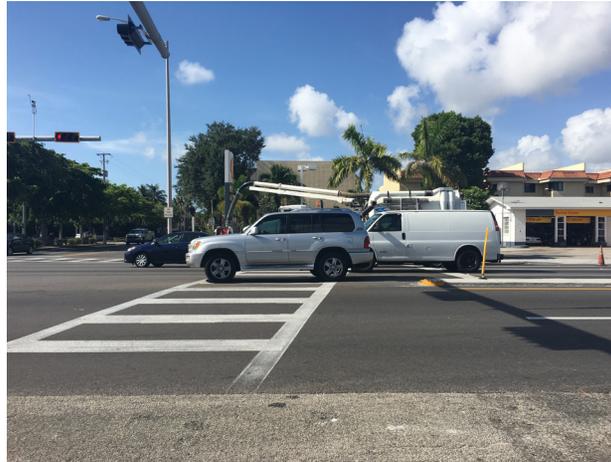
- Drivers turning right on red do not always look for pedestrians in crosswalks before turning.
- During field observations, several drivers almost hit pedestrians or bicyclists in the crosswalks and at driveways.
- Drivers exiting driveways do not always yield or look for pedestrians or bicyclists.
- Drivers stop in the crosswalk and block access to the sidewalks. This is sometimes due vehicles pulling through the stop bars in order to see oncoming traffic because the stop bar is set back.

Vehicle waiting to turn left in the crosswalk.

- Install warning signs at intersections and driveways, such as “Stop Here on Red”.
- Consider implementing “No Right Turn on Red.”
- Educate drivers on safe driving behavior through programs such as best foot forward, alert today, alive tomorrow and by working with Google and Waze.
- Create a progressive enforcement campaign where officers educate, warn, and finally ticket drivers who block crosswalks.
- Consider redesigning the location of the stop bar and crosswalk.

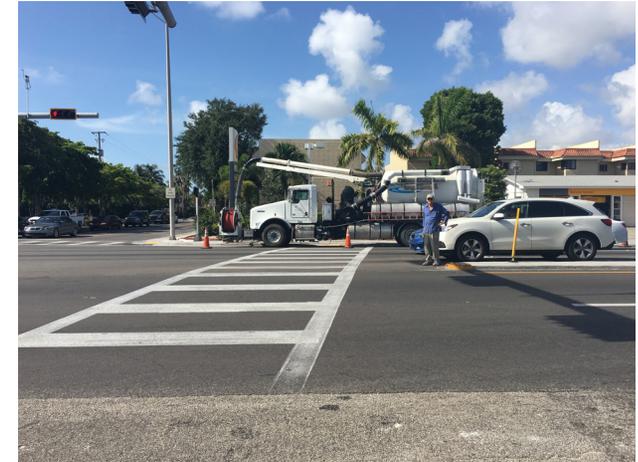
Vehicle parked in the crosswalk.

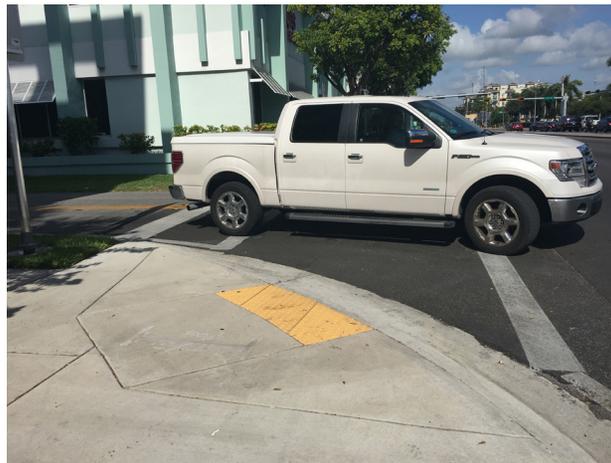
Vehicle parked in the crosswalk.

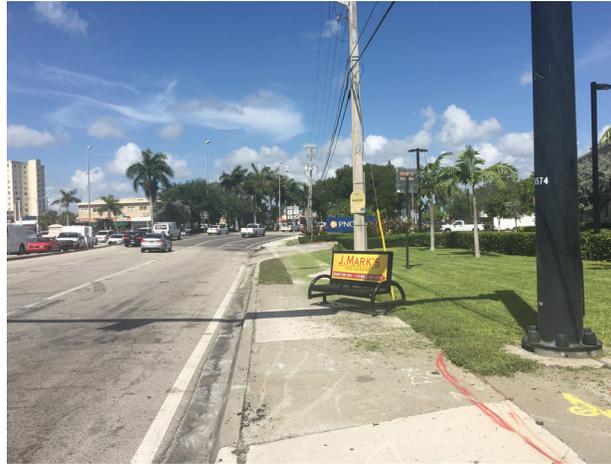
- Throughout the corridor, there is little shade for pedestrians.
- The bus stops lack shelter from the sun and rain. At NE 17th Way, the bus stop does not provide seating for waiting riders.
- At US 1 and other major intersections, no shade is available for pedestrians waiting for the long cycle lengths before safely crossing the road.

Bus stop without shelter on Sunrise Boulevard.

- Upgrade bus stops to provide seating and shelter for users.
- Evaluate options to provide shade and shelter at intersections to encourage pedestrians to use crosswalks.

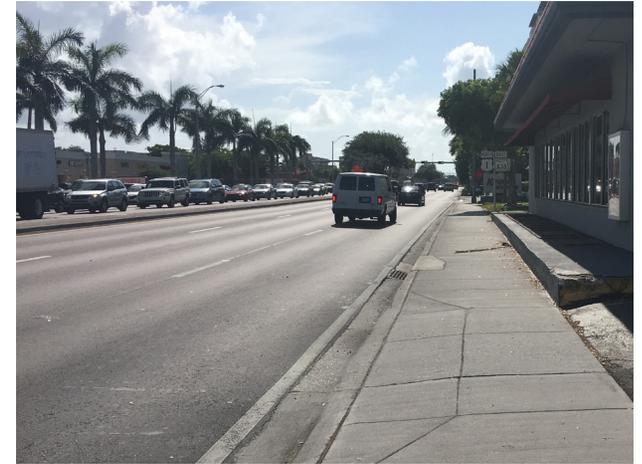
Much of the corridor does not have shade along the sidewalks.

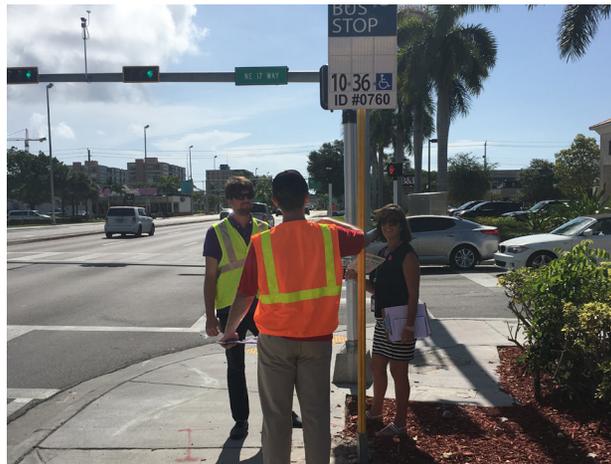
Bus stop without shelter on Sunrise Boulevard.

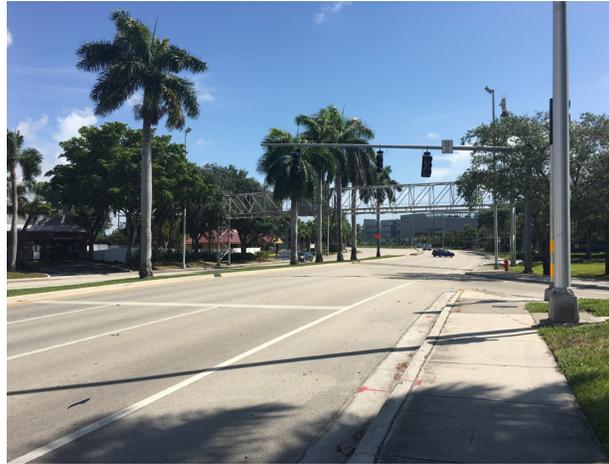
- The Gateway intersection offers limited crossing opportunities.
- There is no opportunity to cross from east to west on the north side of Sunrise Boulevard at Federal Highway.
- Corridor wide, frequent left and right turn lanes create limited opportunities for mid-block crossings.

No east/west crossing for Federal Highway on the north leg of the Gateway intersection.

- Study realignment of the Gateway intersection to allow for an east/west crossing on the north leg.
- Explore locations for safe mid-block crossings and consider bi-directional median opening crosswalks and TWLTL median refuge islands such as on Federal Highway just north of Sunrise Boulevard.

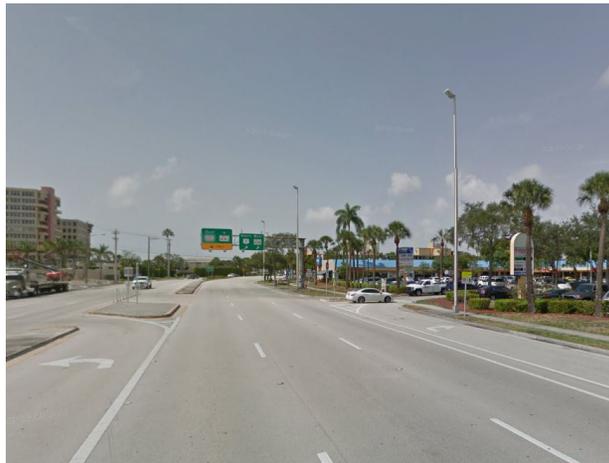
Frequent left and right turn lanes on Federal Highway.

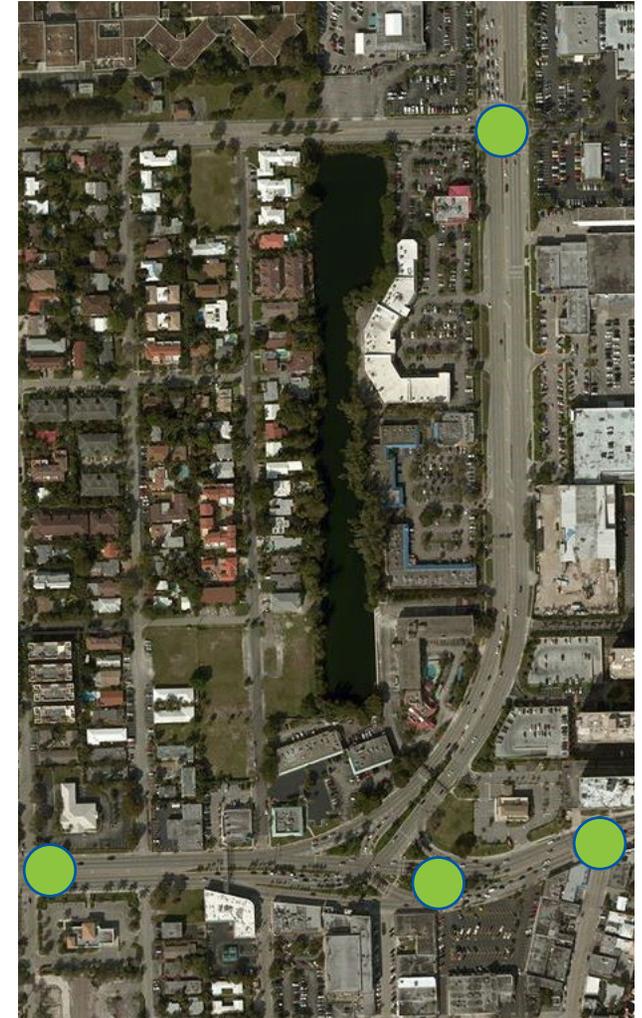
Crossing opportunities around the Gateway intersection.

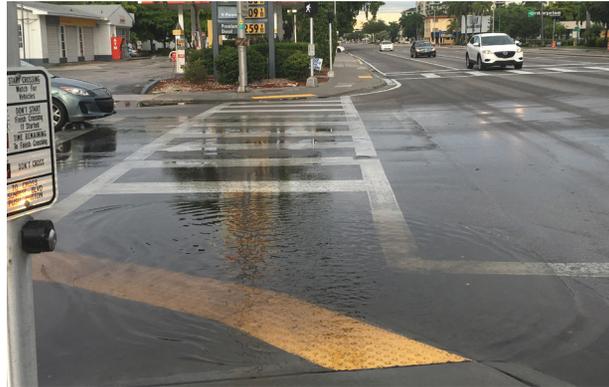
- Drainage is poor throughout the study area, but especially at the intersection of NE 15th Avenue. Flooding at this intersection blocks the sidewalk ramp.

Flooding on the SE corner of the NE 15th Ave intersection.

- Update drainage system throughout corridor. Complete a study to determine specific locations where drainage issues are occurring. Consider options such as elevation modifications and improving draining through landscaping and other opportunities.

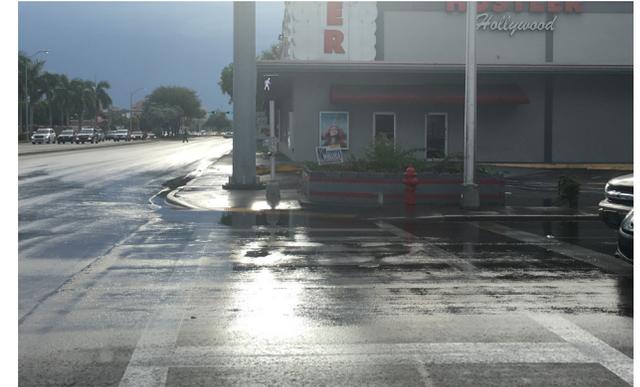
Flooding on the SE corner of the NE 15th Ave intersection.

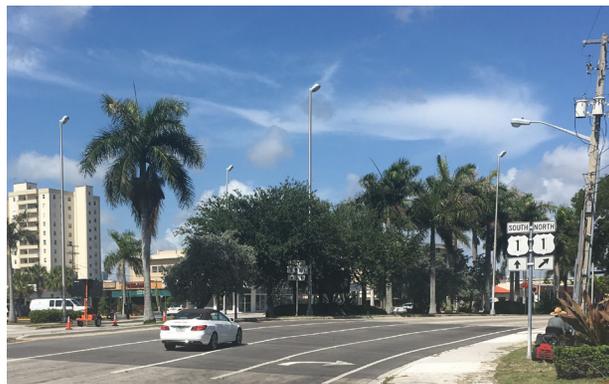
- Almost half of the crashes occurred at night.
- Lighting focuses on street and there is no pedestrian lighting.
- Lighting does not meet new illumination standards as noted in FDOT's Plans Preparation Manual.

Typical auto-oriented cobra head lighting on Sunrise Boulevard.

- Complete a lighting study with a focus on pedestrian lighting.
- Create an outreach campaign to alert pedestrians and bicyclists of the need to wear bright clothing at night and to use lighting.

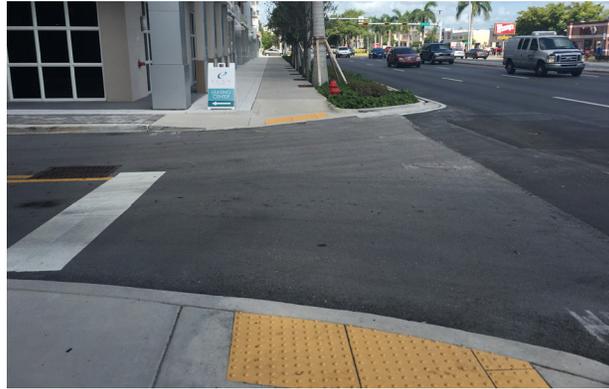
Missing crosswalk in driveway.

- Due to the high pedestrian volumes along the corridor, add crosswalks across all intersection legs.

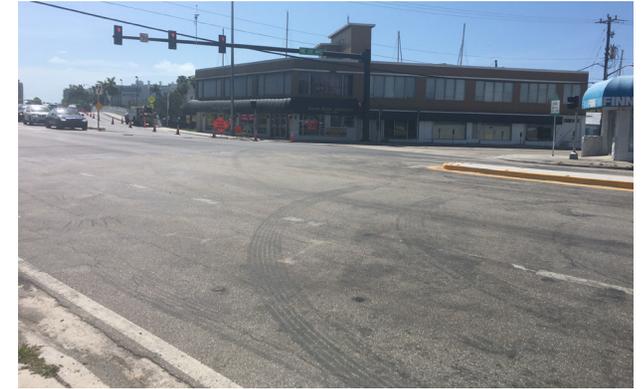
- Many of the crosswalks are faded, worn, or uneven.
- Crosswalks are not present across the west leg the intersection at NE 20th Ave even though there is a bus stop on that leg.
- Crosswalks are not marked across the south leg of NE 16th Avenue, NE 16th Terrace, or NE 17th Avenue.

Missing crosswalk at NE 20th Ave.

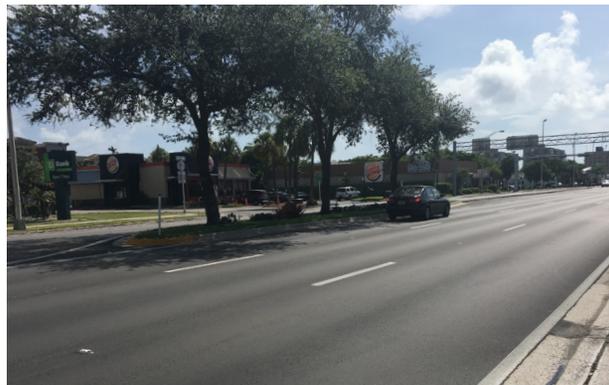
- Most of the medians are concrete curbs, which do not discourage pedestrians from making mid-block crossings.

Median with vegetation that allows pedestrians to pass through.

- Use lush landscaping to close off the medians to prevent pedestrians from making illegal mid-block crossings.

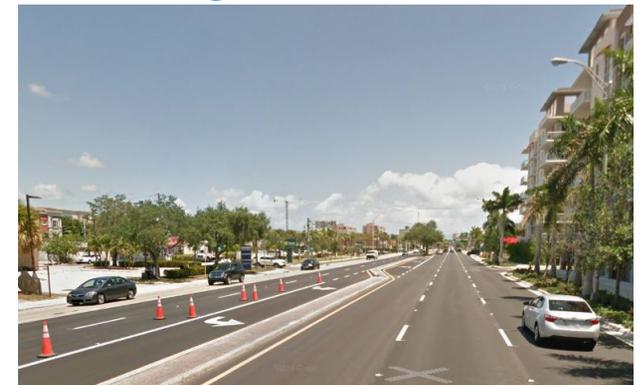
Frequent turn lanes limit space, allowing only for concrete curb medians.

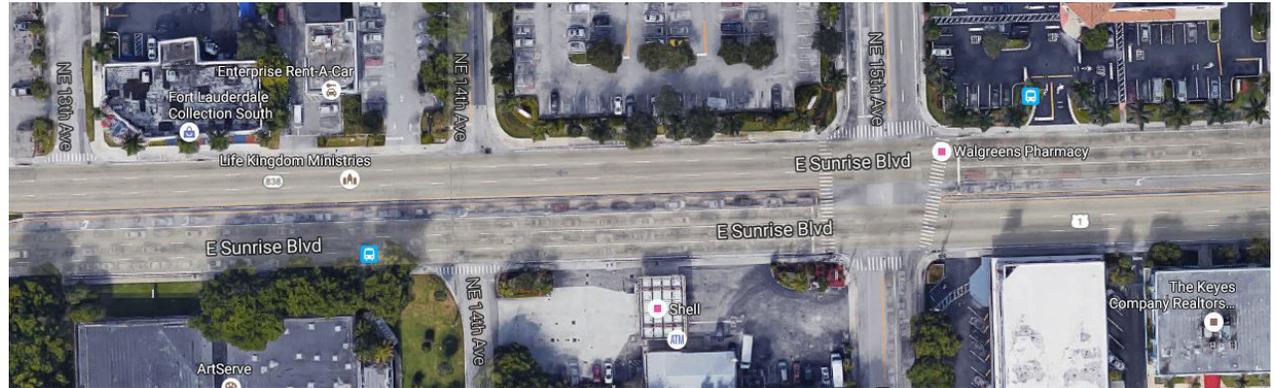
- Mid-block pedestrian crossing is a critical safety concern throughout the corridor. Many, but not all, of the observed illegal mid-block crossings result from bus stops that are not conveniently located near existing crosswalks. Alternatively, crosswalks are not conveniently located near the bus stops.

The bus stop located west of NE 14th Avenue is not close to a crossing of Sunrise Boulevard.

- Evaluate the bus stop locations and potential mid-block crosswalk locations.
- Design mid-block crosswalks with enhanced visibility features, such as Rectangular Rapid Flash Beacons (RRFBs), to encourage use and to improve safety.

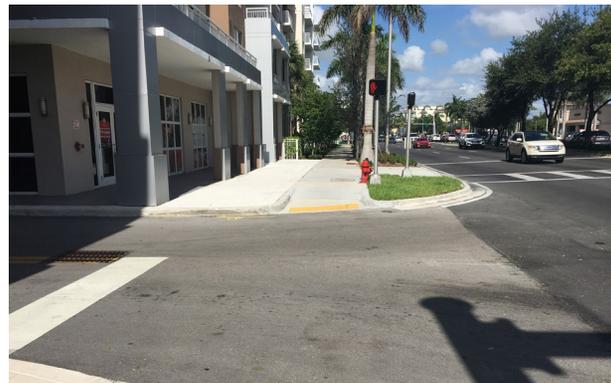
- Signal times are long, which causes long wait times for pedestrians when crossing the street at intersections.
- It was observed that pedestrians cross the street against the signal even in crosswalks instead of waiting for the Walk signals.

The signal on the south leg of NE 16th Terrace rarely changes to allow pedestrians to cross.

- Consider retiming signals with a focus on pedestrian and bicycle mobility.

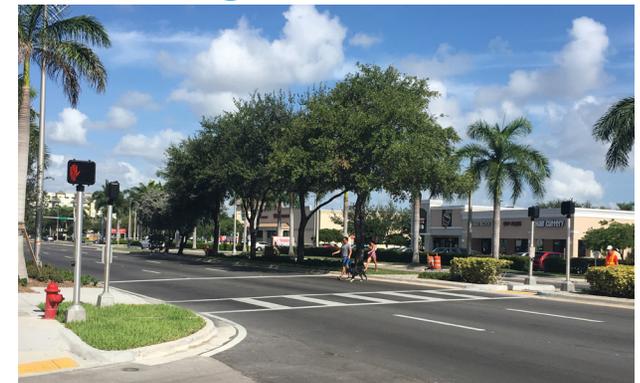
Pedestrians crossing outside of the mid block crosswalk.
