BROWARD BOULEVARD AND ANDREWS AVENUE SUMMARY

BROWARD BOULEVARD AND ANDREWS AVENUE | Intersection Study

BROWARD BOULEVARD AND ANDREWS AVENUE DEMONSTRATION INTERSECTION REVIEW

Broward Boulevard at Andrews Avenue | Fort Lauderdale

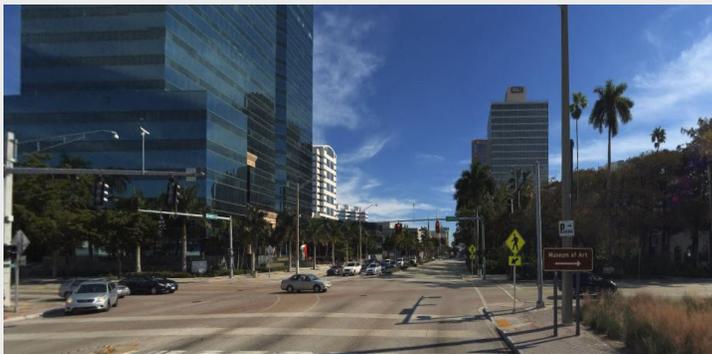
Looking West

Broward Boulevard has three lanes in each direction and Andrews Avenue has two lanes in each direction. Both roads are divided with intermittent right- and left-turn lanes. At the intersection, each leg has left turn lanes. The roads have cement or lightly vegetated medians and cobra style vehicular lighting. The corridor has 6' or wider sidewalks and no marked bike lanes. The intersection is located in the most urban part of Fort Lauderdale and is surrounded by high rise, mixed use buildings arranged in a generally walkable manner.

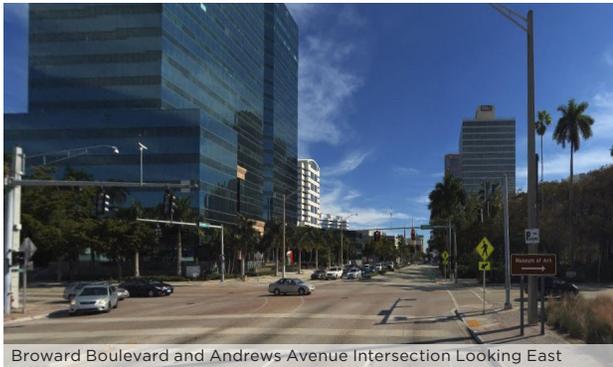
Broward Boulevard and Andrews Avenue Intersection Looking East

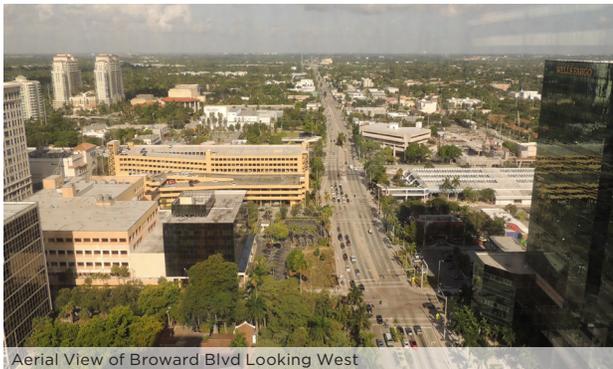
Aerial View of Broward Blvd Looking West

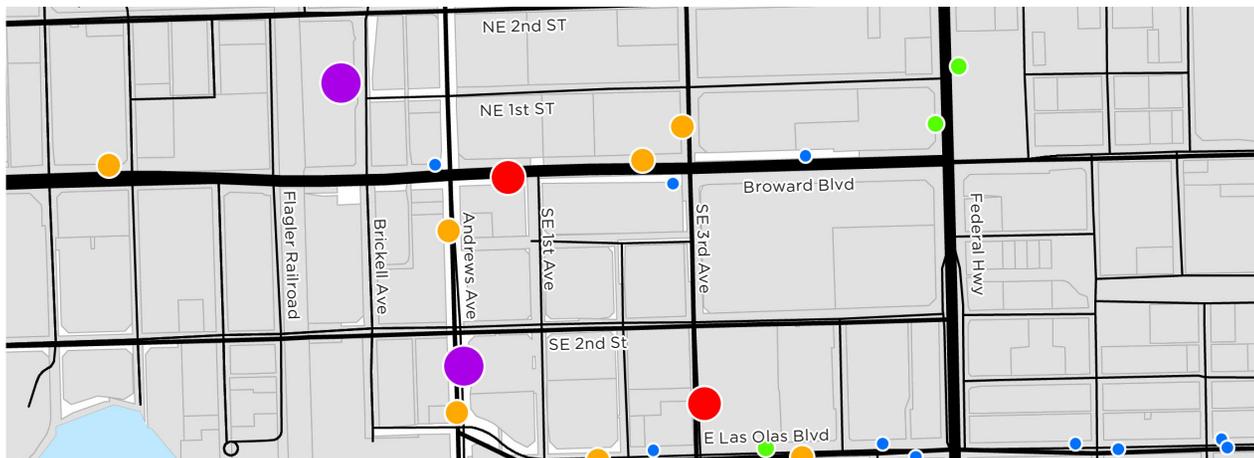
FIGURE 2 | Study Area Transit Ridership

Transit ridership is high in the study area, mainly due to the location of the central terminal for Broward County Transit on Broward Boulevard and Brickell Avenue. Ridership will likely continue to grow when the new Brightline rail station is built opposite to the central terminal. Ridership is also high at the Museum Plaza on Andrews Avenue south of NW 2nd Street. The other bus stops in the corridor see moderate ridership. People were regularly observed waiting at the stops during the field review. Many people were observed crossing illegally at the bus stops as opposed to utilizing the marked crossings or waiting for the walk signal.

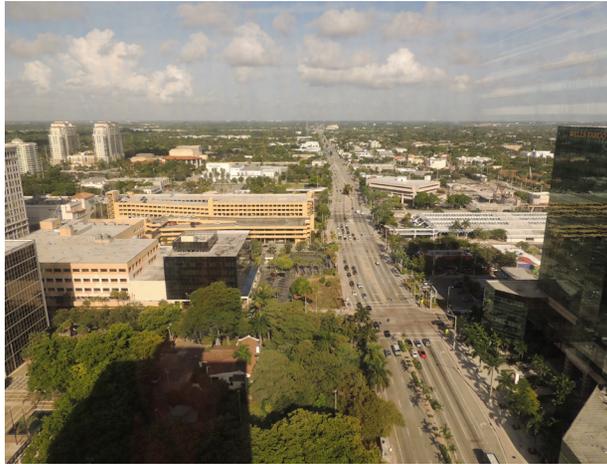
- Downtown Fort Lauderdale is the urban core of Broward County, and as such has high volumes of pedestrians and bicyclists throughout the day. However, Broward Boulevard is a road built to suburban standards and has been widened to better allow vehicles to move faster in and out of downtown. Only minimal accommodations have been given to pedestrians and bicyclists. This creates an uncomfortable and unsafe experience for walking and bicycling and can discourage people from choosing to walk or bike.
- This design has resulted in wide intersections and therefore long crossing distances for pedestrians.
- There are long distances between signalized crossings for pedestrians, which can encourage mid-block crossing and does not promote the urban condition.

Broward Boulevard is a wide corridor that divides Downtown Fort Lauderdale and is difficult to cross for pedestrians.

- Begin a discussion on user priority. This discussion should take into account the context of an area in determining roadway design. A visioning effort could help to determine areas which are intended for pedestrian and bicycling priority. New standards should be applied to roads which are intended for greater pedestrian/bicycling focus. These standards should include performance measures based on elements beyond congestion that consider a broader definition of mobility, including those that evaluate the pedestrian and bicycle environment.

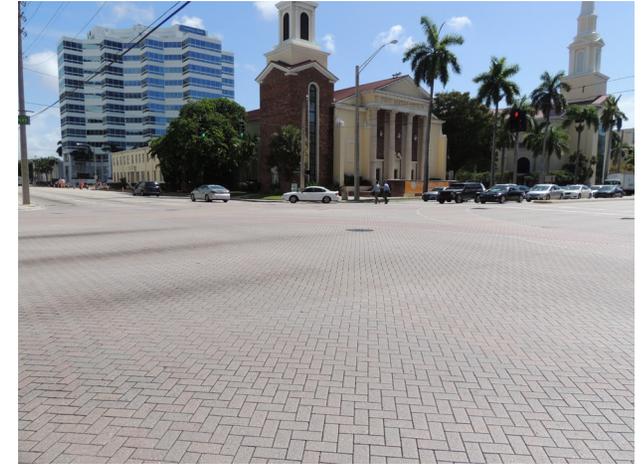
Wide intersections create long crossing distances for pedestrians.

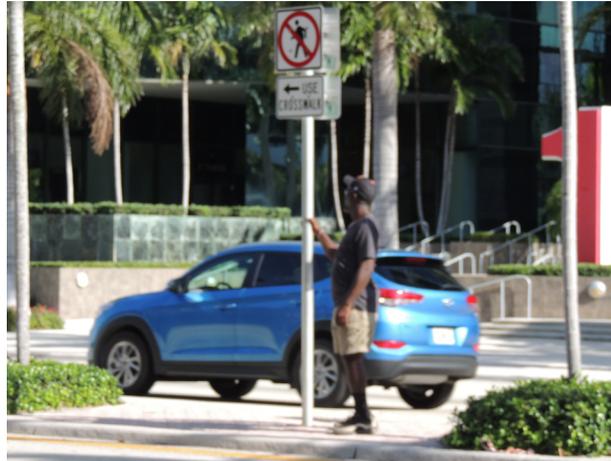
- Mid-block crossings observed at bus stops and where there are destinations on either side of the street.
- The distances between signalized crossings is very long in most locations.
- The signal times are long, which can discourage people from waiting for the signal to cross.
- In some locations, “Do Not Cross” signs have been installed, however they do not seem to have much of an impact based on field observations.
- Many pedestrians were observed crossing mid-block on Brickell Ave in front of the Broward Central Terminal.

Pedestrians using the median as a refuge.

- Explore locations for safe mid-block crossings and consider bi-directional median opening crosswalks and TWLTL median refuge islands.
- Install thick shrubs in the median to physically prevent pedestrians from crossing medians mid-block.
- Consider relocating bus stops closer to crossings to create incentive for crossing at signals.
- Create a progressive enforcement campaign where officers educate, warn, and finally ticket pedestrians who cross mid-block.

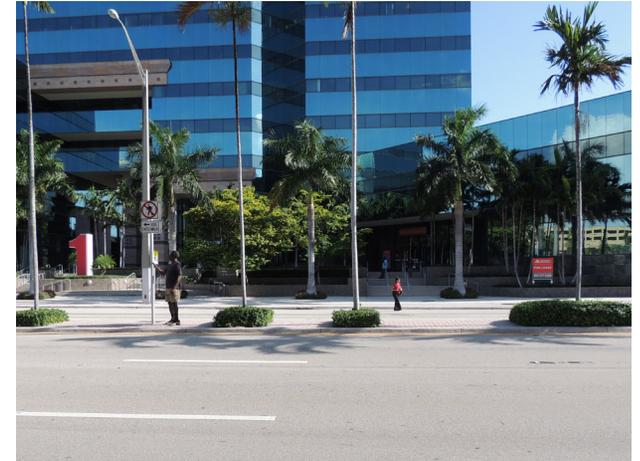
Pedestrian crossing mid-block.

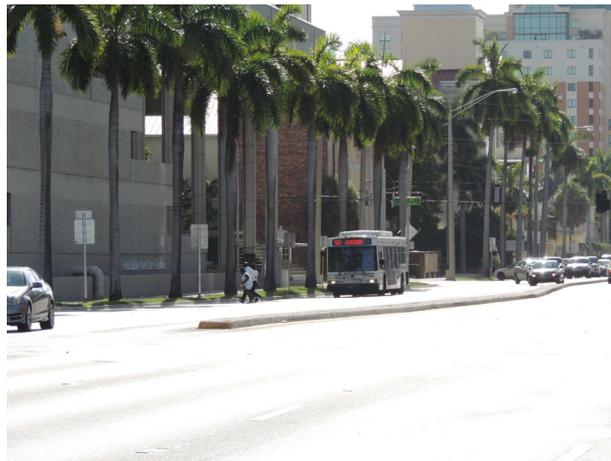
Pedestrian crossing mid-block.

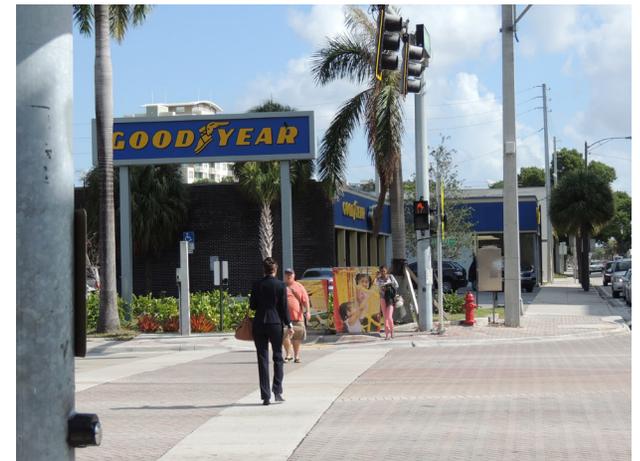
Pedestrians crossing against the signal.

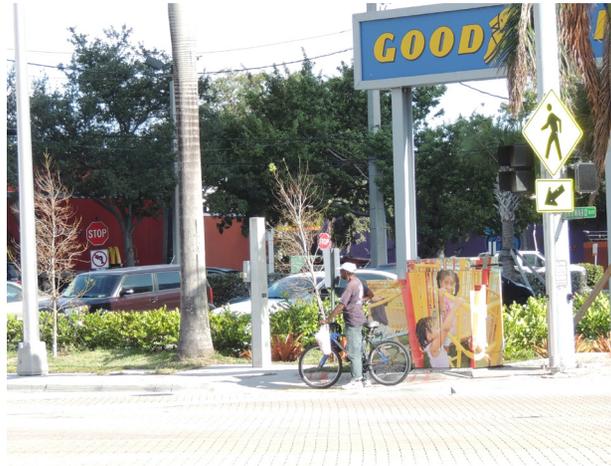
- There are no bike lanes in the study area.
- Bicyclists ride on the narrow sidewalks, creating conflicts between bicyclists and pedestrians.
- Bicyclists were also observed riding on the sidewalk in the opposite direction of vehicles.
- These conditions create safety issues for bicyclists, especially at intersection and driveway crossings.

Bicyclists riding on the sidewalk.

- Evaluate the addition of bike lanes throughout the study area. Ensure that the bike lanes are designed to have sufficient width to safely separate bikes from the high-speed and high-volume vehicular traffic in the study area in order to promote use of the bike lanes rather than the sidewalks. The high volumes and speeds suggest the need for protected or separated bike lanes on Broward Boulevard to accommodate the needs of riders. This could potentially be done through restriping.

- Provide additional visual separation of bike lanes through buffers.
- Use green paint at intersections, driveways, or other conflict points to highlight to drivers that bicyclists may be crossing.

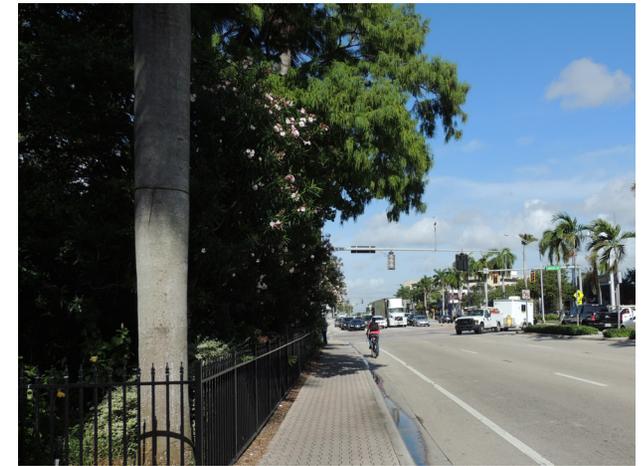
Bicyclist riding the wrong way in the shoulder on Broward Blvd.

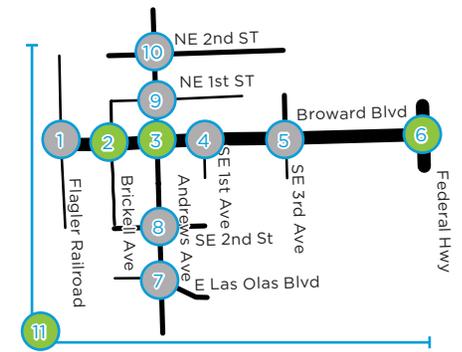
- Sidewalks are directly adjacent to travel lanes without any separation from vehicles.
- Sidewalks do not follow desire lines.
- Utility poles, sign poles, fire hydrants, and bus stop benches are mounted within the sidewalks or on approaches throughout the study area.

Pedestrian desire line.

- Consider adding a landscaped buffer between the sidewalk and the street.
- Look at where pedestrians are crossing and create better connectivity to and between destinations.
- Relocate fixed objects off of sidewalks or provide additional sidewalk width to bypass. There should be a minimum of 4-foot clearance around fixed objects in accordance with forthcoming Public Right of Way Accessibility Guidelines.

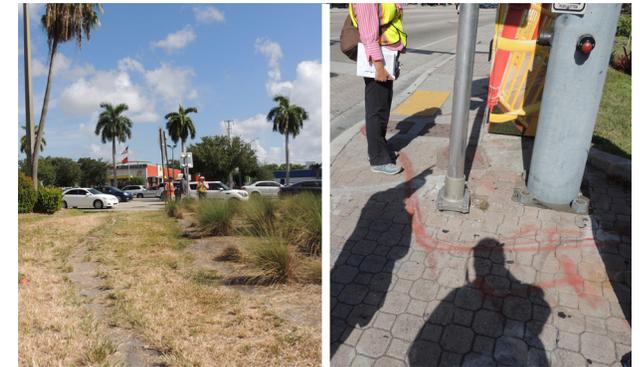
Objects in the sidewalk.

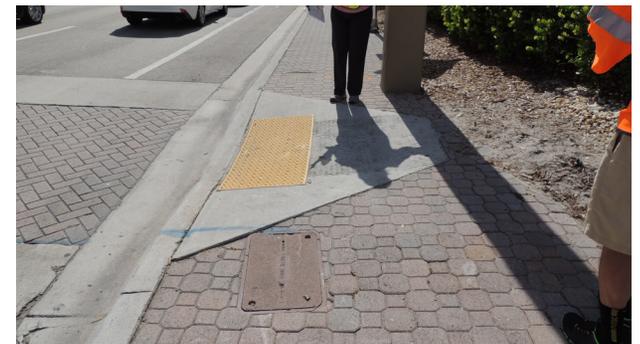
- Fixed objects are mounted within the sidewalks,
- Sidewalk ramps do not comply with ADA requirements at every intersection in the study area.
- In general, the truncated domes are missing, worn, or misaligned.
- In several areas, accessible sidewalk connections are not present between the sidewalk and driveways or private parking lots.
- In several locations, the pedestrian signal push buttons are located far from the crosswalk ramps or too close to each other.
- Some worn paths have been made where sidewalks do not exist.

The sidewalk does not provide a level surface behind the ramp as required by ADA.

- Update all ADA ramps along corridor to meet requirements.
- Relocate pedestrian signal push buttons to achieve proper separation and proximity to crosswalks.
- Expand sidewalk network to connect sidewalks with safe driveway crossings.

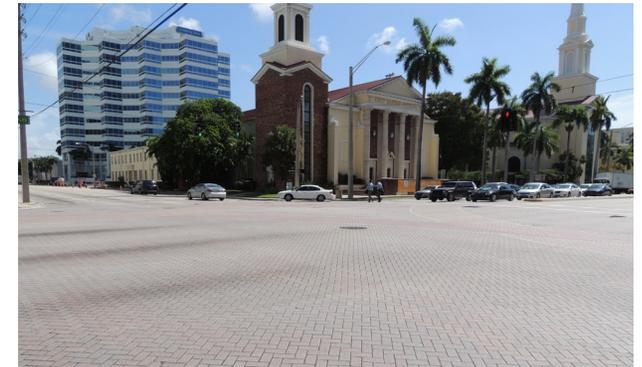
- Many intersections have excessive pavement widths. This is confusing to vehicles operating the intersection - especially with poorly maintained pavement markings - and yields long crossing distances for pedestrians.

Wide intersection at Broward Blvd and NE 3rd Ave.

- Evaluate the need for separate turn lanes and consider road diets where possible.
- Utilize excess space to incorporate bump outs, bike lanes, and other improvements to the bicycle and pedestrian realm.

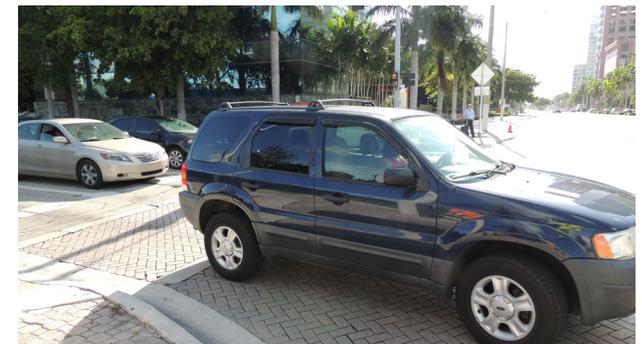
- Drivers turning right on red do not always look for pedestrians in crosswalks before turning.
- During field observations, several drivers almost hit pedestrians or bicyclists in the crosswalks and at driveways.
- Drivers exiting driveways do not always yield or look for pedestrians or bicyclists.
- Drivers stop in the crosswalk and block access to the sidewalks. This is sometimes due vehicles pulling through the stop bars in order to see oncoming traffic because the stop bar is set back.

Vehicle waiting in crosswalk to turn right at a signal.

- Install warning signs at intersections and driveways, such as "Stop Here on Red".
- Consider implementing "No Right Turn on Red."
- Educate drivers on safe driving behavior through programs such as best foot forward, alert today, alive tomorrow and by working with Google and Waze.
- Create a progressive enforcement campaign where officers educate, warn, and finally ticket drivers who block crosswalks.
- Consider redesigning the location of the stop bar and crosswalk.

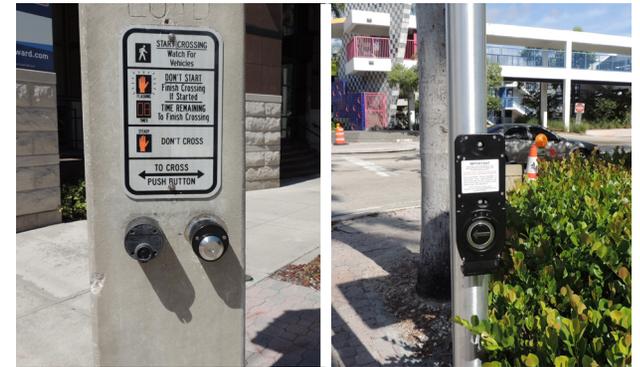
- Pedestrian signals are not functioning or the countdown signal is not working at multiple intersections.
- Many of the pedestrian signal push button signs do not provide the street names or signs with directions on how to properly use pedestrian signal heads.

Signs are out of date and either do not state which street they are referring to do not have instructions.

- Replace or fix pedestrian signals/controllers.
- Update pedestrian signal push button signs as necessary to meet standards.

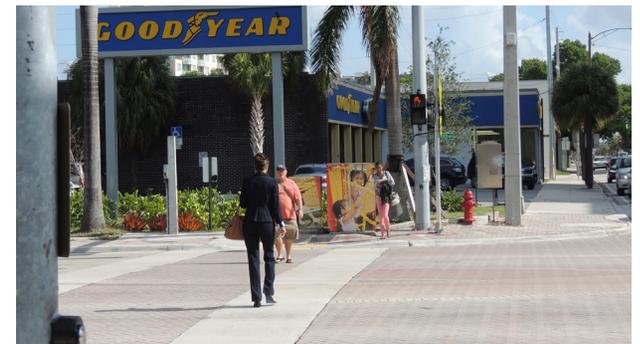
- Signal times are long, which causes long wait times for pedestrians when crossing the street at intersections.
- It was observed that pedestrians cross the street against the signal even in crosswalks instead of waiting for the Walk signals.

Pedestrian crossing against a signal.

- Consider retiming signals with a focus on pedestrian and bicycle mobility.

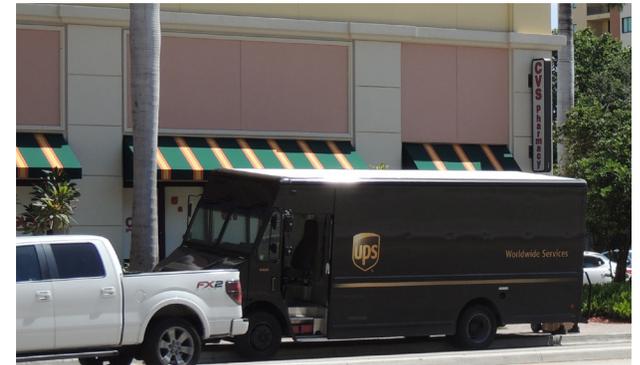
- Delivery trucks were observed parking on sidewalk or along the street.

Delivery truck parked in the sidewalk.

- Evaluate the locations of loading and unloading areas.
- Enforce the use of loading and unloading areas.

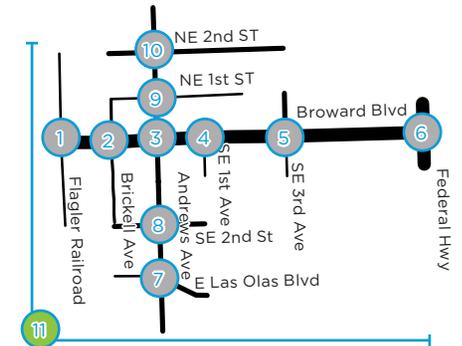
- Lighting is poor outside of the intersection of Broward Boulevard and Andrews Avenue.
- Some of the lamps were out at the intersection of Broward Boulevard and Andrews Avenue.

Inadequate lighting on Broward Boulevard

- Implement the recommendations of FDOT's 2015 safety study. The study recommends installing six additional lights along Broward Boulevard.
- Complete a lighting study on Andrews Avenue with a focus on pedestrian lighting.
- Create an outreach campaign to alert pedestrians and bicyclists of the need to wear bright clothing at night and to use lighting.

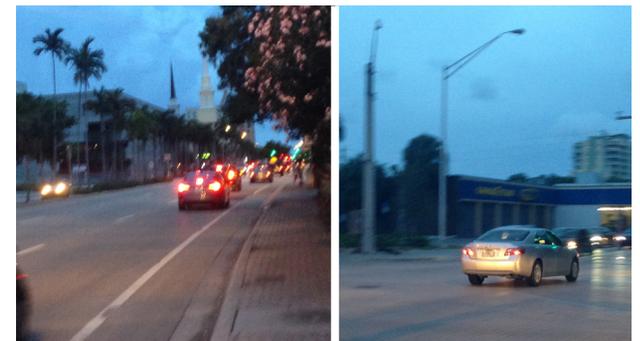
Lamps out on Broward Boulevard at Andrews Avenue
