# Walking Audit Report

## City of Pembroke Pines

SR 817/University Drive  
from County Line Road  
to Taft Street

August 2019

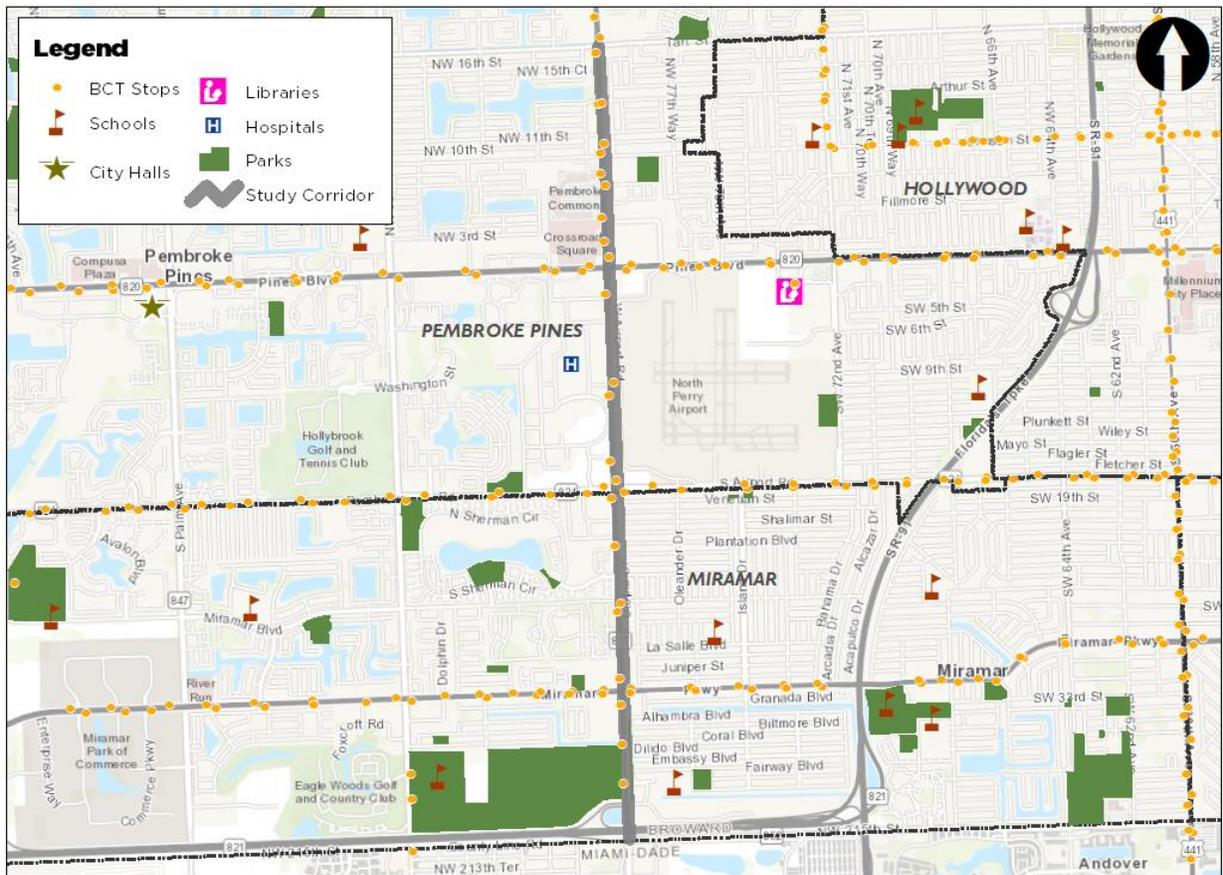
Figure 1. Study Corridor

SR 817/University Drive is a 6-lane divided state road. The study corridor has a posted speed limit of 45 miles per hour (MPH) and a 2018 Average Annual Daily Traffic (AADT) of 57,500 to 59,000. The functional classification for the roadway is an urban principal arterial. Access for non-motorized users is provided along the entirety of the west side of SR 817/University Drive and majority of the east side except from County Line Road to SR 820/Pines Boulevard. There

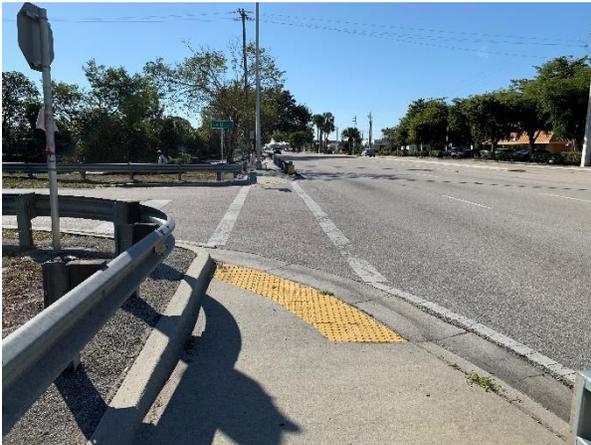
Marked crosswalk with detectable warnings on curb ramps is present at SR 817/ University Drive at NW 13<sup>th</sup> Street which is an east-west road that leads to residential neighborhoods.

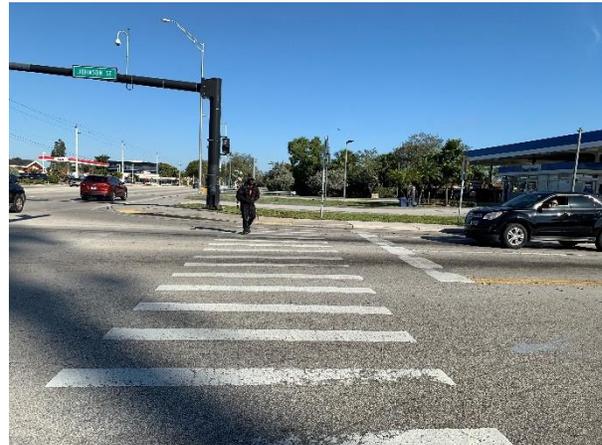
The intersection of Johnson Street and Taft Street has special emphasis crosswalk markings with pedestrian pushbuttons.

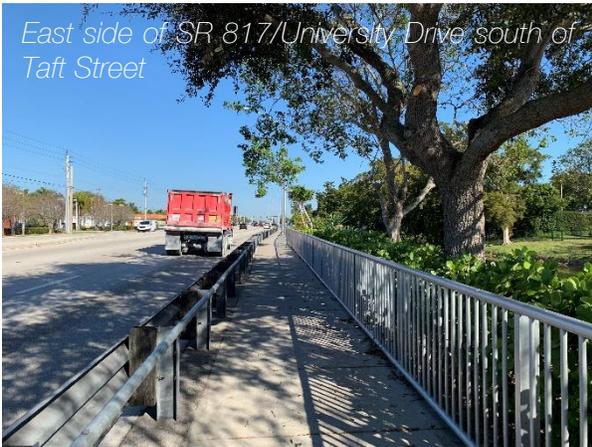
East side of SR 817/University Drive south of Taft Street

The east side of SR 817/University Drive Street has aluminum fencing by the canal and guardrails between the edge of pavement and sidewalk. There are trees on the canal bank which provide shade to people on the sidewalk.

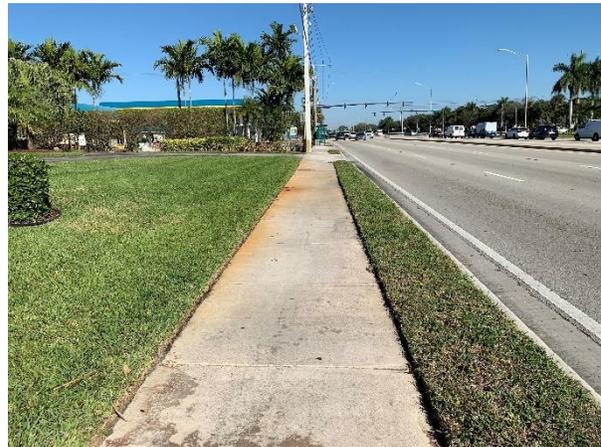
There is a typical 5 feet sidewalk with a narrow grass strip on the west side of SR 817/University Drive Street south of Taft Street. Sidewalks provide a safe path for people to walk along and the narrow grass strip provides additional separation for non-motorized users and motor vehicles.

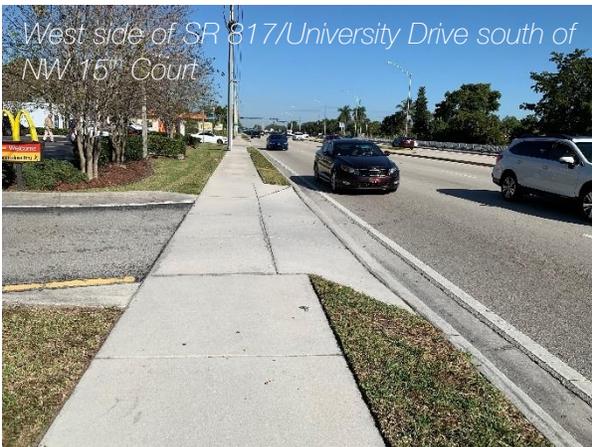
West side of SR 817/University Drive south of NW 15<sup>th</sup> Court

The sidewalk at McDonald's provides a flat driveway crossing that is at least three feet wide with a side slope of less than 2%.

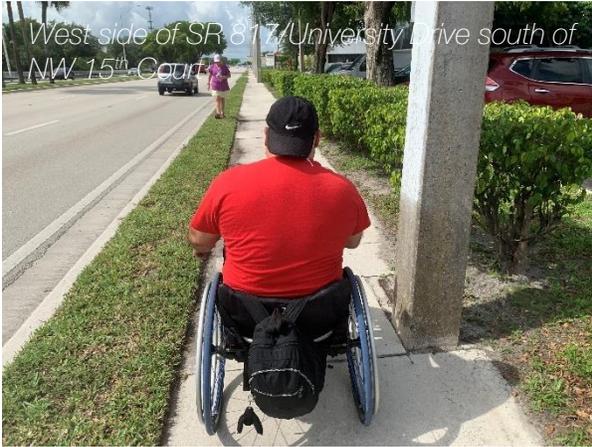
The minimum width of a pedestrian access route is 5 feet and where there are street fixtures, the pedestrian access route may be reduced to 4 feet.

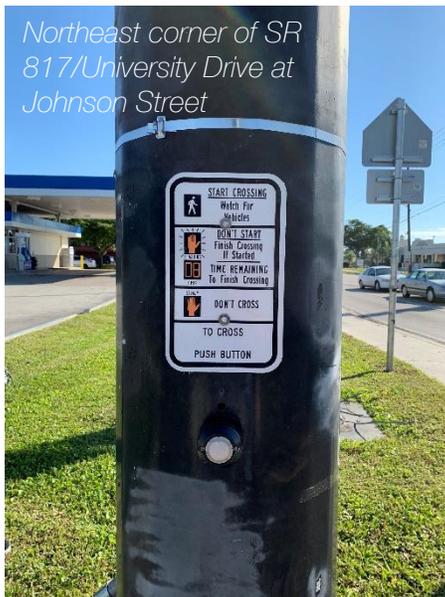
Pedestrian push button signs are present along the corridor.

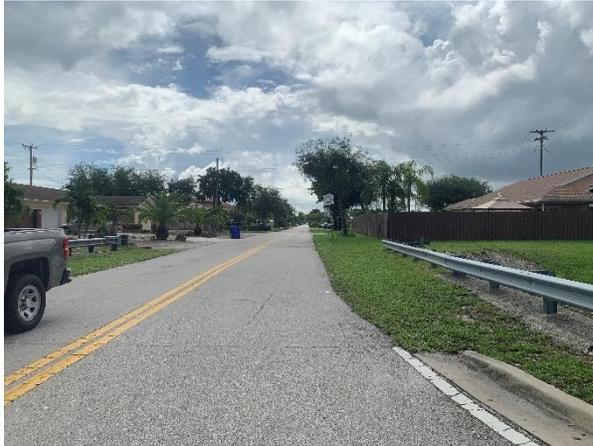
NW 13<sup>th</sup> Street, an east-west road, does not have sidewalk connectivity to University Drive. NW 13<sup>th</sup> Street is one of the few roads that provides direct access to residential homes.

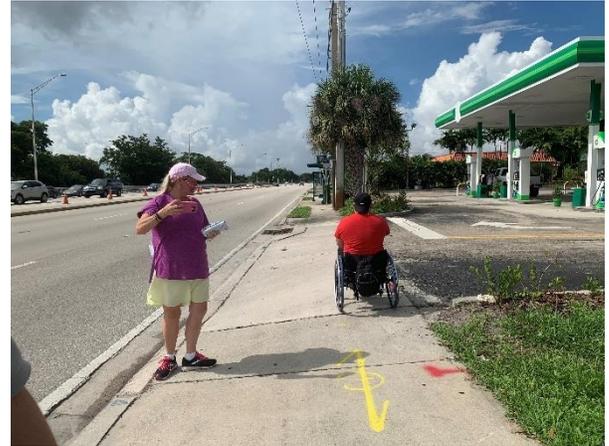
The driveway apron goes through the sidewalk/pedestrian crossing at BP Gas Station, which is located at the southwest corner of SR 817/University Drive at Taft Street.

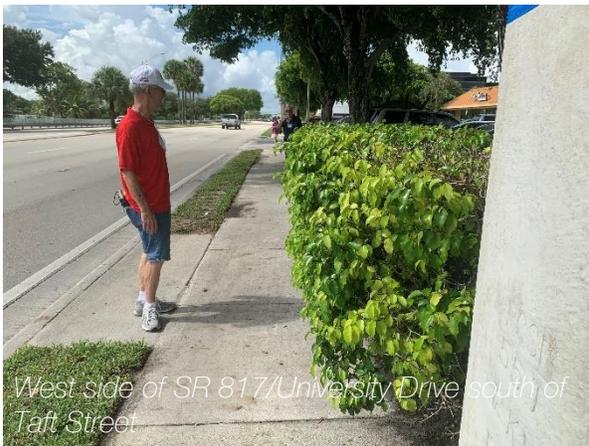
*West side of SR 817/University Drive south of Taft Street*

Unmaintained bushes and shrubs may cause discomfort for non-motorized users since it encroaches the sidewalk area.

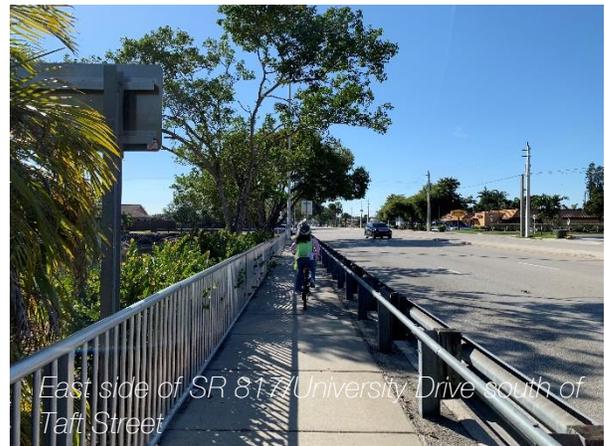
*East side of SR 817/University Drive south of Taft Street*

There is a lack of bicycle facilities throughout the corridor resulting in bicyclists riding in the pedestrian zone.

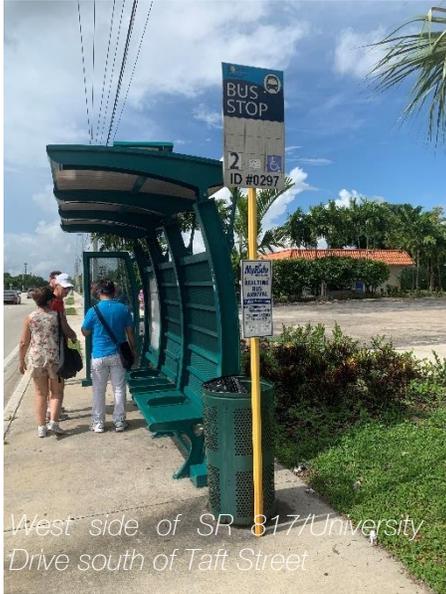
West side of SR 817/University Drive south of Taft Street

The installation of the bus shelter for BCT Stop ID#0297 could have potentially be set back to the edge of concrete providing a wider space for the pedestrian zone.

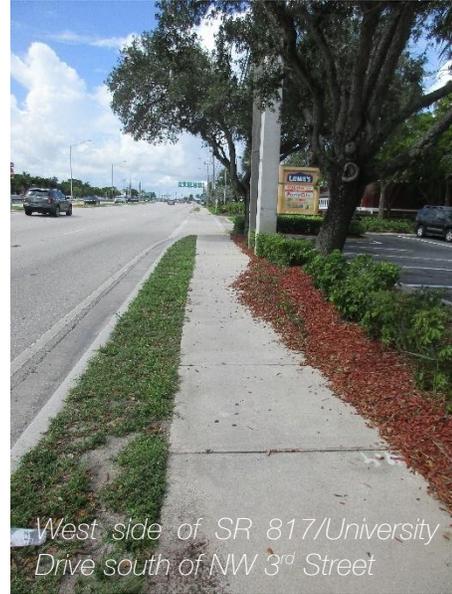
West side of SR 817/University Drive south of NW 3<sup>rd</sup> Street

Unmaintained landscape.

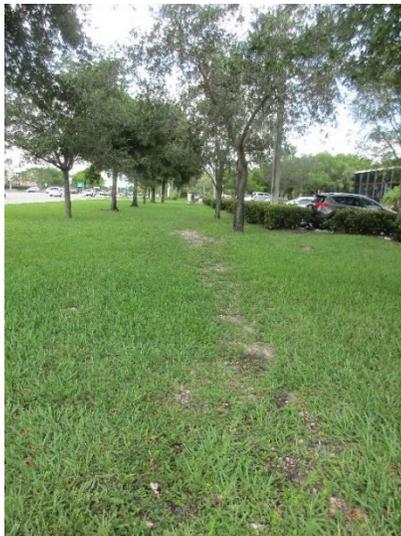
Desire path on the west side of SR 817/University Drive south of Johnson Street showing pedestrians would rather walk on the grass to be under the shade instead of using the existing sidewalk facility.

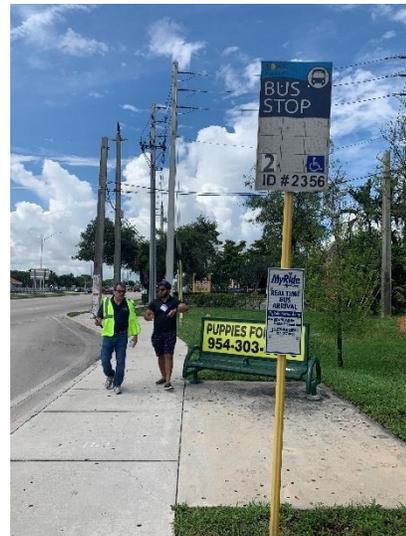
BCT Stop ID# 2356 located on the west side of SR 817/University Drive north of SR 820/Pines Boulevard does not have a shelter or other amenities such as bicycle racks, trash receptacles, etc.

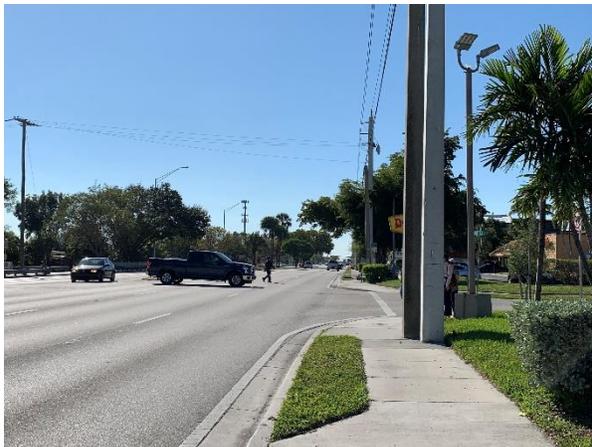
A motorist making a U-turn and a pedestrian crossing simultaneously near NW 13<sup>th</sup> Street could have been a collision.

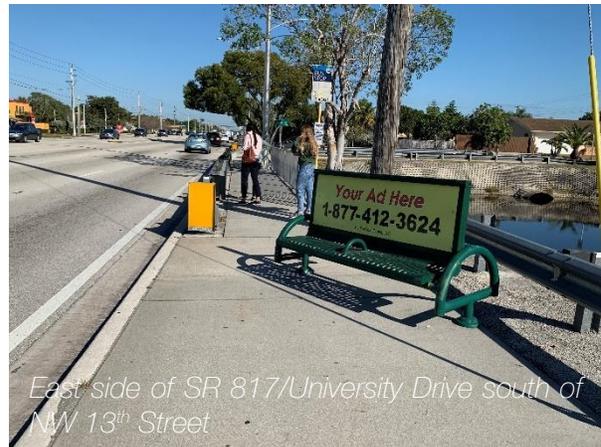
BCT Stop ID# 3931 does not provide an ADA landing pad of at least 5 feet wide and 8 feet deep adjacent to the curb and does not provide a shelter.

Provide a clear unobstructed 5'x8' ADA landing pad (5 feet measured parallel to the curb; 8 feet measured perpendicular to the curb) and provide amenities such as bench, shelter, trash receptacle, bike racks, lighting and a handrail at BCT stops.

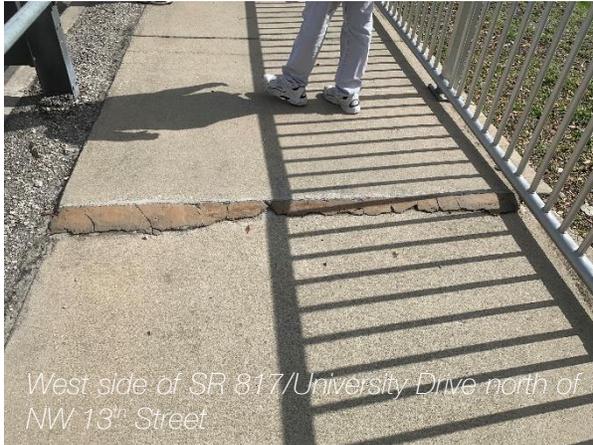
*West side of SR 817/University Drive north of NW 13<sup>th</sup> Street*

Cracked sidewalk/trip hazards along the sidewalk.

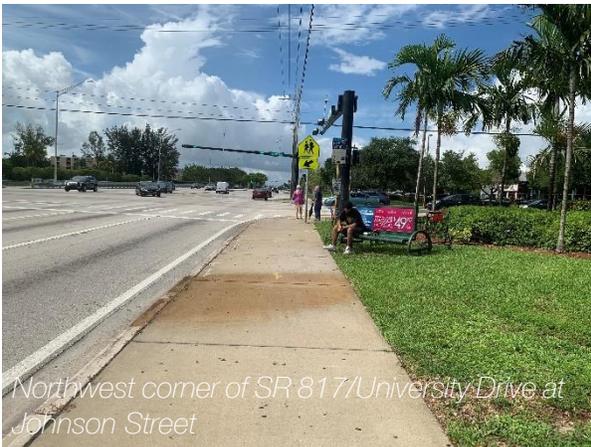
*Northwest corner of SR 817/University Drive at Johnson Street*

BCT Stop ID# 0299 does not have a hard surface concrete pad for the placement of the bench and is lacking amenities such as a shelter, bicycle racks, trash receptacles, etc.

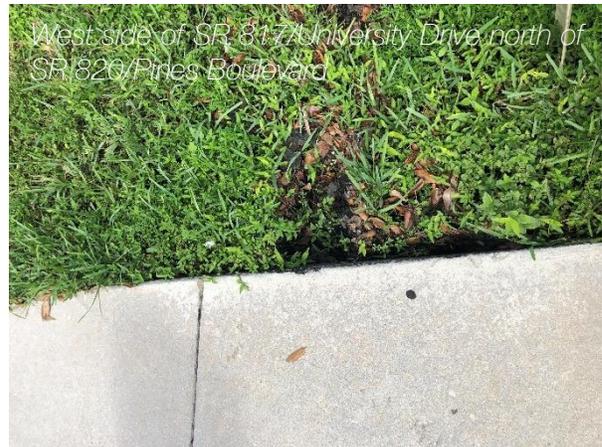
*West side of SR 817/University Drive north of SR 826/Pines Boulevard*

Soil wash out/erosion of subbase underneath concrete sidewalk.

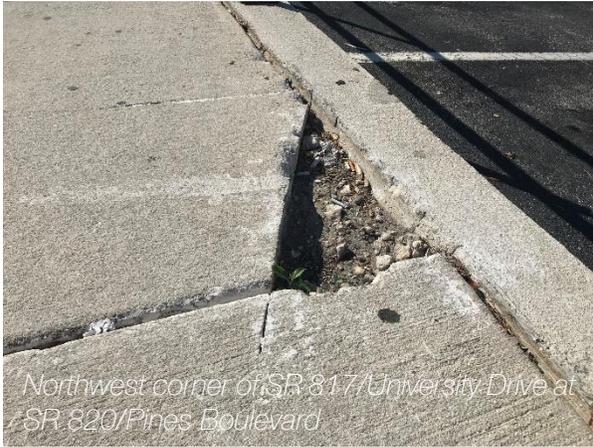
*Northwest corner of SR 817/University Drive at SR 820/Pines Boulevard*

An intentional cut within the sidewalk.

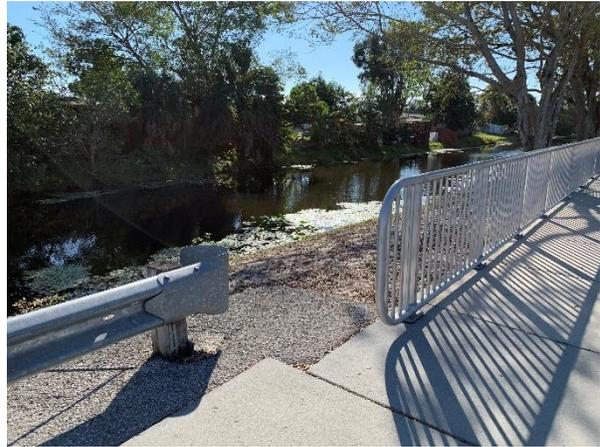
At a few locations on the east side of SR 817/University Drive south of Taft Street, there were gaps between the aluminum fencing and guardrail.

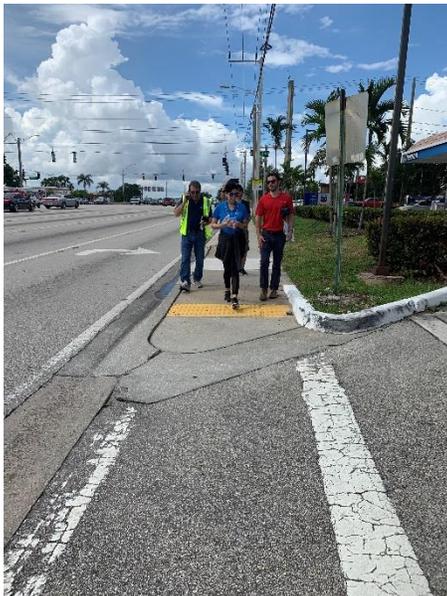
There is a lack of furnishing zone along the west side of SR 817/University Drive north of SR 820/Pines Boulevard.

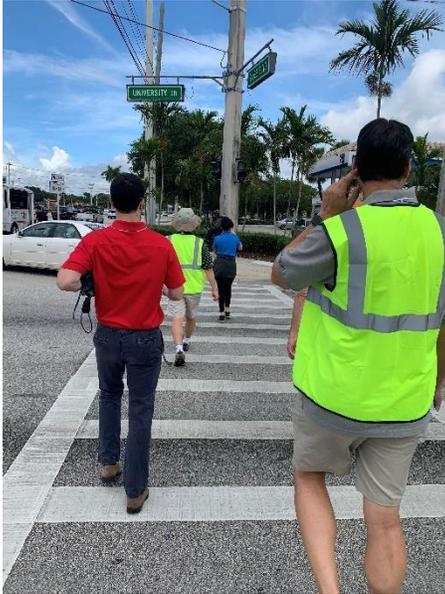
Motorist pulling forward at the intersection of SR 817/University Drive and SR 820 /Pines Boulevard which blocks the marked crosswalk.
