Walking Audit Report

City of Miramar

Miramar Parkway
from SW 172nd Avenue to
SW 160th Avenue

June 2022

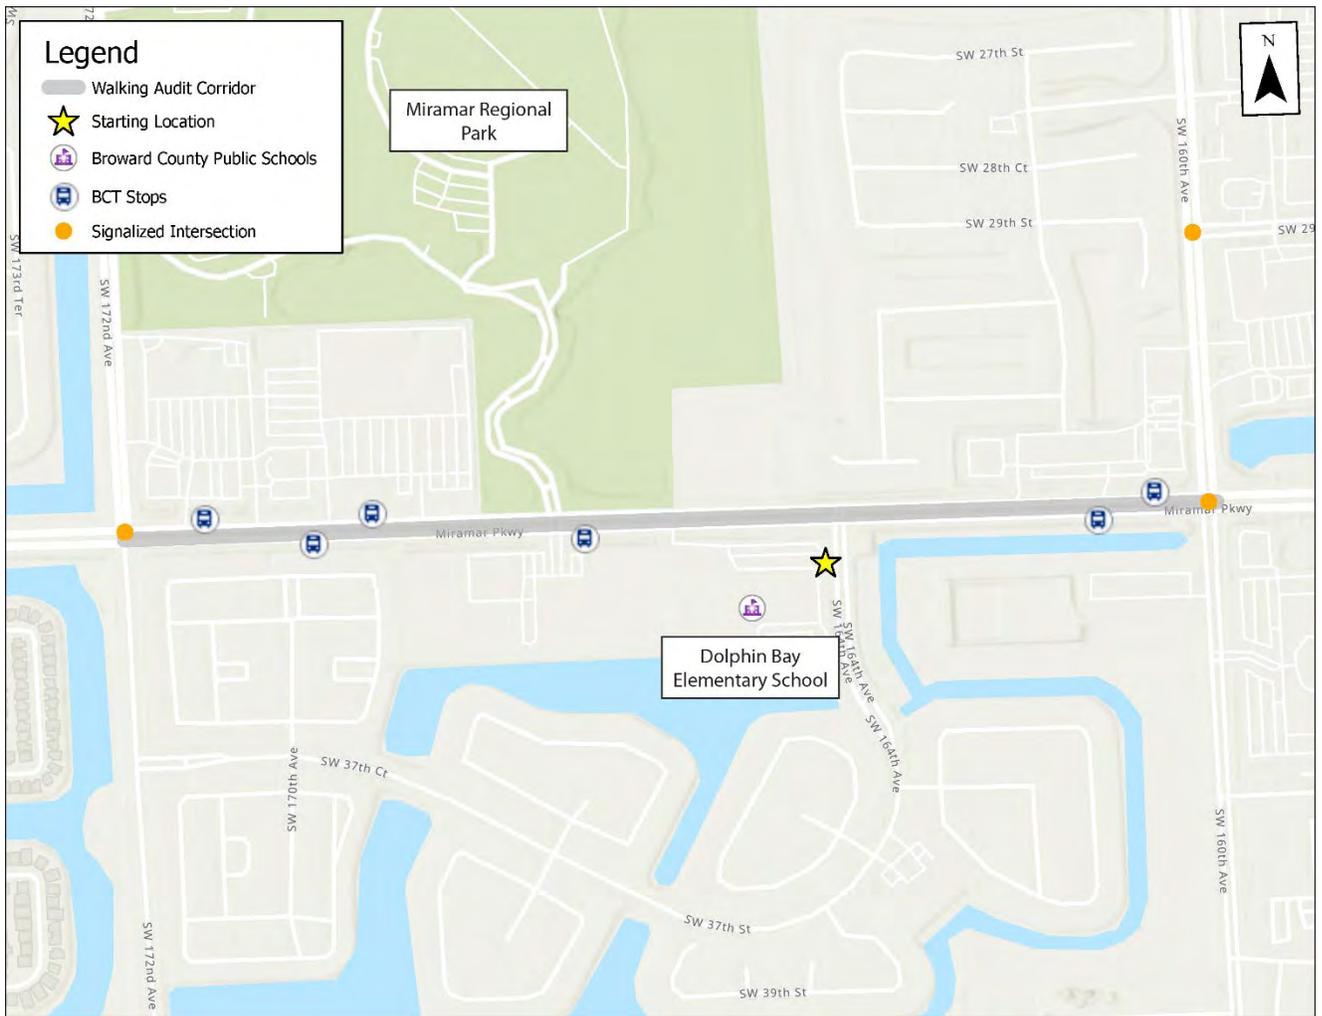
Figure 1. Study Corridor

documented to provide the Walking Audit Participants with background context. The study intersection is located in the City of Miramar near Miramar Regional Park, as shown in **Figure 1**. There are a mix of land uses on or near the corridor including commercial, institutional, and residential contributing to the diverse modes of travel, lane widths, and traffic patterns. Some destinations near the corridor include restaurants, schools, banks, offices, churches, and retail. 773 students attend Dolphin Bay Elementary School, which is located off SW 164th Avenue, along the subject corridor. Multiple residential communities are located adjacent to the study corridor, these communities and accompanying land uses generate frequent pedestrian and vehicle activity along both corridors.

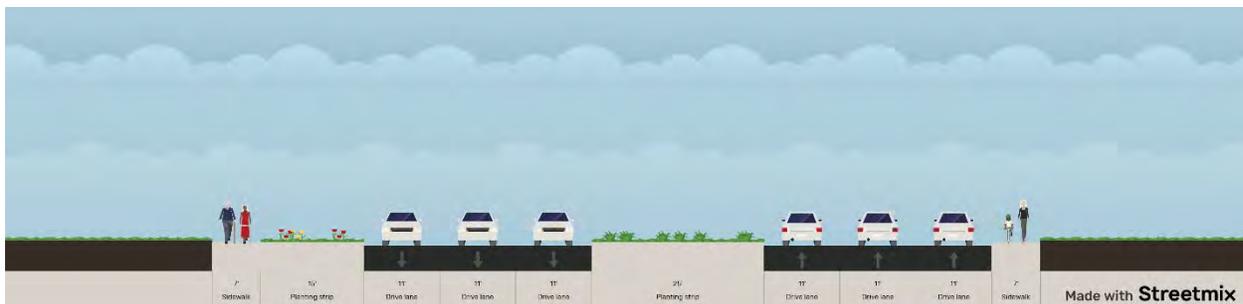
Current roadway section on Miramar Parkway from SW 172nd Avenue to SW 160th Avenue.

Lane widths range from 10-12 feet throughout the corridor. The largest medians throughout the corridor are approximately 20 feet wide. Sidewalk width ranges between

5-10 feet. Currently, there is little to no buffer between the sidewalk and the roadway on the south side of Miramar Parkway. There is a landscape buffer between the sidewalk and the roadway ranging between 2-15 feet throughout most of the corridor on the north side of Miramar Parkway. Other conditions noted during the Pre-Walking Corridor Assessment include lack of audible pedestrian signals, no pedestrian connections to residential neighborhoods along the corridor, inconsistent and faded bike lane designations, and lack of mid-block crossings.

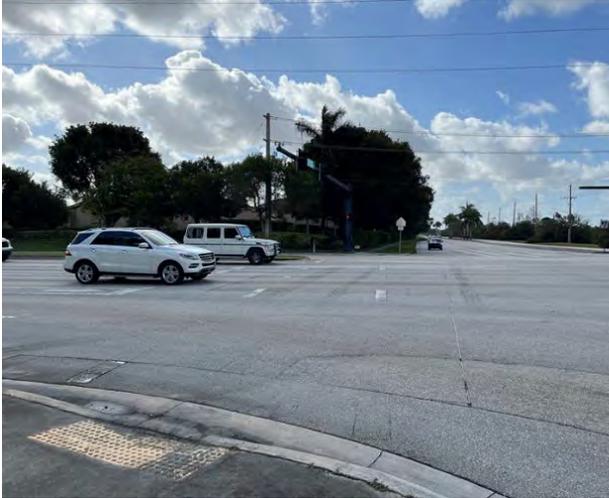
Crosswalk at SW 172nd Avenue needs re-striping and audible signals.

- Upgrade pedestrian crossing signage at the signalized intersections of Miramar Parkway & SW 172nd Avenue and Miramar Parkway & SW 160th Avenue.
Responsible Party: Broward County Engineering

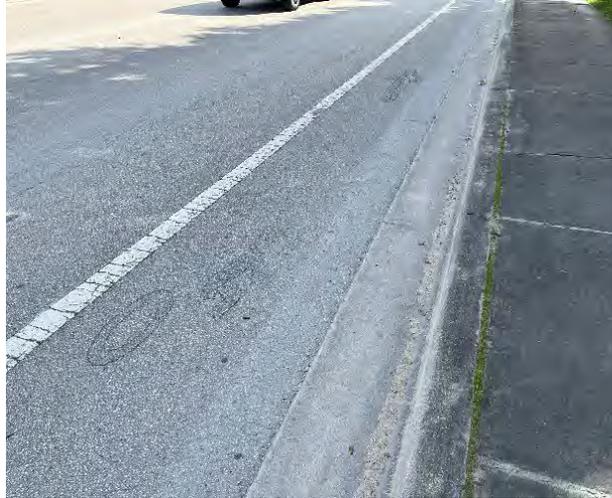
Bicycle lane striping along the south side of Miramar Parkway is now worn away and hard to discern.

- In line with the Complete Streets Master Plan, replace the existing conventional bike lanes on both sides of the roadway with a widened sidewalk of 10-12 feet to accommodate multimodal travel- see Streetmix typical section provided below.
 - On the south side of Miramar Parkway, the existing curb and sidewalk should be extended into the roadway, replacing the existing conventional bike lane.
 - On the north side of Miramar Parkway, the existing curb and sidewalk should be extended into the roadway, replacing the existing conventional bike lane. There is an existing landscape buffer between the sidewalk and roadway throughout most of the corridor that should be reimplemented between the roadway and widened sidewalk space if ROW permits.

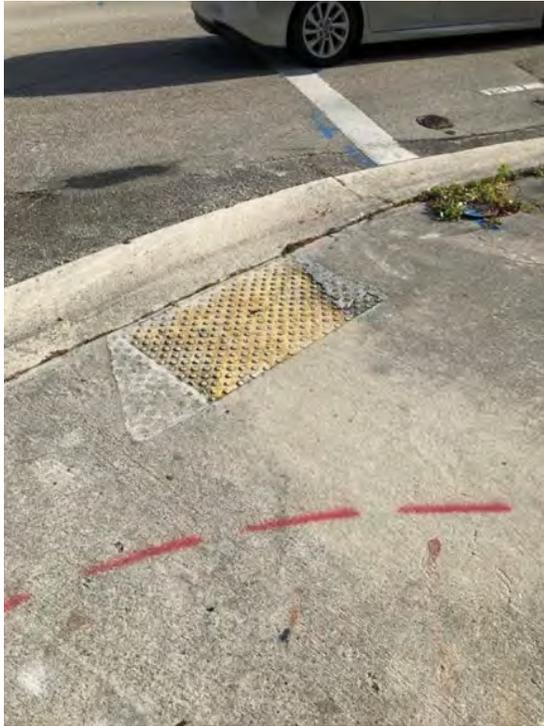
Outdated and worn ADA detectable warning surface at the SW 160th Avenue intersection.

- See Recommendation #7 in [Appendix A](#) on the Infrastructure map.
Responsible Party: City of Miramar
- Replace outdated/worn ADA ramps and detectable warning surfaces at the signalized intersections of Miramar Parkway & SW 172nd Avenue and Miramar Parkway & SW 160th Avenue.
Responsible Party: City of Miramar

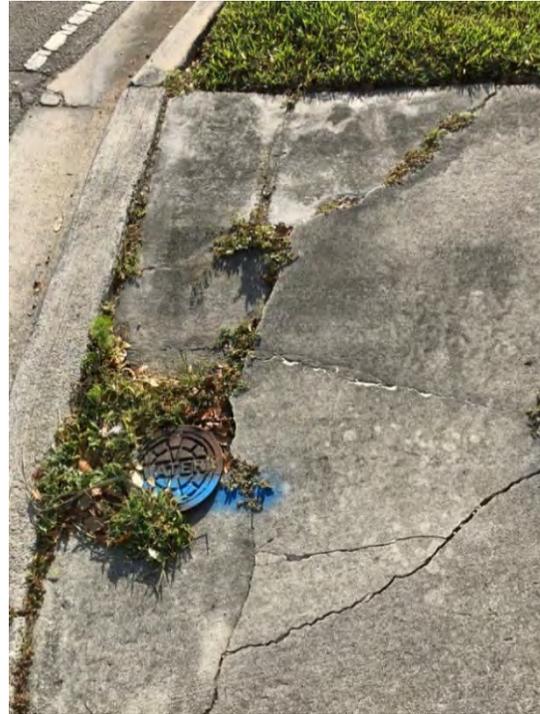
Cracked and vertically deflected sidewalk at the SW 160th Avenue intersection.

- Replace the section of sidewalk that is causing vertical deflection approximately 120 feet east of Bus Stop ID# 2653 on the south side of Miramar Parkway.

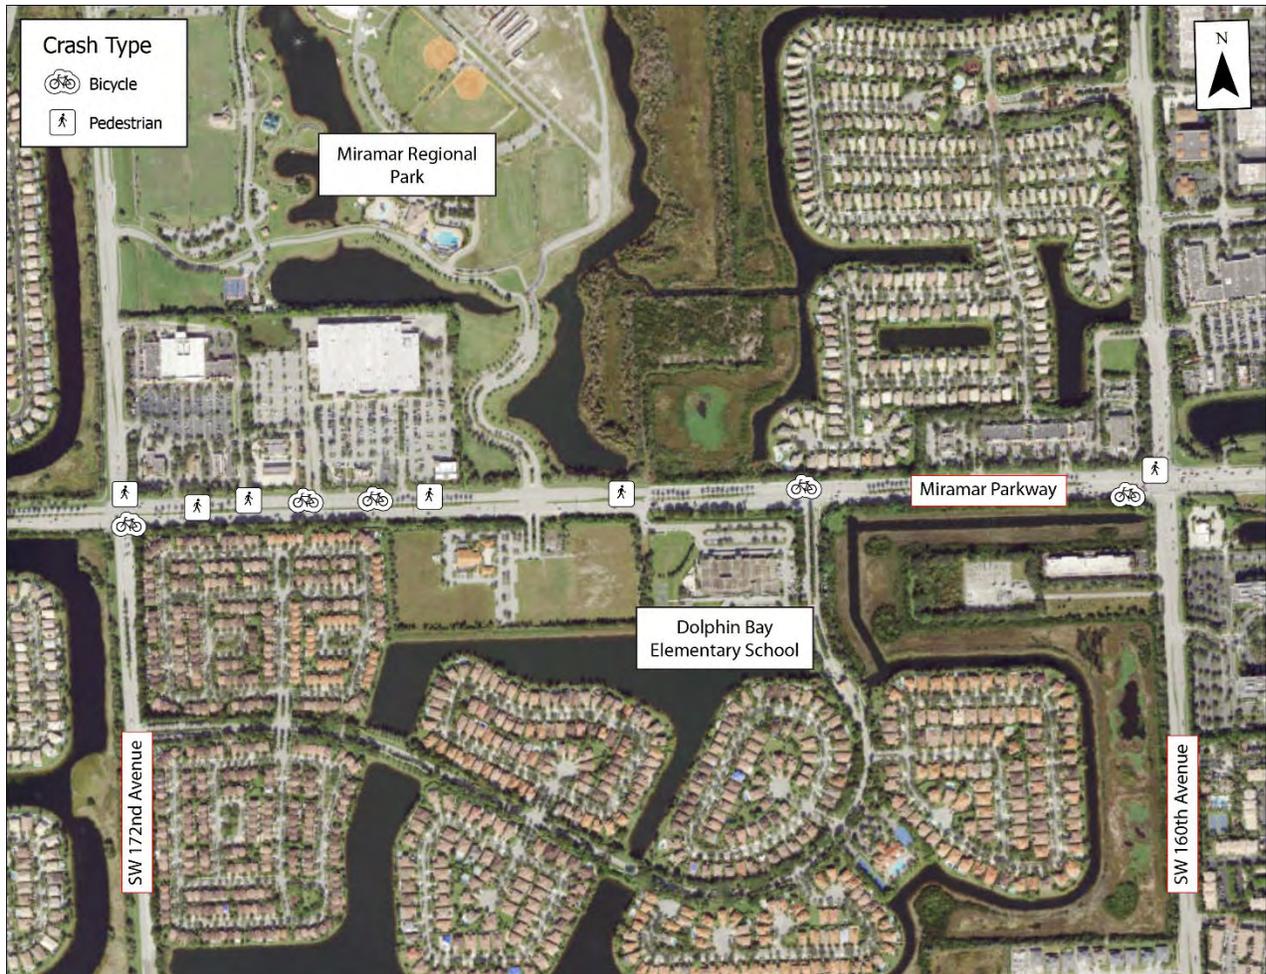
Figure 2. Bicycle & Pedestrian Crash Data

Most crashes on Miramar Parkway occurred near the intersection of Miramar Parkway and SW 172nd Avenue. Out of the 11 total crashes involving bicyclists and pedestrians, 10 resulted in injury. Four of those crashes occurred in dark conditions.

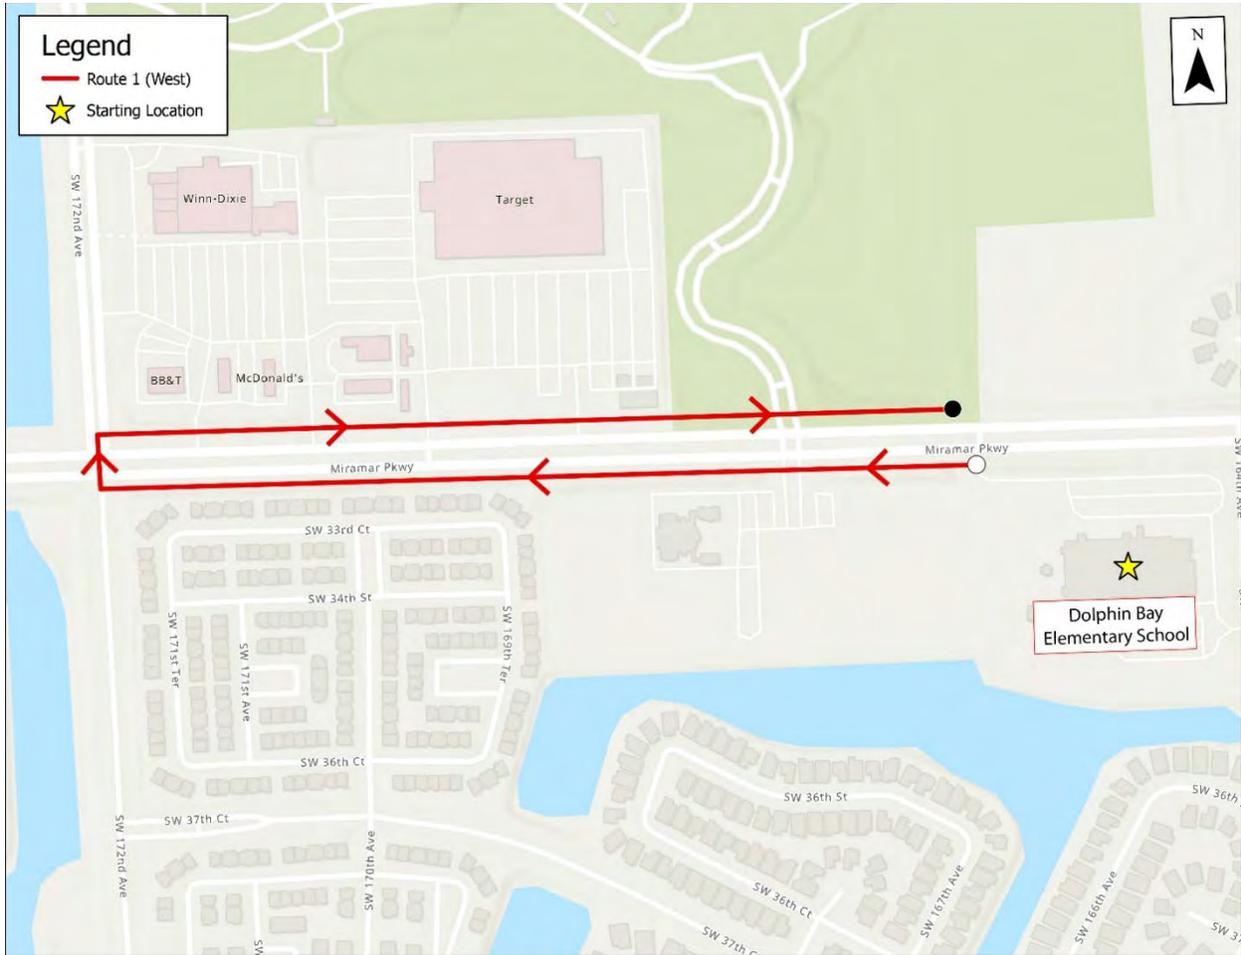
Figure 3. Route 1 – West

Figure 3 displays Route 1 (red line) and is approximately 0.95 miles in length. Participants walked from Dolphin Elementary School on the south side of Miramar Parkway to SW 172nd Avenue, crossed Miramar Parkway and proceeded back to Dolphin Elementary School on the north side.

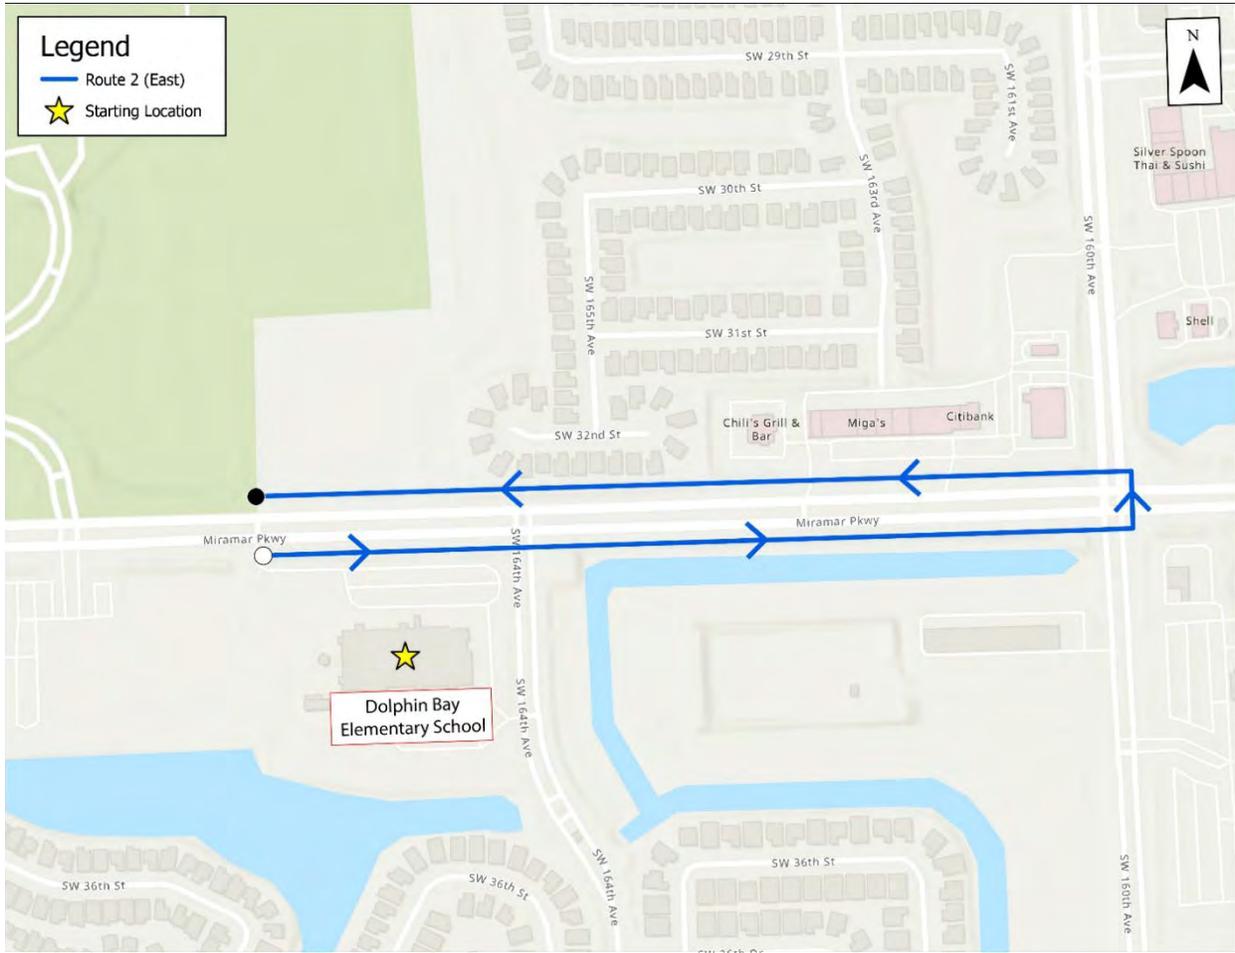
Figure 4. Route 2 – East

Figure 4 displays Route 2 (blue line) and is approximately 1.01 miles in length. Participants walked from Dolphin Elementary School on the south side of Miramar Parkway to SW 160th Avenue, crossed Miramar Parkway and proceeded back to Dolphin Elementary School on the north side.

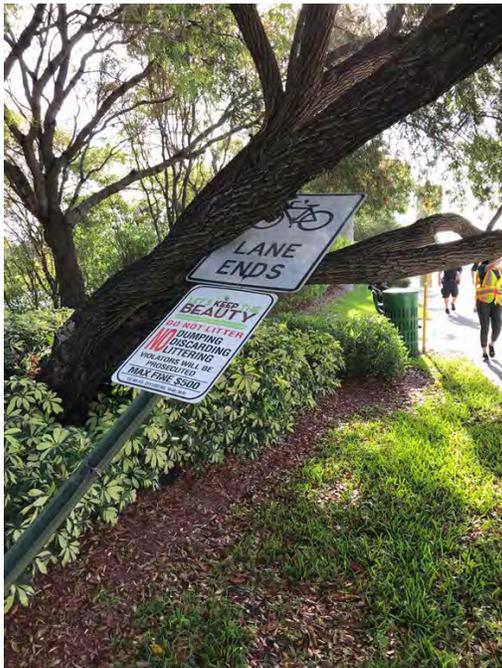
Observation 12:
“Sign removed and leaning on tree, near a public bus stop.”

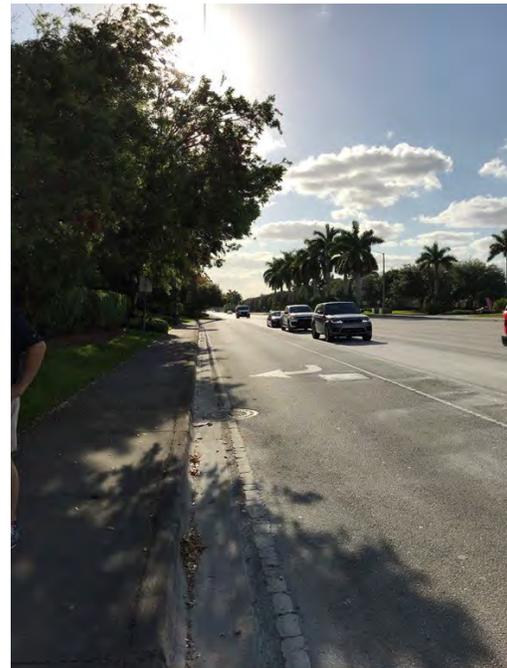
Observation 14:
“No light poles on south side.”

- Install pedestrian lighting on the south side of Miramar Parkway to improve pedestrian and vehicle visibility.
Responsible Party: City of Miramar
- Move Bus Stop ID# 4502 serving westbound Route 28 and Bus Stop ID# 2653 serving eastbound Route 28 closer to the intersection to reduce the possibility of pedestrians crossing at an unmarked location after exiting the bus. The stop is currently located approximately 300 feet east of the intersection of Miramar Parkway & SW 172nd Avenue.
Responsible Party: Broward County Transit

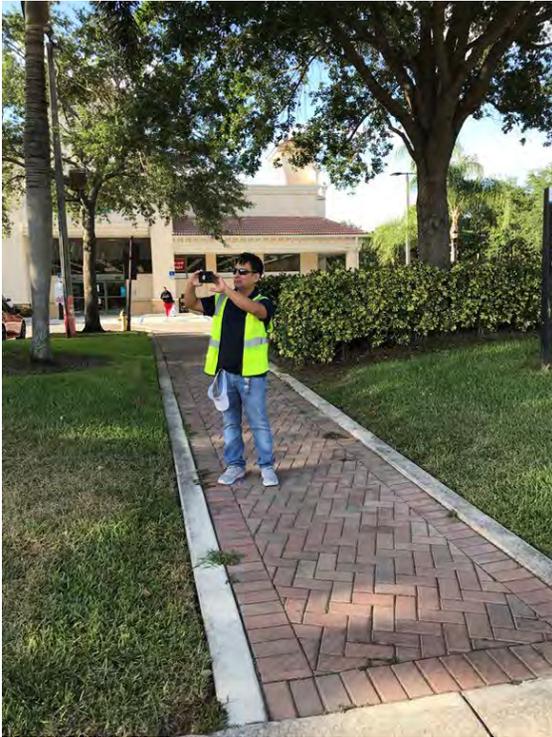
Observation 24:
“Pedestrian connection to the uses along the Miramar Parkway.”

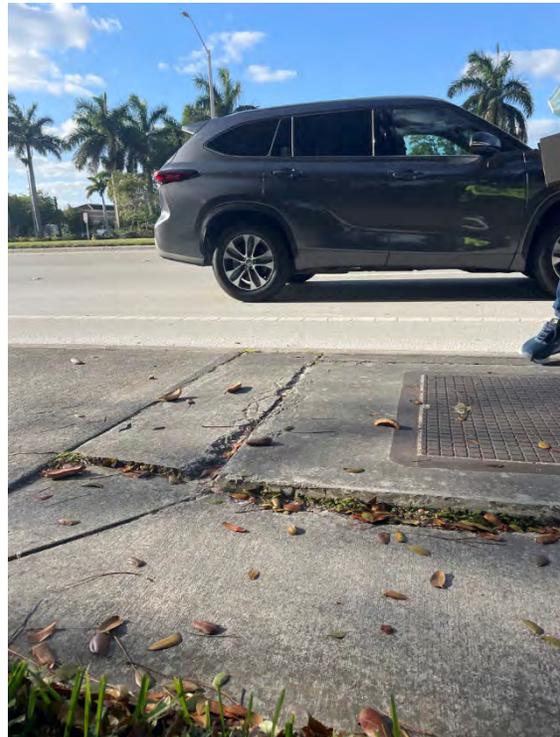
Observation 28:
“Raised utility cover where concrete has settled unevenly around the covering.”

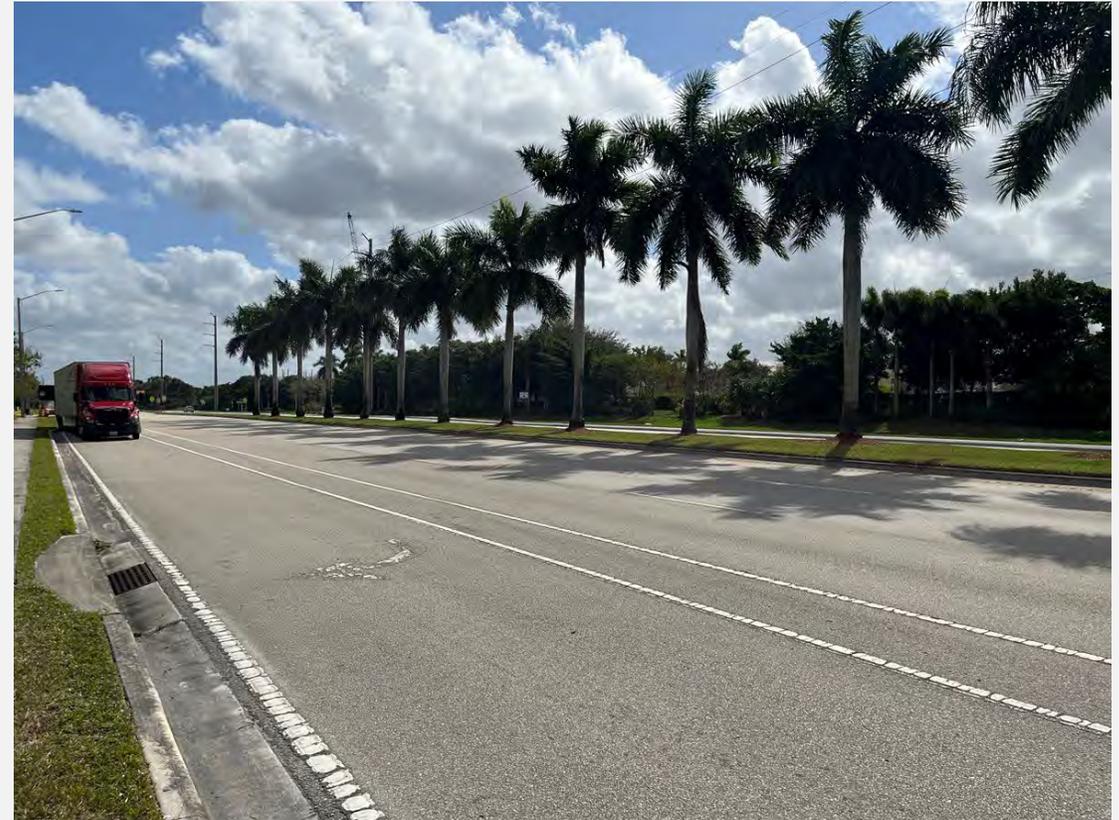
Miramar Pkwy from SW 172nd Ave to SW 160th Ave

- Length: ~1 mile
- Roadway: 6-lane divided
- Traffic: 34,500 per day
- Speed: 45 miles per hour
- 15-mph school zone in front of Dolphin Bay Elementary School
- Bike lanes
- Sidewalks
- Lack of crosswalks at driveways
