Walking Audit - Virtual Appendix

City of Fort Lauderdale: Flagler Village

January 2015

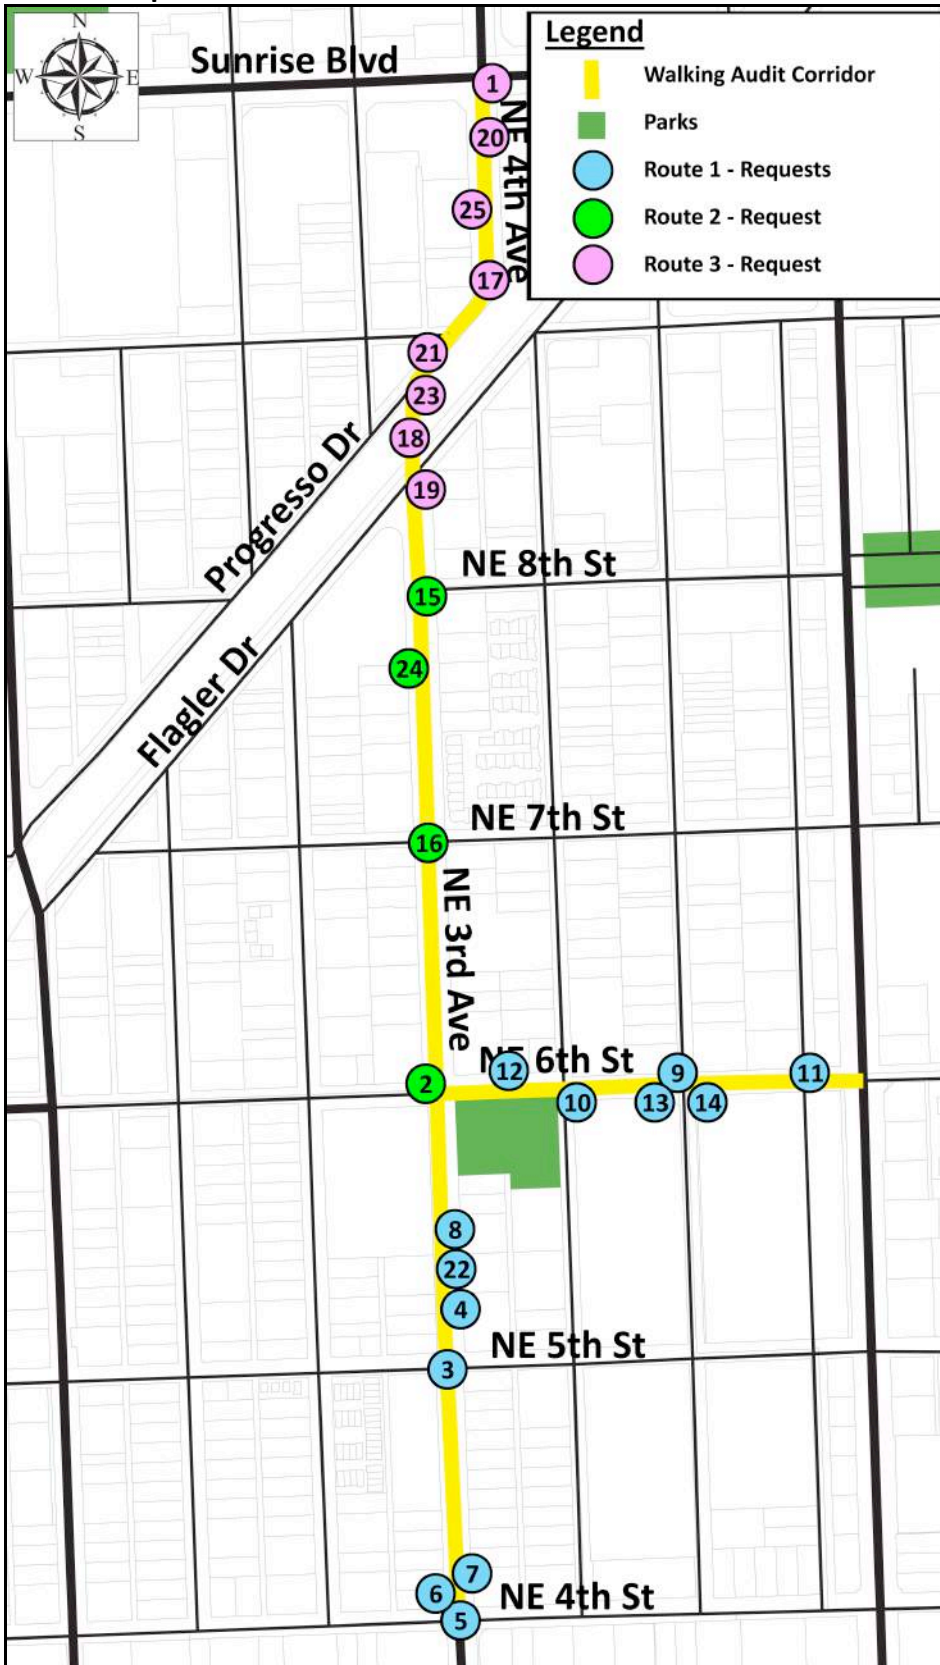
Service Requests Submitted to Lauderserv

Requests related to Route 1 are shown by blue dots. Requests related to Routes 2 and 3 are represented as green dots. A Map ID has been used to associate the points on the map (page 5) with specific service requests (pages 6 – 24).

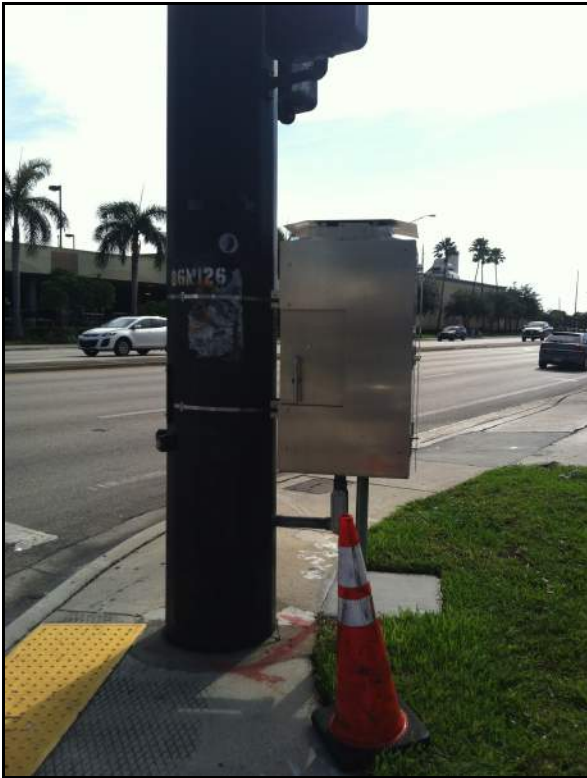
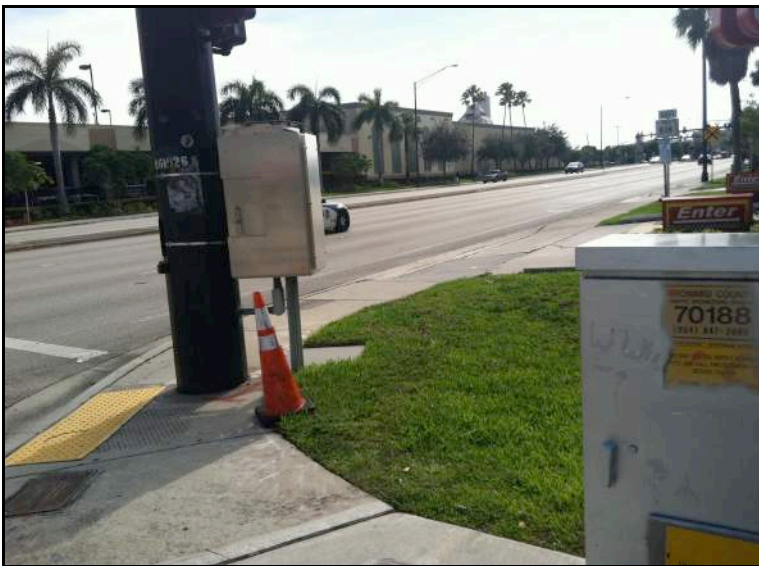
Service Request Map ID: 1

Road/ Street Concerns / Sidewalk Damage

- Service Request #: 13184
- Service Request Location: 992-998 NE 4TH AVE
- The sidewalk and pedestrian path is obstructed by many utility poles and electrical boxes, and there may be an opportunity to improve the safety for all pedestrians if the sidewalk was widened or extended more on the inside of the curve from NE 4th Ave. to Sunrise Blvd.

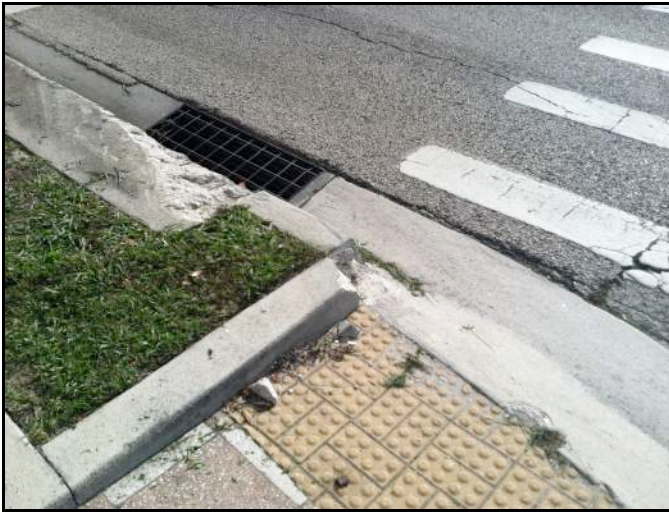
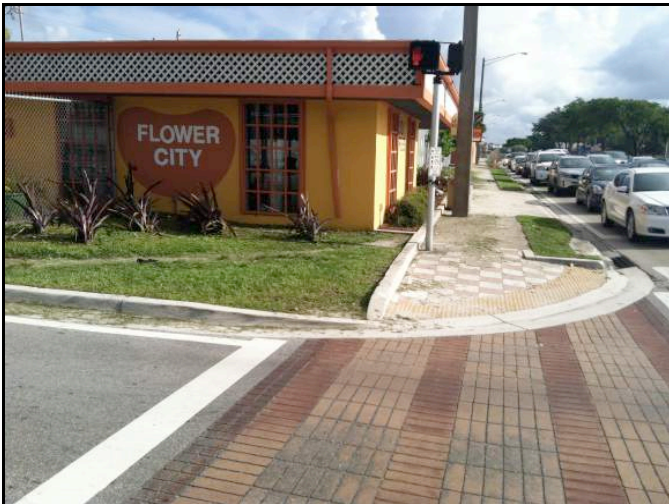
Service Request Map ID: 2

Curb Damage / Road/ Street Concerns

- Service Request #: 13647
- Service Request Location: 551-599 NE 6TH ST
- The NW corner of NE 6th St. and US 1 shows that it has been run over by large trucks and shows damage. What's more concerning is the lack of pedestrian sidewalks from this corner leading to the west, along the north side of NE 6th St.; a pedestrian pathway was observed, alluding to moderate pedestrian traffic along the narrow shoulder.

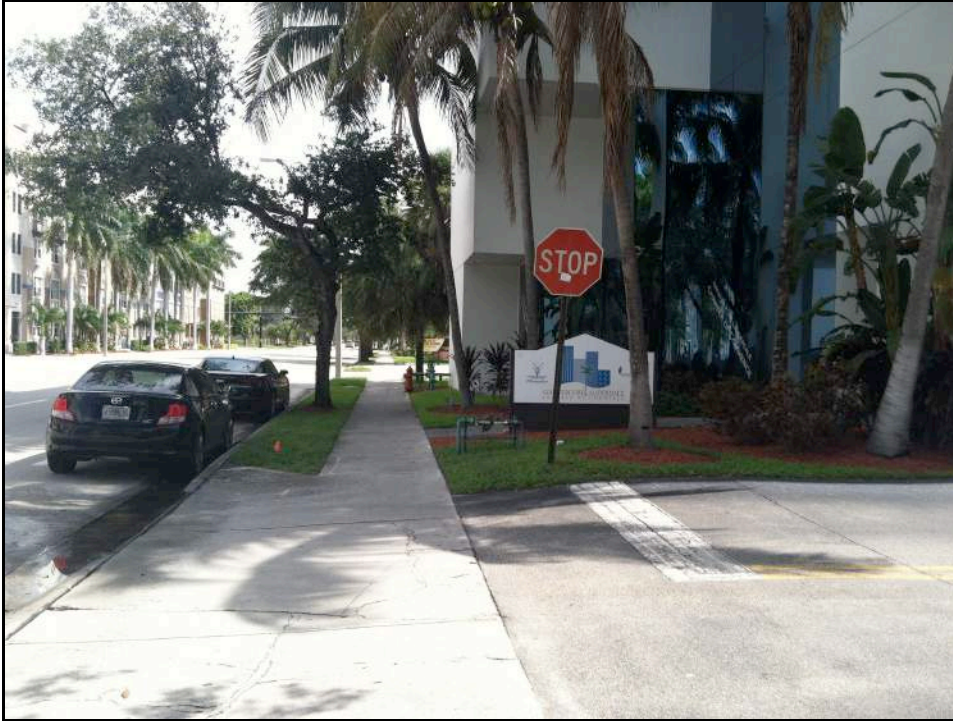
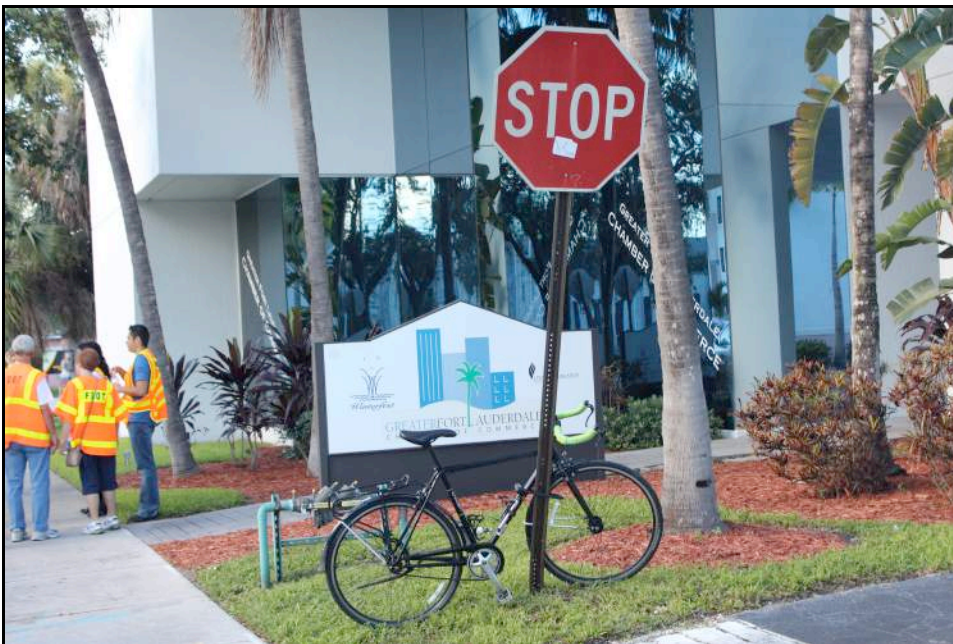
Service Request Map ID: 4

Street Sign - Non Decorative / Street Signage / Transportation & Mobility

- Service Request #: 13648
- Service Request Location: 512 NE 3RD AVE
- Stop sign in front of the Greater Ft. Lauderdale Chamber of Commerce is twisted 90 degrees to the south, oriented towards the sidewalk and not towards vehicles exiting onto NE 3rd Ave.

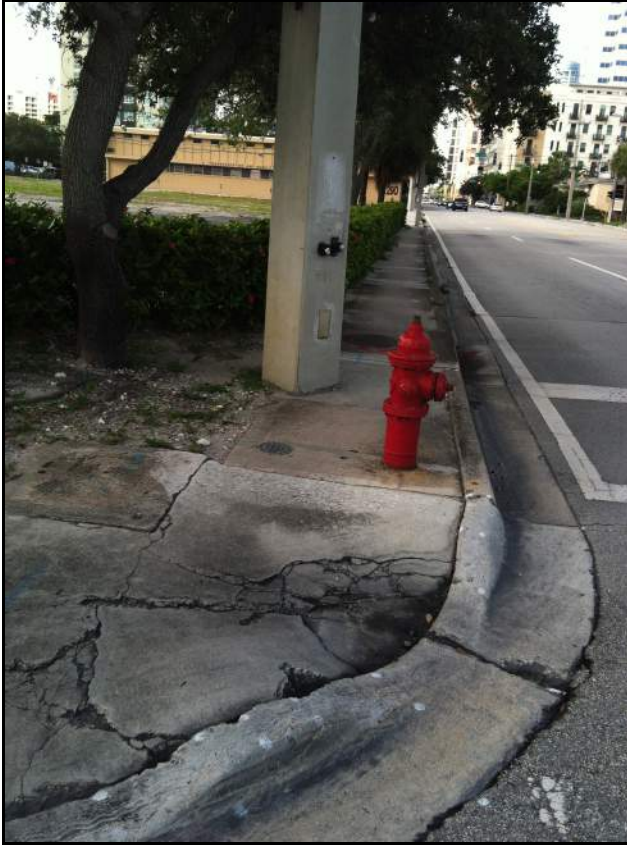
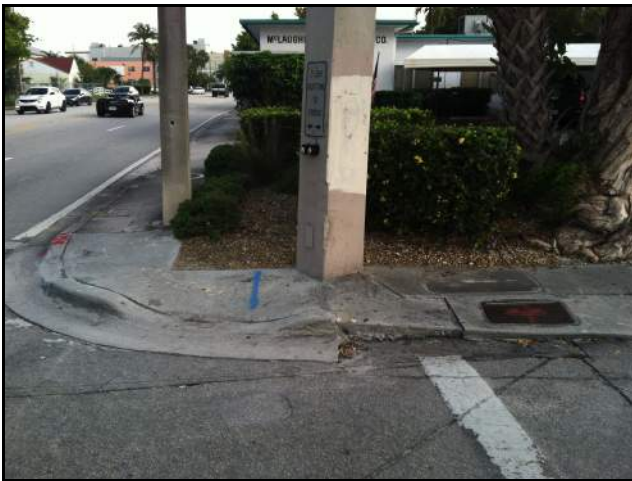
Service Request Map ID: 5

Repaving Inquiry / Road/ Street Concerns

- Service Request #: 13637
- Service Request Location: 201 NE 4TH ST
- Intersection of NE 3rd Ave and NE 4th St: ADA ramps on all corners except SW corner of intersection are in poor condition and are perceived to not be navigable in a wheelchair; also walkers or joggers cannot pass without running into the street.

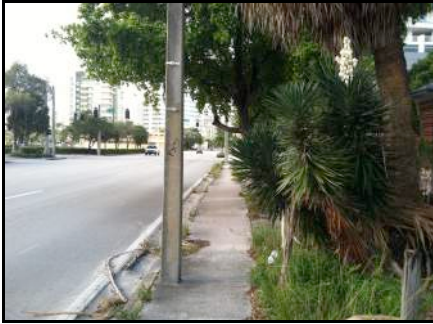
Service Request Map ID: 7

Ask Us / General Customer Service Inquiry

- Service Request #: 13640
- Service Request Location: 504 NE 3RD AVE
- While not a Road Hazard, the road has been perceived to be a hazard; since the distance between the sidewalk and the travel lanes is very narrow, it makes walking uncomfortable.

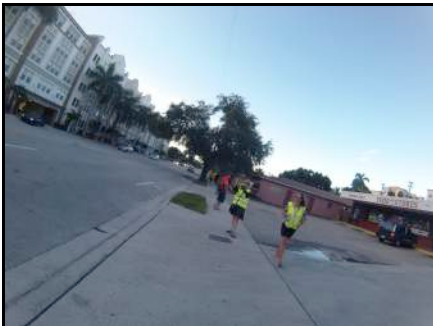
Service Request Map ID: 8

Ask Us / General Customer Service Inquiry

- Service Request #: 13642
- Service Request Location: 512 NE 3RD AVE
- Food store driveway next to Chamber of Commerce creates pedestrian conflicts. Two driveway openings make it difficult to cross. There is a small piece of curb between the driveway openings that could be visually confusing for a driver. A recommended solution may be converting food store parking to angle parking and/or a directional flow. This may alleviate conflicts between vehicles entering/exiting, and prevent cars from backing straight out towards the sidewalk, which is very close by.

- Recommendation: Recommend converting food store parking to angle parking. This may alleviate conflicts between vehicles entering/exiting, and prevent cars from backing straight out towards the sidewalk, which is very close by.

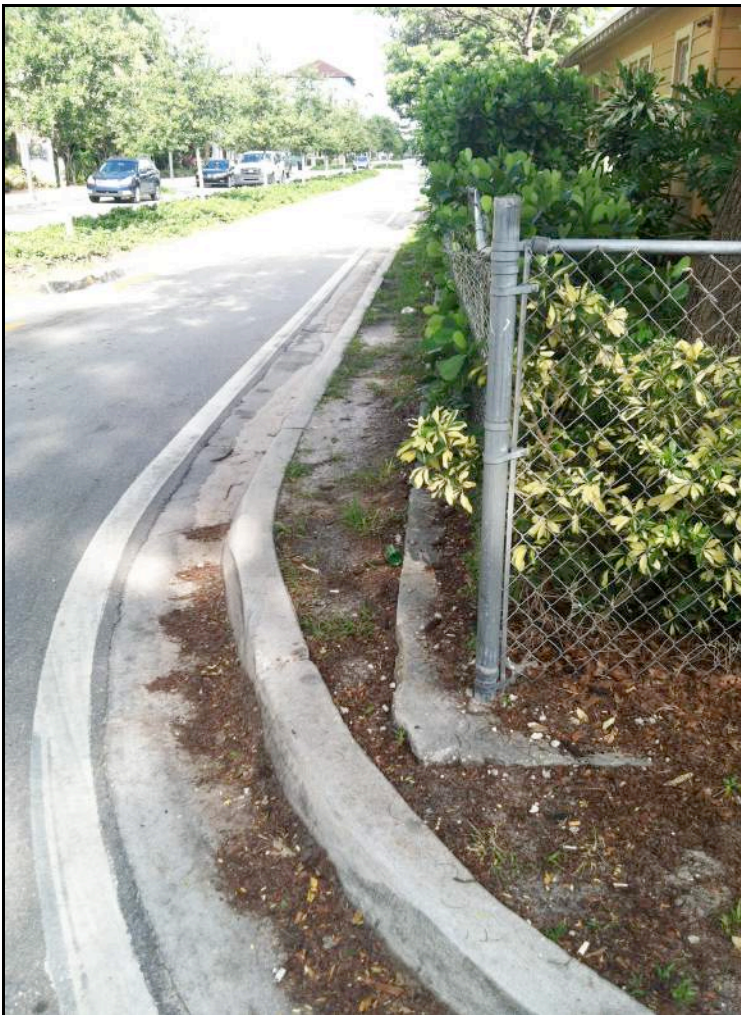
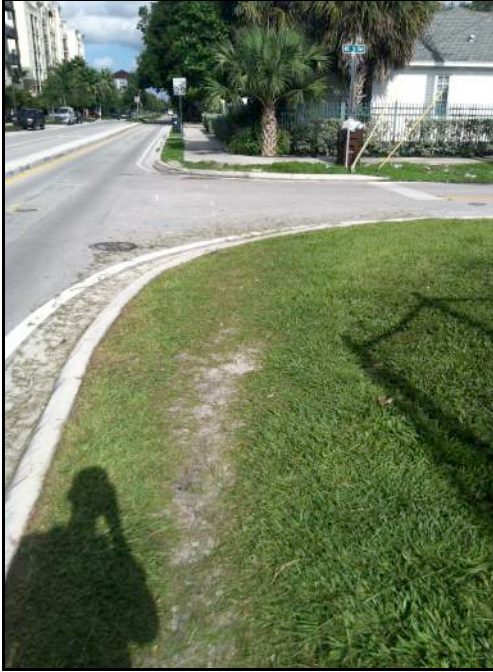
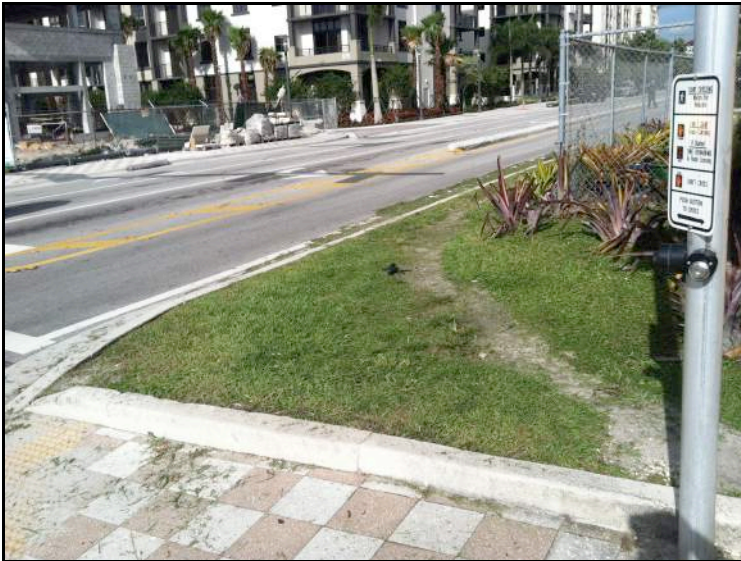
Service Request Map ID: 9

Ask Us / General Customer Service Inquiry

- Service Request #: 13644
- Service Request Location: 601 NE 5TH AVE
- The north side of Sistrunk Boulevard has no sidewalks, but it shows plenty of pedestrian foot traffic. This is concerning because there were numerous pedestrian hazards noted along the north side of the shoulder of NE 6th St., including too narrow of a distance to walk safely between fence and roadway, holes in the grass, and large differentiations between roadway, curb and what's on the other side of the curb (such as a drop in height to a perceived hole or trip hazard), lack of curb ramps, lack of pedestrian- or bicycle-oriented signage.

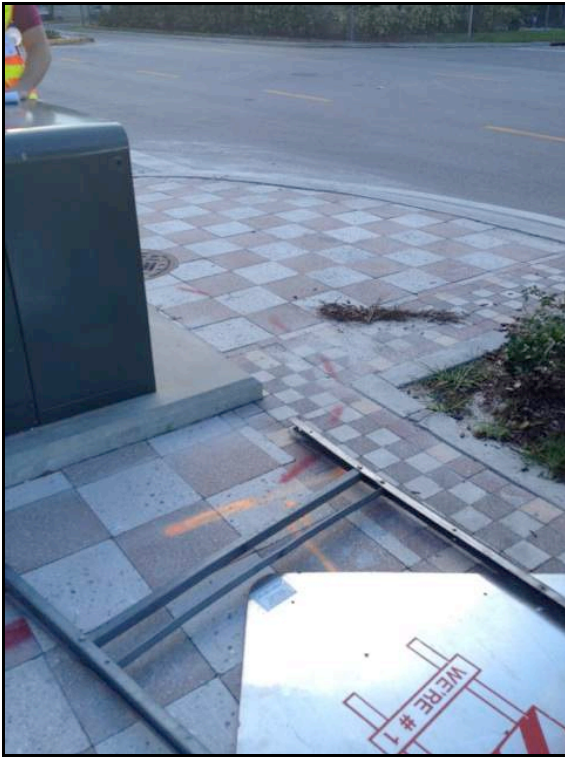
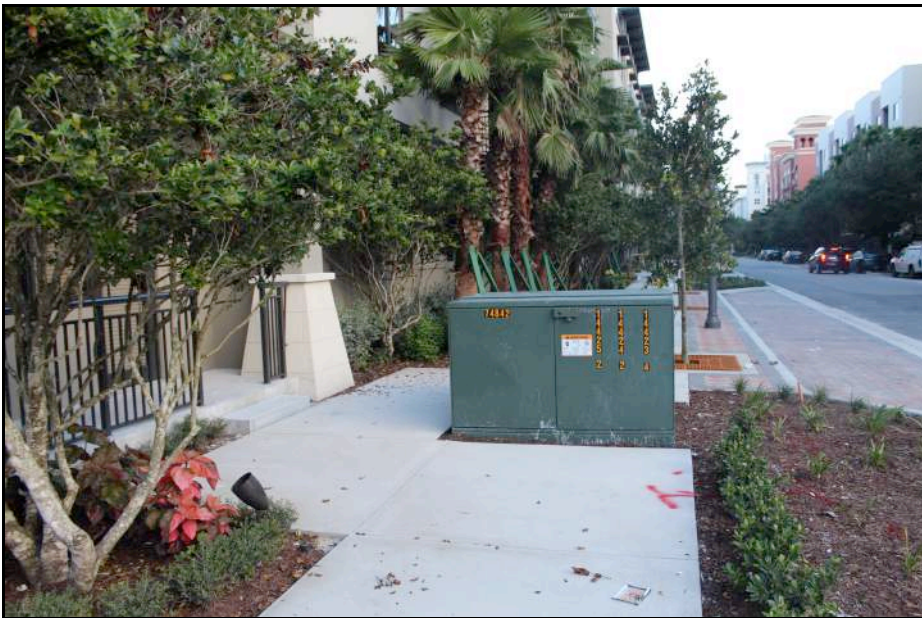
Service Request Map ID: 10

Ask Us / General Customer Service Inquiry

- Service Request #: 13645
- Service Request Location: 500-548 NE 6TH ST
- The tree grates installed on the south side sidewalk along Sistrunk Boulevard were identified as being "meandering" and forcing pedestrians to weave along the sidewalk instead of walking a straight path.

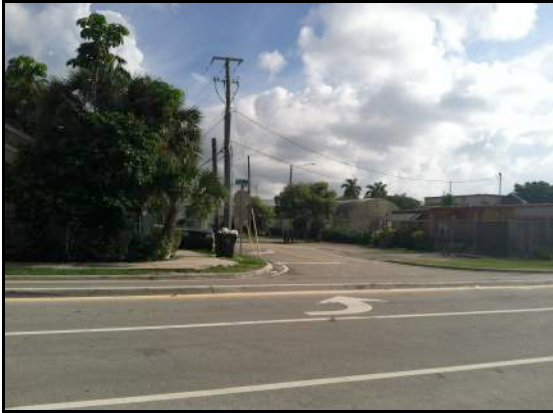
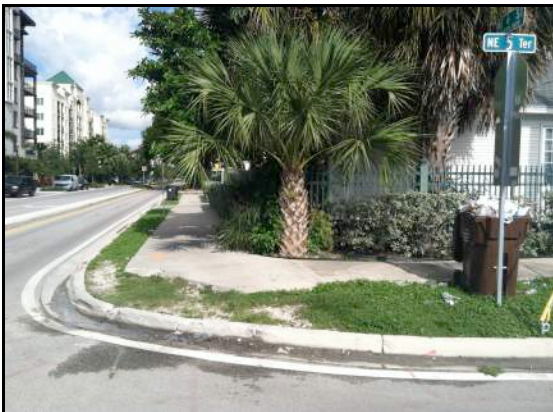
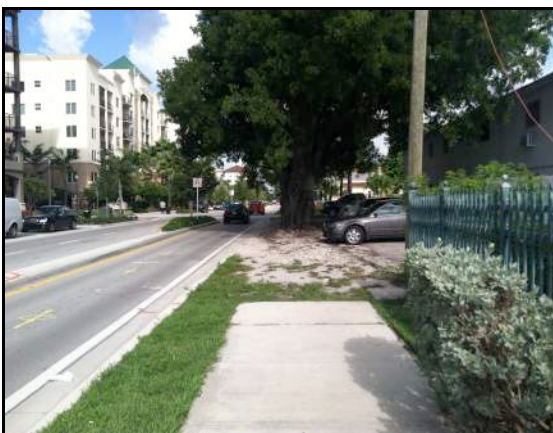
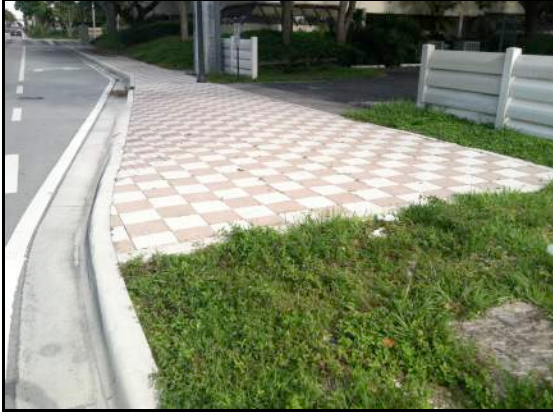
Service Request Map ID: 12

Ask Us / General Customer Service Inquiry

- Service Request #: 13649
- Service Request Location: 315 NE 6TH ST
- General request to continue sidewalks: it has been observed that there has a segment along NE 6th St. (Sistrunk Boulevard) with sidewalks that end abruptly and/or don't connect with pedestrian crosswalks, ramps or perceived ways to cross the street.

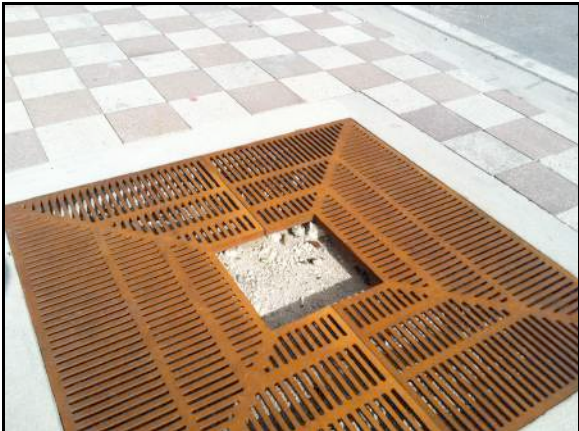
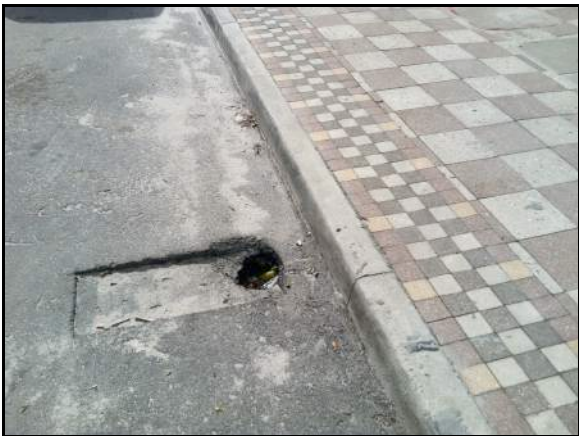
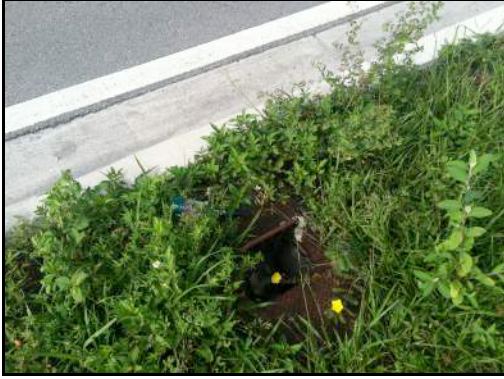
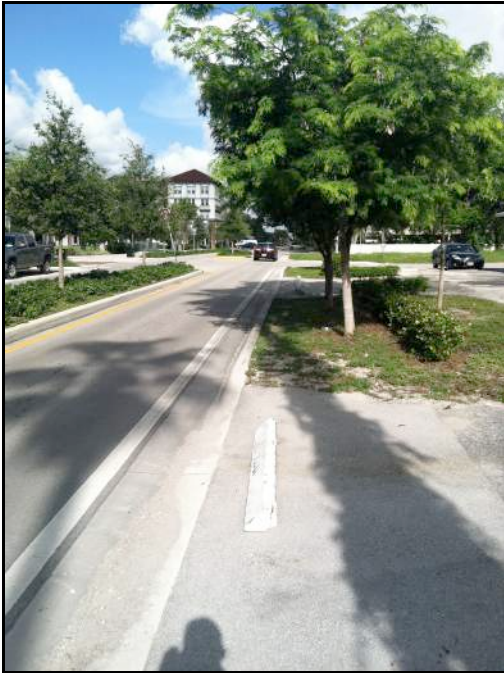
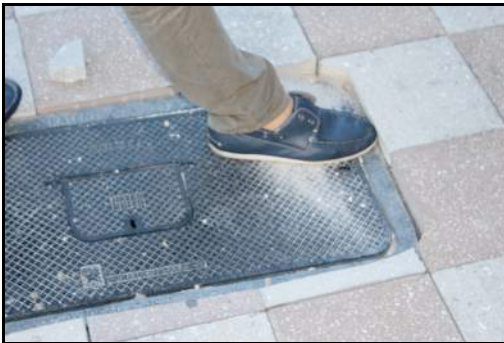
Service Request Map ID: 13

Ask Us / General Customer Service Inquiry

- Service Request #: 13651
- Service Request Location: 536 NE 12TH AVE
- There was concern expressed over some minor trip hazards along this newly developed street segment: some photos are attached.

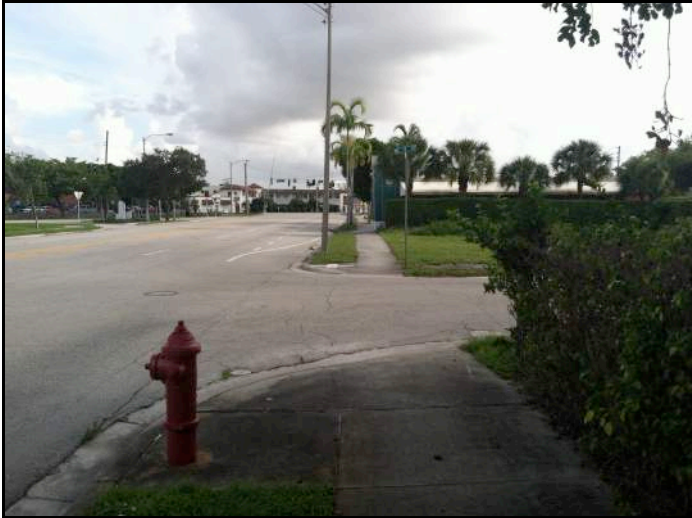
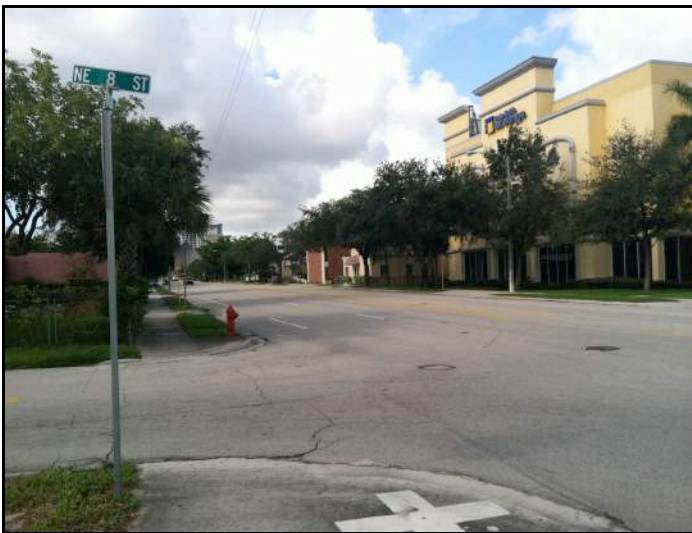
Service Request Map ID: 15

Ask Us / General Customer Service Inquiry

- Service Request #: 13653
- Service Request Location: 301-399 NE 8TH ST
- Crosswalks were desired at this intersection, along the other intersections lacking pedestrian crosswalks; sidewalks were desired to be continued from NE 3rd Ave. to the east, along NE 8th St. and the other streets to the east and west.

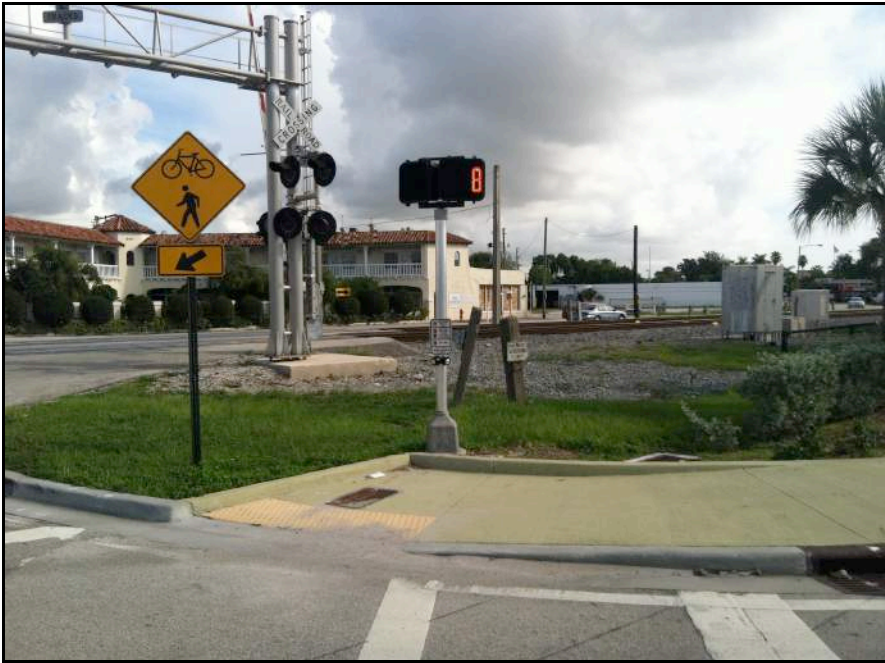
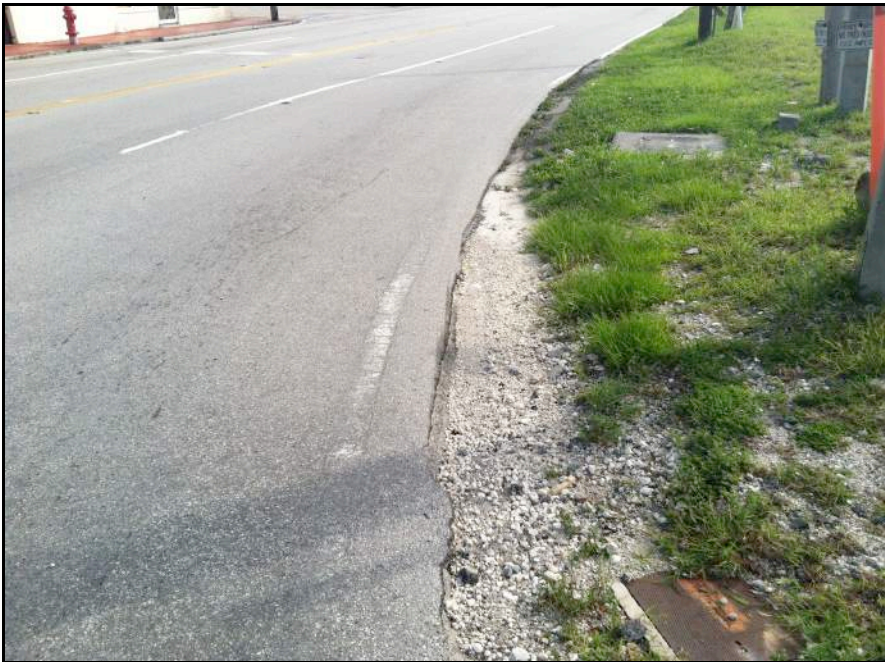
Service Request Map ID: 16

Ask Us / General Customer Service Inquiry

- Service Request #: 13654
- Service Request Location: 704 NE 3RD AVE
- Bicycle infrastructure, facilities and signage are desired throughout the area, and specifically along NE 3rd Ave., NE 6th Ave. and Progresso Dr., since the only bike path and/or bicycle-related sign was observed at the Flagler Greenway intersection of NE 3rd Ave. and Flagler Dr.

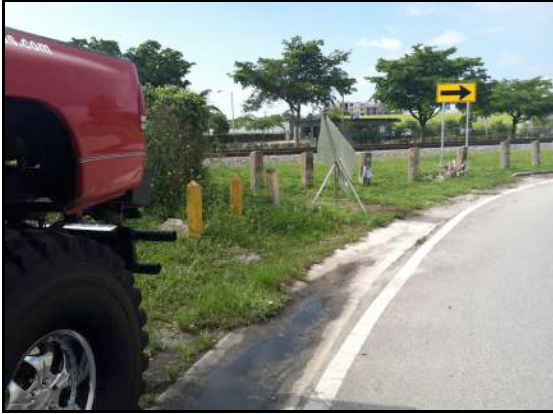
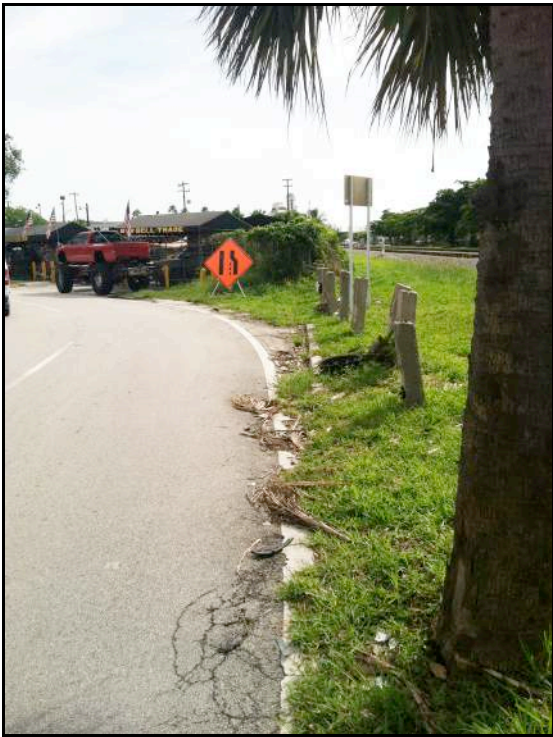
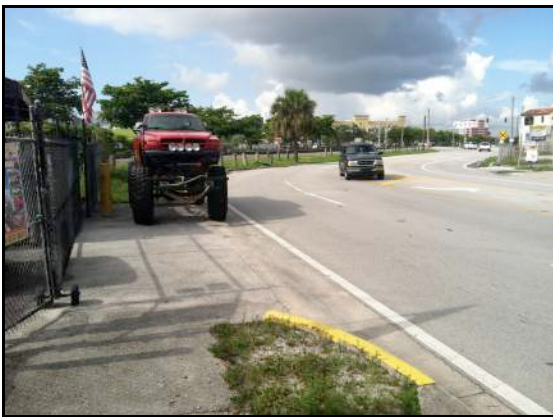
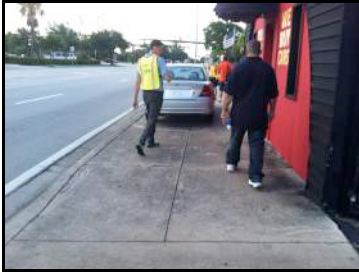
Service Request Map ID: 17

Ask Us / General Customer Service Inquiry

- Service Request #: 13658
- Service Request Location: 908 NE 4TH AVE
- Multiple cars parked on shoulder or sidewalk, making it potentially difficult or dangerous for pedestrians to maneuver around them in high-traffic scenarios.

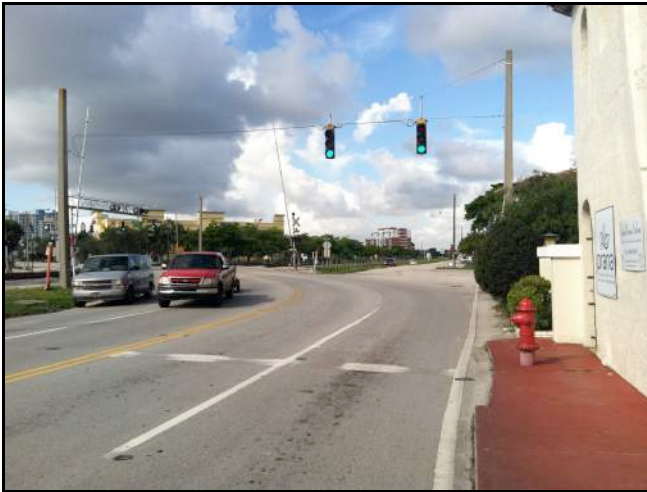
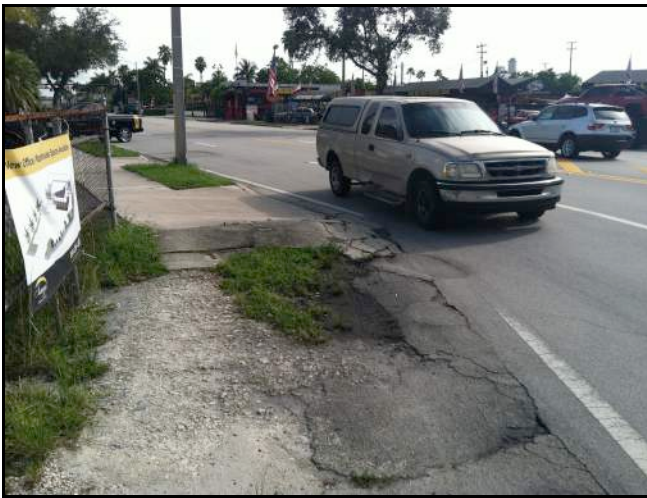
Service Request Map ID: 21

Tree/ Bush Trim / Tree/Landscape Concerns

- Service Request #: 13656
- Service Request Location: 901 PROGRESSO DR
- At this point along Progresso Dr., the sidewalk stops and landscaping has been perceived to be overgrown and ill- maintained, which further reduces the amount of narrow roadway shoulder that pedestrians are forced to walk along, after the sidewalk abruptly ends; additionally, the landscaping has grown around signage and the sign is in need of replacement; additionally, more signage could be added to this area since pedestrians observed a lack of consistency and a stark difference in signage between the Flagler Greenway and the surrounding area; in the northbound direction, the sidewalk abruptly ends around the turn, making the pedestrians feel uncomfortable along the shoulder of both sides (north and south) of Progresso Dr., where pedestrians are forced onto narrow shoulders that include: trash and debris, damaged signs and structures, overgrown vegetation and evidence of cars driving on the shoulder of the roadway.

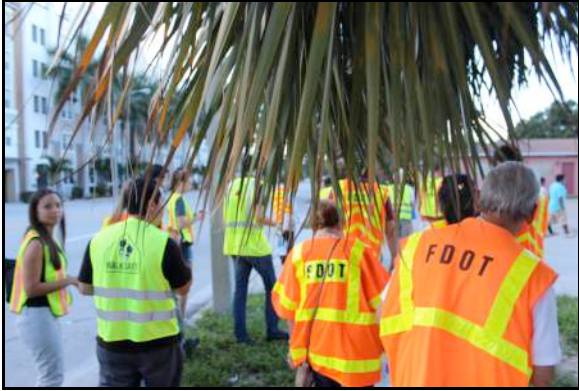
Service Request Map ID: 22

Tree/ Bush Trim / Tree/Landscape Concerns

- ID #: 13641
- Service Request Location: 512 NE 3RD AVE
- Palm tree in front of Greater Ft. Lauderdale Chamber of Commerce building not trimmed; had to move palm leaves out of the way to walk under, even for shorter pedestrians, and bicyclists were observed riding south along the sidewalk, which could lead to a collision or accident.

- Recommendation: This is a simple maintenance issue.
- No crosswalks to cross NE 6th St. or connecting sidewalks on the north side of NE 4th and 5th Ave.'s

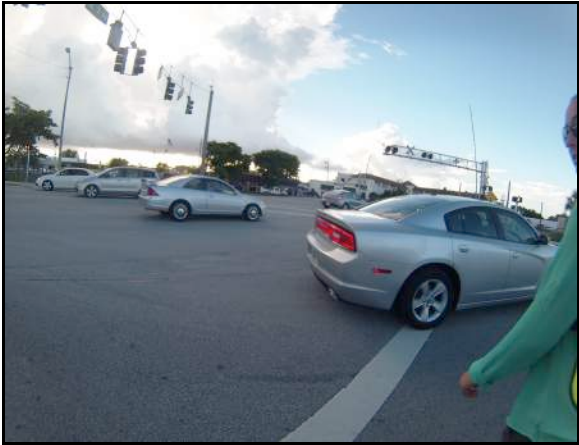
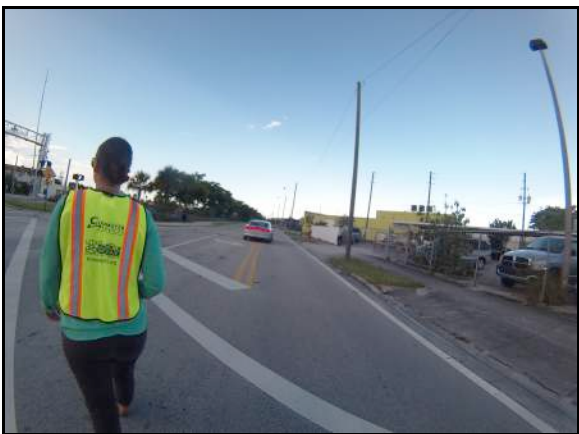
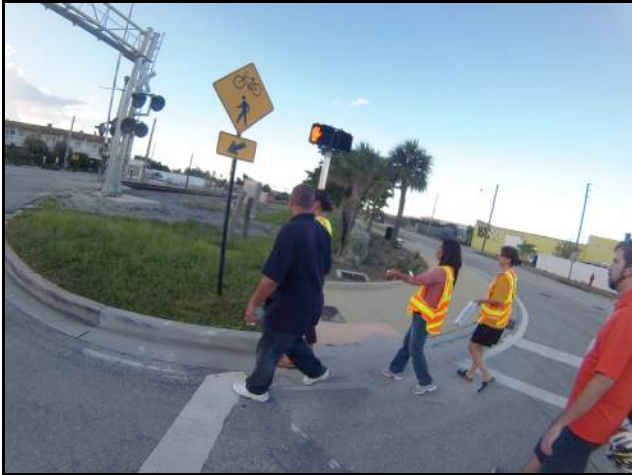
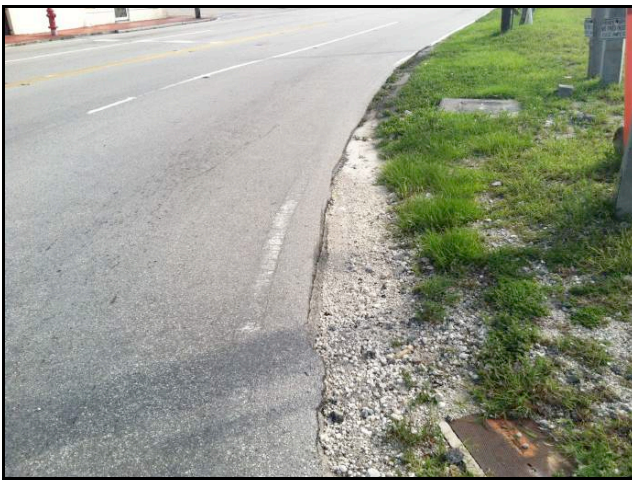
Service Request Map ID: 23

Pedestrian Warrant / Traffic Study Request / Transportation & Mobility

- ID #: 13655
- Service Request Location: 829-833 NE 3RD AVE
- A lot of concern was generated by pedestrians over the intersections surrounding the railroad tracks and the perceived danger in crossing; due to the wide turning radius, cars were observed speeding from NE 3rd Ave. onto the northbound lanes of Flagler Dr. while not yielding to a group of pedestrians and turning nearly completely into oncoming lanes to avoid stopping and waiting for pedestrians to cross; the railroad tracks pose many potential threats, including lack of pedestrian path, narrow shoulder and lack of dynamic signage or crosswalks; drivers headed NE onto Progresso Dr. were observed driving off the road and onto the shoulder where pedestrians were walking; photos attached.

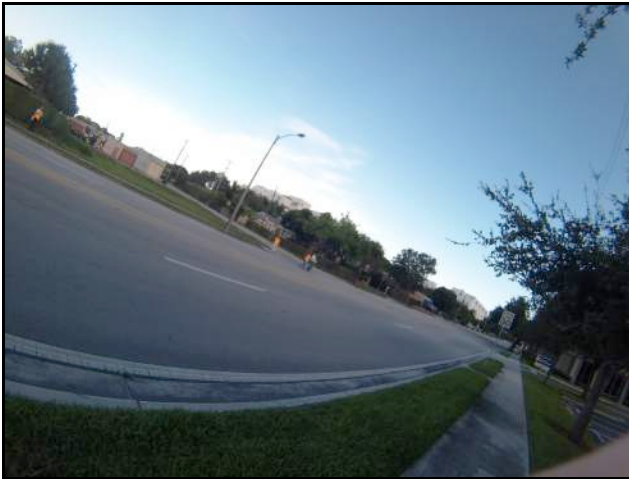
Service Request Map ID: 24

Pedestrian Warrant / Traffic Study Request / Transportation & Mobility

- ID #: 13657
- Service Request Location: 707-711 NE 3RD AVE
- As pedestrians were observed crossing at this location (without signalization, a crosswalk or intersection) and there are bus stops on both sides of the roadway, pedestrians recommended that mid-block pedestrian crossings be considered for the area and this location in particular.

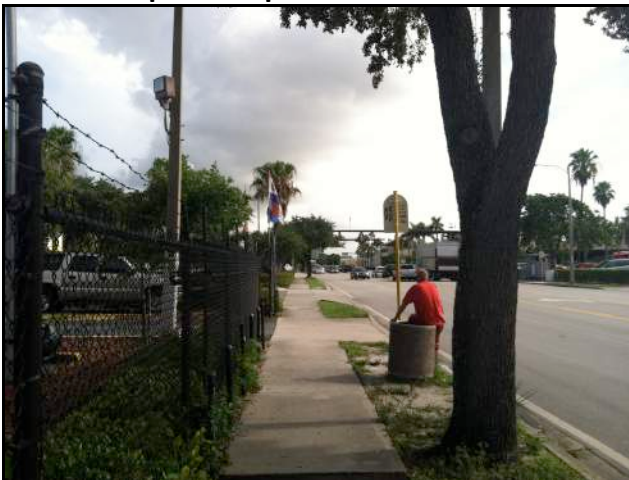
Service Request Map ID: 25

Transportation & Mobility / Transportation & Mobility - General Inquiry

- ID #: 13662
- Service Request Location: 931 NE 4TH AVE
- On the east side of the street, people were observed sitting in a large sheltered bus stop with a long bench, and on the west side of the street, just southeast, a gentleman was observed sitting on a trash can, possibly because he had nowhere else to sit, at a bus stop that may not be ADA compliant because of a perceived lack of an ADA compliant landing pad.
