OAKLAND PARK BOULEVARD CORRIDOR SUMMARY

OAKLAND PARK BOULEVARD DEMONSTRATION CORRIDOR REVIEW

From NW 84th Avenue to Atrium West | Sunrise

The following review describes the results of the corridor safety review and general observations of the corridor. A field review was conducted on Tuesday, July 12th, 2016 from 2:00 PM to 6:00 PM and a night time field review was completed on Tuesday, July 12th, 2016 from 8:30 to 9:30 PM.

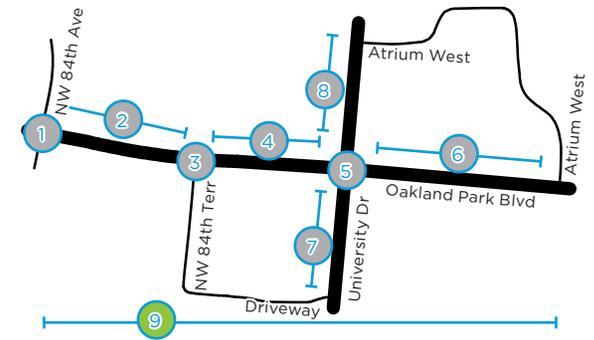
Location: 9 (Whole Area)

Issue: Mid-Block Crossings

- Mid-block crossings observed at bus stops and where there are destinations on either side of the street.
- The distances between signalized crossings is very long in most locations.
- The signal times are long, which can discourage people from waiting for the signal to cross.
- In some locations, “Do Not Cross” signs have been installed, however they do not seem to have much of an impact based on field observations.
- The City of Sunrise Police Department has been implementing a High Visibility Enforcement campaign focused on pedestrian and bicyclist issues over the past year. This strategy utilizes a progressive enforcement approach, where officers educate, warn, and finally ticket pedestrians, bicyclists, and drivers. The focus is heavy on pedestrian interaction, with police officers making contact with over 1,000 pedestrians, 50 motorists, and 27 bicyclists.

- Explore locations for safe mid-block crossings and consider bi-directional median opening crosswalks and TWLTL median refuge islands.
- Install thick shrubs in the median to physically prevent pedestrians from crossing medians mid-block.
- Consider relocating bus stops closer to crossings to create incentive for crossing at signals.
- Evaluate the effects of the High Visibility Enforcement campaign to determine if this kind of specialized focus worked in the study area. If so, continue the a progressive enforcement campaign where officers educate, warn, and finally ticket pedestrians who cross mid-block.

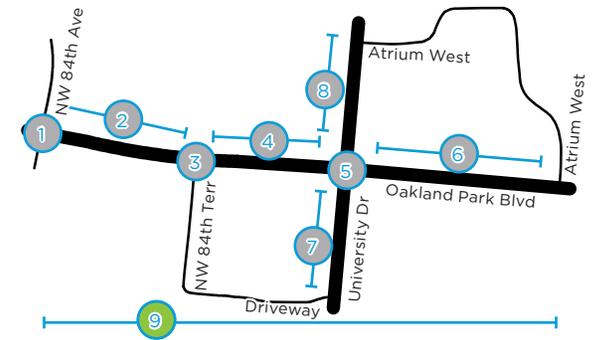
Location: 9 (Corridor Wide)

Issue: Noncompliant ADA Sidewalks and Ramps

- Fixed objects are mounted within the sidewalks,
- Sidewalk ramps do not comply with ADA requirements at every intersection along the corridor.
- In general, the truncated domes are missing, worn, or misaligned.
- In several areas, accessible sidewalk connections are not present between the sidewalk and driveways or private parking lots.
- In several locations, the pedestrian signal push buttons are located far from the crosswalk ramps or too close to each other.
- Some worn paths have been made where sidewalks do not exist.

- Update all ADA ramps along corridor to meet requirements.
- Relocate pedestrian signal push buttons to achieve proper separation and proximity to crosswalks.
- Expand sidewalk network to connect sidewalks with safe driveway crossings.

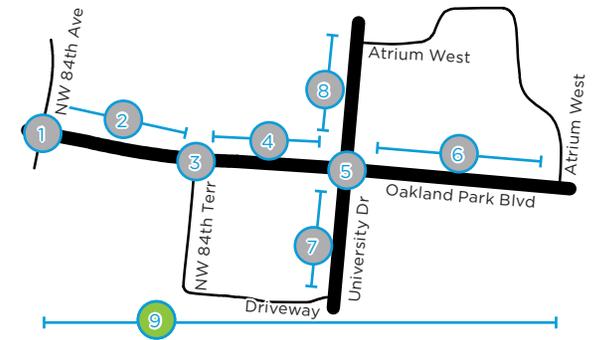
Location: 9 (Corridor Wide)

Issue: Crosswalk Deficiencies

- Many of the crosswalks are faded, worn, uneven, or difficult to discern from other pavement markings.
- Crosswalks are not present for all legs of all intersections.
- The pedestrian crossing signal time is too short for slower pedestrians in some locations and crossing distances are long at some intersections.

- Due to the high transit ridership along the corridor, add crosswalks across all intersection legs where possible.
- Review signal timing plans for corridor and extend pedestrian crossing times to meet minimum recommendations of 3.5 feet per second.
- Consider creating pedestrian bump outs and refuge islands to reduce pedestrian crossing distances.

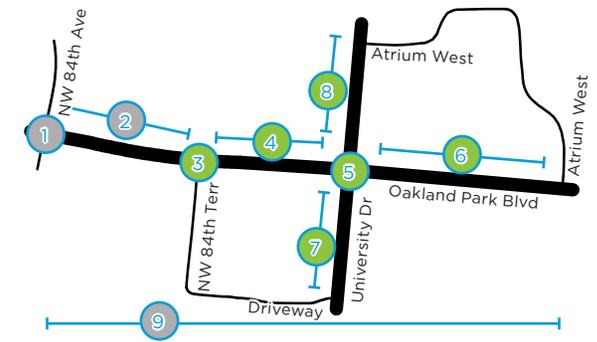
Location: 3, 4, 5, 6, 7, 8

Issue: Bus Stop Locations

- Mid-block pedestrian crossing is a critical safety concern throughout the corridor. Many, but not all, of the observed illegal mid-block crossings result from bus stops that are not conveniently located near existing crosswalks. Alternatively, crosswalks are not conveniently located near the bus stops.

- Evaluate the bus stop locations and potential mid-block crosswalk locations.
- Design mid-block crosswalks with enhanced visibility features, such as Rectangular Rapid Flash Beacons (RRFBs), to encourage use and to improve safety.

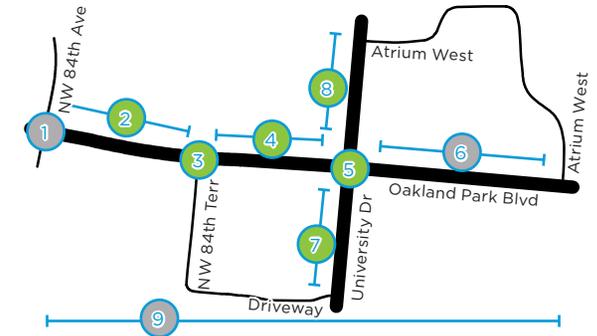
Location: 2, 3, 4, 5, 7, 8

Issue: Lighting

- Complete a lighting study with a focus on pedestrian lighting.
- Create an outreach campaign to alert pedestrians and bicyclists of the need to wear bright clothing at night and to use lighting.
