*SR 7 MULTIMODAL IMPROVEMENTS CORRIDOR STUDY*

# TECHNICAL APPENDIX C: HOT SPOT PRELIMINARY SAFETY AND TRAFFIC OPERATIONS REVIEWS

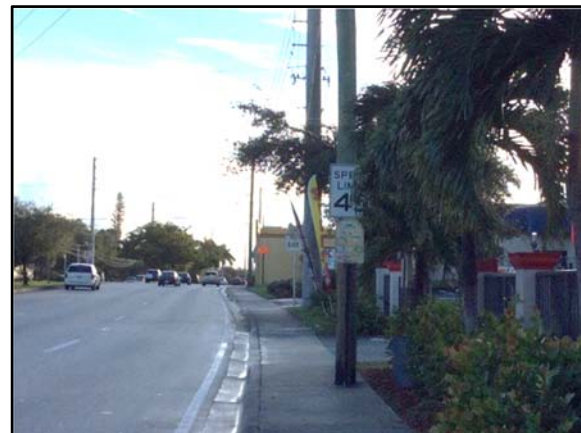
The eastbound “SCHOOL SIGN” (S1-1) is not visible as it is behind the signal pole. The “SCHOOL SIGN” should be relocated for better visibility.

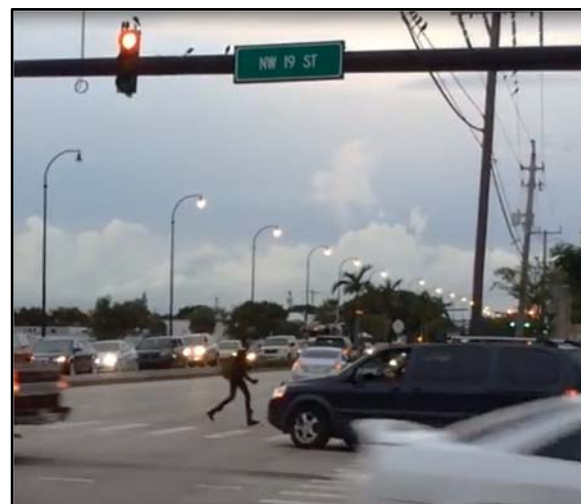
The westbound right-turn movement had 240 vph during the AM peak hour and 452 vph. During observations the vehicular movement was very heavy during the PM

peak hour and pedestrians had difficulty crossing the northern and eastern crosswalks. Consider a right-turn overlap with the left-turn movement by installing a four-section right-turn arrow to display a green arrow during the left-turn phase and a flashing yellow (or red) right-turn arrow during the pedestrian phase to encourage drivers to yield to pedestrians. This improvement would require prohibiting the U-turn movement.

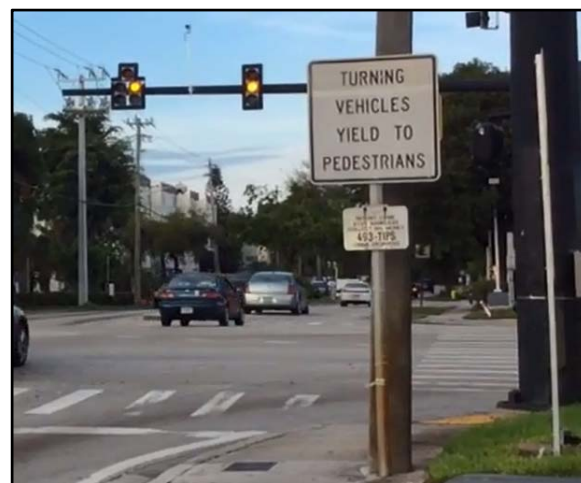
The “TURNING VEHICLES YIELD TO PEDESTRIANS” sign is outdated. This should

be replaced with a “YIELD TO PEDESTRIANS” (R10-15R) sign.

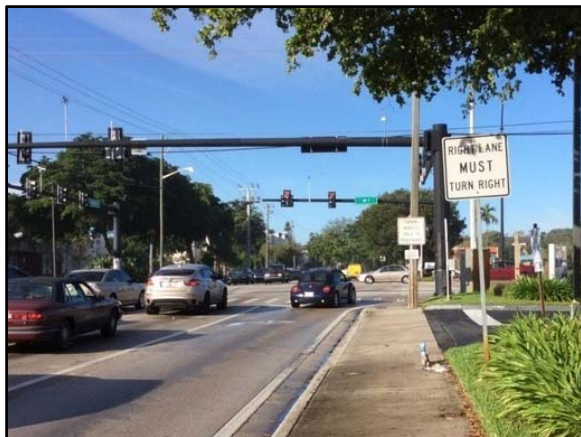
As a westbound driver approaches the intersection with the intention of traveling straight through, the right-through lane becomes a westbound right-turn lane. Uncertainty about downstream lane assignment produces hesitancy during the intersection approach; this in turn decreases available maneuver time and diminishes the driver’s attentional resources available for effective response to potential traffic conflicts at and near intersections. To warn motorists of the lane drop of the right-through lane to a right-turn lane in advance of the signalized intersection, install additional shoulder mounted “RIGHT TURN ONLY”(R3-5) sign and add additional “ONLY” pavement markings, per Section 2B.20 of the Federal Highway Administration’s (FHWA) Manual on Uniform Traffic Control Devices (MUTCD).

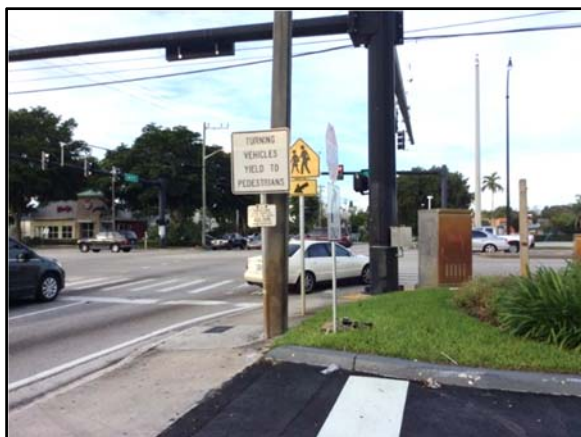
The westbound “SCHOOL SIGN” (S1-1) is not visible as it is behind the pole and the “TURNING VEHICLES YIELD TO PEDESTRIANS” sign. The “SCHOOL SIGN” should be relocated for better visibility.

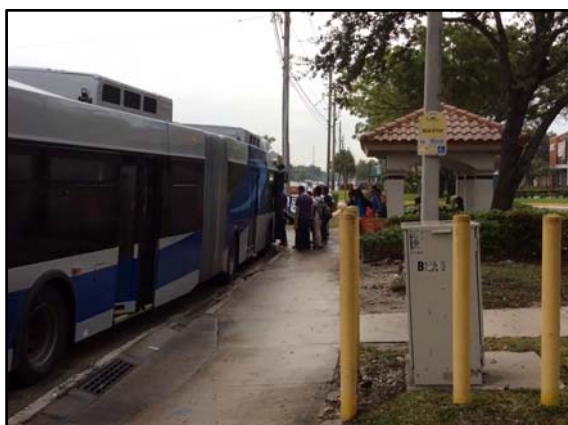
Many pedestrians were observed using transit during both peak hours.

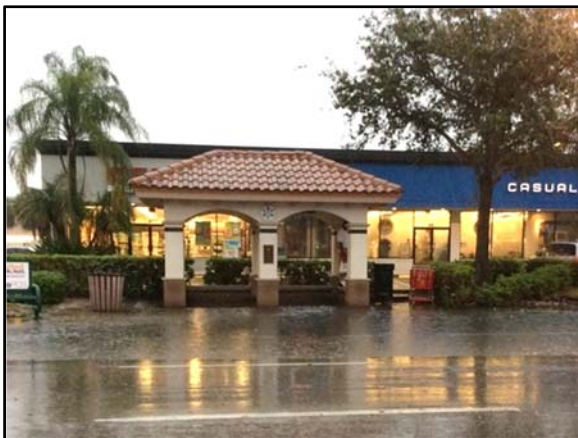
The bus stop along the east side of SR 7, just north of Oakland Park Boulevard, was flooded with over an inch of water over the sidewalk. Drainage at this location and along the intersection should be reviewed for potential improvements.

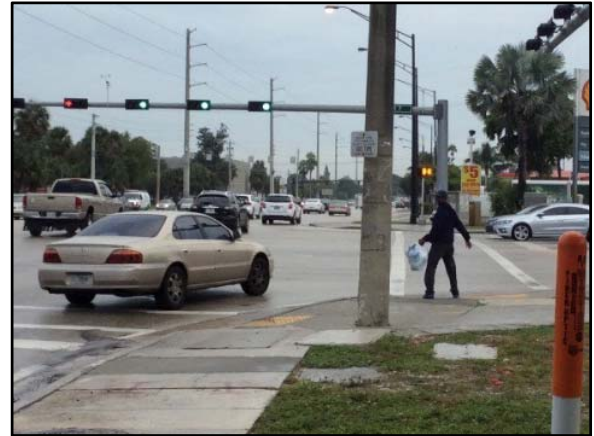
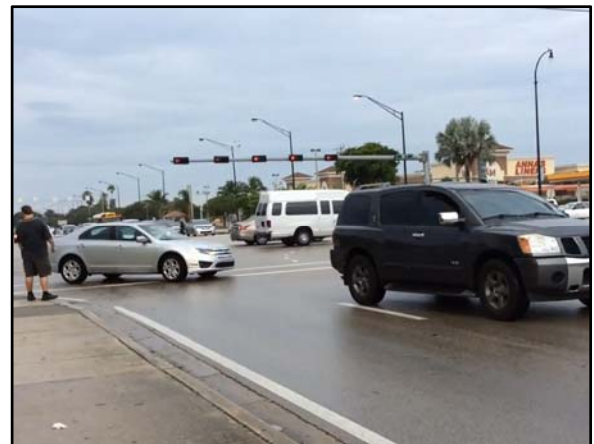
Pedestrians crossing the crosswalks had a difficult time crossing as right turning vehicles were not yielding to them. Consider a right-turn overlap with the left-turn movement by installing a four-section right-turn arrow to display a green arrow during

the left-turn phase and a flashing yellow (or red) right-turn arrow during the pedestrian phase to encourage drivers to yield to pedestrians. This improvement would require prohibiting the U-turn movement.

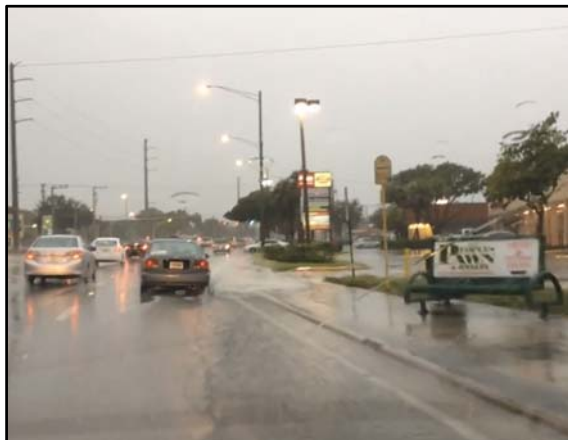
The roadway was flooded at the intersection. Consider reviewing the drainage at the intersection.

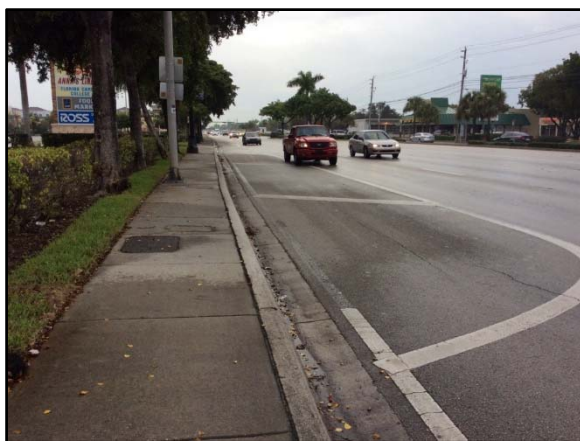
The west side of SR 7 just north of Oakland Park Boulevard has an area that is striped with chevrons that could be used as a bus bay. Consider relocating the bus stop 150 feet south and restriping the chevrons area to a bus bay. A queue jump could be evaluated for this location.

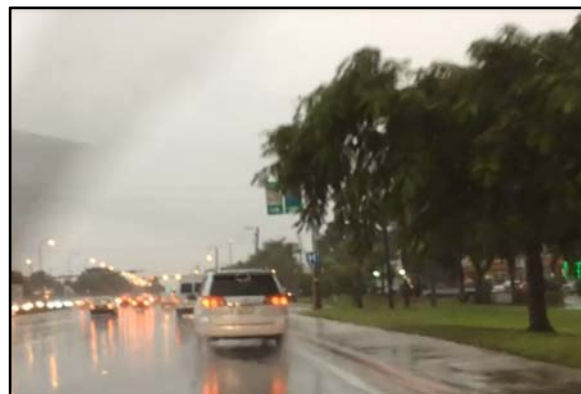
The signs on the cantilever pole along the east side of SR 7 for northbound traffic is behind a tree and not visible to northbound traffic. The vegetation should be trimmed for better visibility.

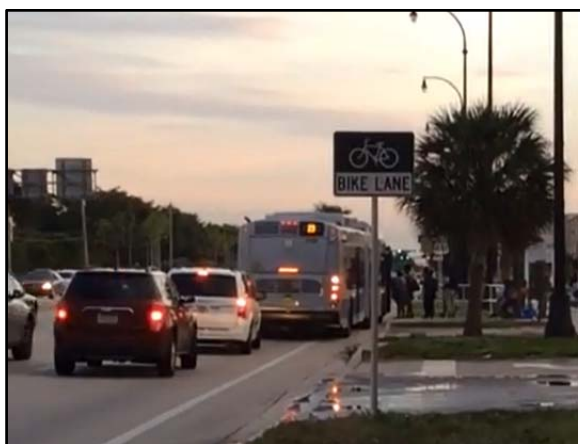
Many pedestrians were observed using transit during both peak hours.

Pedestrians were observed crossing during the “DO NOT WALK” pedestrian phase. Enforcement of pedestrians who do not obey pedestrian signals should be increased. The pedestrian push buttons should be separated and relocated closer to the curb ramps for better accessibility.

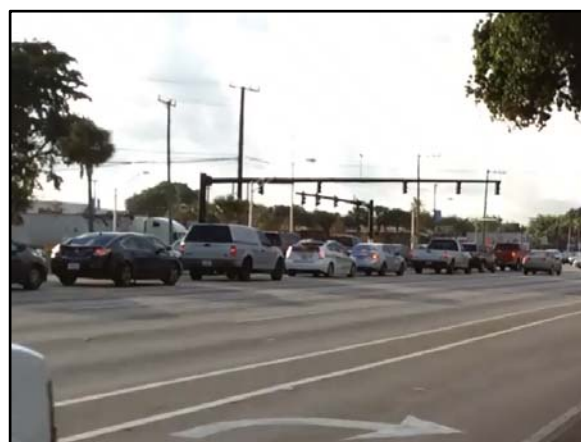
The southbound left-turn movement was observed having large queues during the AM peak hour with 441 vph in the left-turn lanes. Aggressive driving, including speeding and red light running, was observed as phase failures occurred often. Consider reviewing the timings to extend the southbound left-turn timings for the AM peak hour.

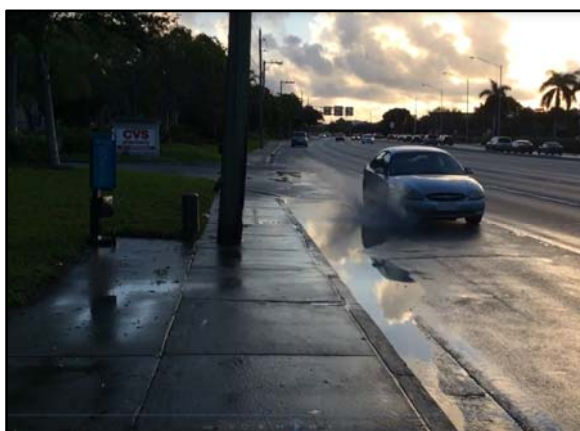
Standing water was observed during the AM and PM peak hours in the right-turn lane of westbound Commercial Boulevard. Drainage at this location should be reviewed further to identify potential improvements.
