SUNRISE BOULEVARD CORRIDOR SUMMARY

SUNRISE BOULEVARD DEMONSTRATION CORRIDOR REVIEW

From NW 13th Avenue to Middle River | Fort Lauderdale

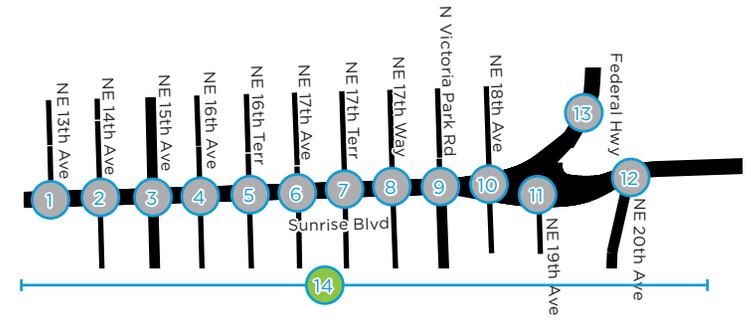
Location: 14 (Corridor Wide)

Issue: No Bike Lanes

- There are no bike lanes in the corridor.
- Bicyclists ride on the narrow sidewalks, creating conflicts between bicyclists and pedestrians.
- Bicyclists were also observed riding on the sidewalk in the opposite direction of vehicles.
- These conditions create safety issues for bicyclists, especially at intersection and driveway crossings.

- Evaluate the addition of bike lanes throughout the corridor. Ensure that the bike lanes are designed to have sufficient width to safely separate bikes from the high-speed and high-volume vehicular traffic along Sunrise Boulevard, in order to promote use of the bike lanes rather than the sidewalks. The high volumes and speeds suggest the need for protected or separated bike lanes to accommodate the needs of riders.

- Provide additional visual separation of bike lanes through buffers.
- Use green paint at intersections, driveways, or other conflict points to highlight to drivers that bicyclists may be crossing.

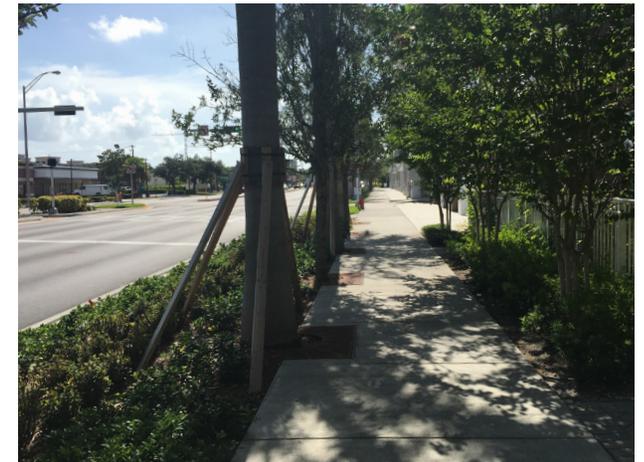
Some of the newer sidewalks are designed with buffers and shade trees.

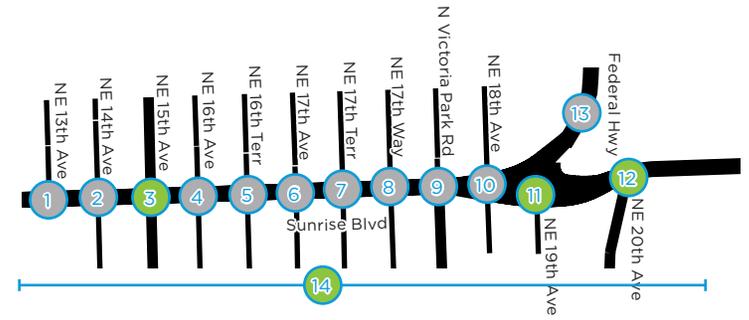
Location: 3, 14 (Corridor Wide)

Issue: Noncompliant ADA Sidewalks and Ramps

- Fixed objects are mounted within the sidewalks,
- Sidewalk ramps do not comply with ADA requirements at every intersection along the corridor.
- In general, the truncated domes are missing, worn, or misaligned.
- In several areas, accessible sidewalk connections are not present between the sidewalk and driveways or private parking lots.
- The drainage inlet on the northwest corner of NE 15th Avenue blocks the ramp.

- Update all ADA ramps along corridor to meet requirements.
- Expand sidewalk network to connect sidewalks with safe driveway crossings.
- Move the drainage inlet on the northwest corner of NE 15th Avenue away from ramp.

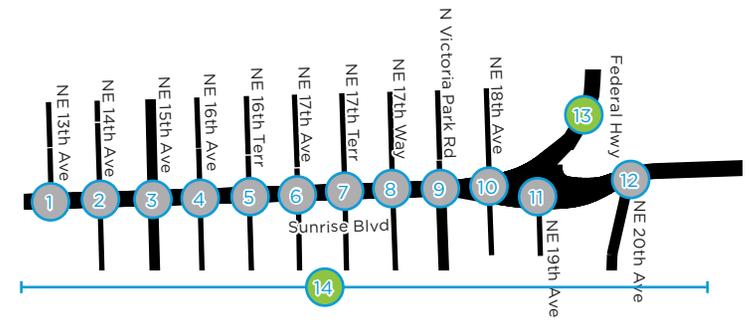
Location: 14 (Corridor Wide)

Issue: Driveway Frequency & Design

- There are a number of driveways between intersections along the corridor. Many of these driveways have poorly marked crosswalks.
- Many driveways along the corridor are very wide and allow drivers to turn in and out without slowing down.
- Many drivers were observed turning out of driveways without looking for or yielding to pedestrians.
- In section 13, almost every development has a right turn lane. These prevent new pedestrian crossings from being created and allow drivers to turn quickly in to driveways.

- Refresh pavement markings to emphasize crosswalks across driveways.
- Create an outreach campaign to alert bicyclists of the dangers of riding on the sidewalks and to alert drivers of the need to look for bicyclists when turning in to and out of driveways.
- Encourage cross access agreements between developments to limit the number of driveways approved along the corridor.
- Consider narrowing driveways where possible and ensure that driveway width is considered in development review for new developments.
- Consider whether right turn lanes are needed at every development. If not, consider where they might be able to be removed.

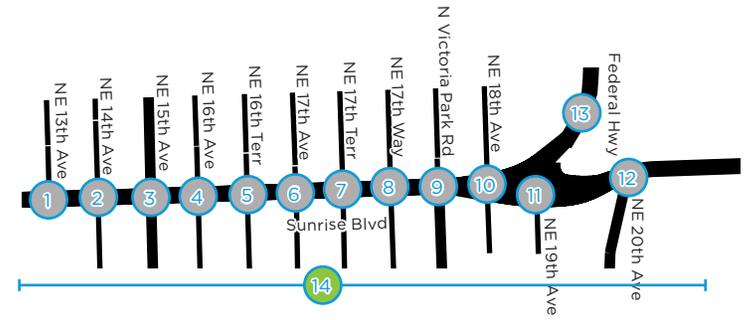
Issue: Driver Behavior
Location: 14 (Corridor Wide)

- Drivers turning right on red do not always look for pedestrians in crosswalks before turning.
- During field observations, several drivers almost hit pedestrians or bicyclists in the crosswalks and at driveways.
- Drivers exiting driveways do not always yield or look for pedestrians or bicyclists.
- Drivers stop in the crosswalk and block access to the sidewalks. This is sometimes due vehicles pulling through the stop bars in order to see oncoming traffic because the stop bar is set back.

- Install warning signs at intersections and driveways, such as “Stop Here on Red”.
- Consider implementing “No Right Turn on Red.”
- Educate drivers on safe driving behavior through programs such as best foot forward, alert today, alive tomorrow and by working with Google and Waze.
- Create a progressive enforcement campaign where officers educate, warn, and finally ticket drivers who block crosswalks.
- Consider redesigning the location of the stop bar and crosswalk.

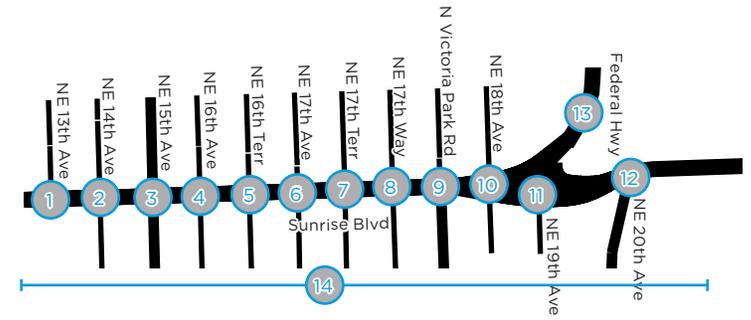
Issue: Lack of Shade & Shelter
Location: 14 (Corridor Wide)

- Throughout the corridor, there is little shade for pedestrians.
- The bus stops lack shelter from the sun and rain. At NE 17th Way, the bus stop does not provide seating for waiting riders.
- At US 1 and other major intersections, no shade is available for pedestrians waiting for the long cycle lengths before safely crossing the road.

- Upgrade bus stops to provide seating and shelter for users.
- Evaluate options to provide shade and shelter at intersections to encourage pedestrians to use crosswalks.

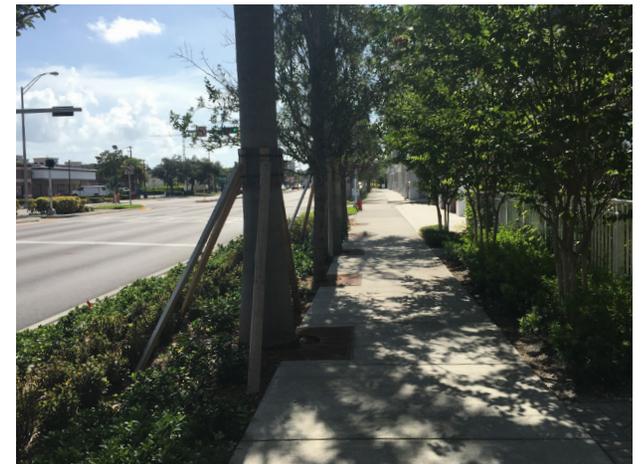
Some of the newer sidewalks are designed with buffers and shade trees.

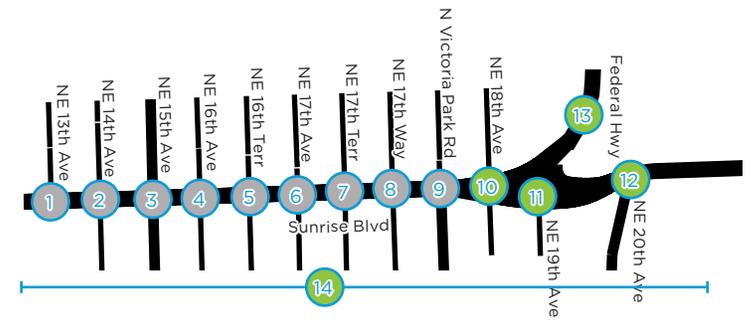
Location: 10, 11, 12, 13, 14 (Corridor Wide)

Issue: Limited Crossing Opportunities

- The Gateway intersection offers limited crossing opportunities.
- There is no opportunity to cross from east to west on the north side of Sunrise Boulevard at Federal Highway.
- Corridor wide, frequent left and right turn lanes create limited opportunities for mid-block crossings.

- Study realignment of the Gateway intersection to allow for an east/west crossing on the north leg.
- Explore locations for safe mid-block crossings and consider bi-directional median opening crosswalks and TWLTL median refuge islands such as on Federal Highway just north of Sunrise Boulevard.

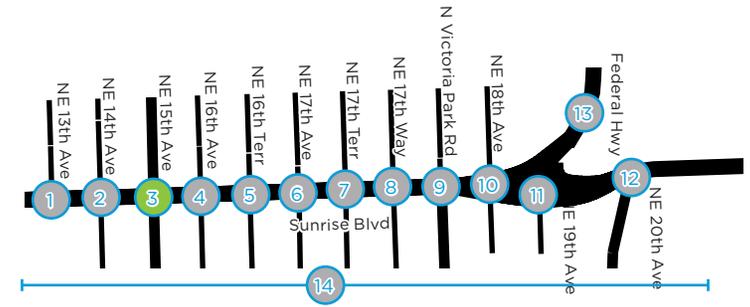
Location: 3

Issue: Drainage / Flooding

- Drainage is poor throughout the study area, but especially at the intersection of NE 15th Avenue. Flooding at this intersection blocks the sidewalk ramp.

- Update drainage system throughout corridor. Complete a study to determine specific locations where drainage issues are occurring. Consider options such as elevation modifications and improving draining through landscaping and other opportunities.

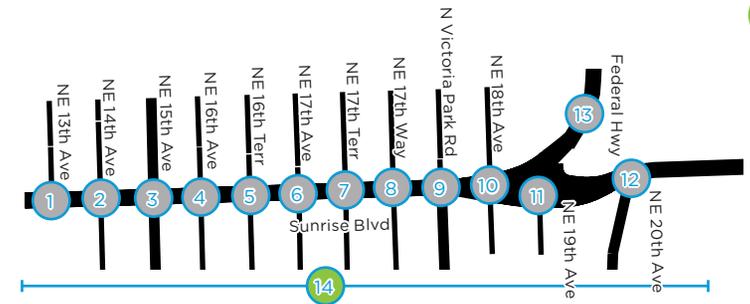
- Almost half of the crashes occurred at night.
- Lighting focuses on street and there is no pedestrian lighting.
- Lighting does not meet new illumination standards as noted in FDOT's Plans Preparation Manual.

- Complete a lighting study with a focus on pedestrian lighting.
- Create an outreach campaign to alert pedestrians and bicyclists of the need to wear bright clothing at night and to use lighting.

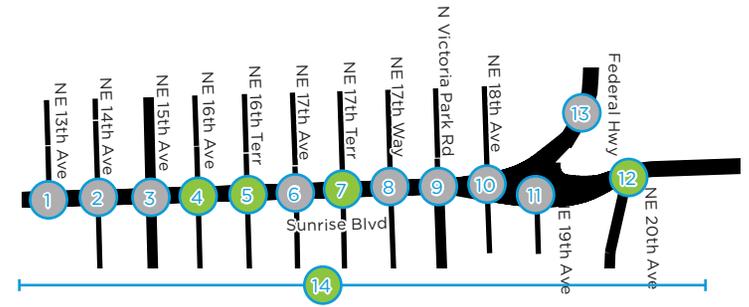
Issue: Crosswalk Deficiencies

- Many of the crosswalks are faded, worn, or uneven.
- Crosswalks are not present across the west leg the intersection at NE 20th Ave even though there is a bus stop on that leg.
- Crosswalks are not marked across the south leg of NE 16th Avenue, NE 16th Terrace, or NE 17th Avenue.

- Due to the high pedestrian volumes along the corridor, add crosswalks across all intersection legs.

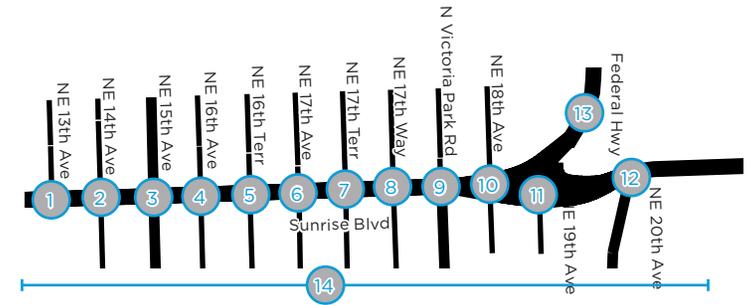
- Mid-block pedestrian crossing is a critical safety concern throughout the corridor. Many, but not all, of the observed illegal mid-block crossings result from bus stops that are not conveniently located near existing crosswalks. Alternatively, crosswalks are not conveniently located near the bus stops.

- Evaluate the bus stop locations and potential mid-block crosswalk locations.
- Design mid-block crosswalks with enhanced visibility features, such as Rectangular Rapid Flash Beacons (RRFBs), to encourage use and to improve safety.

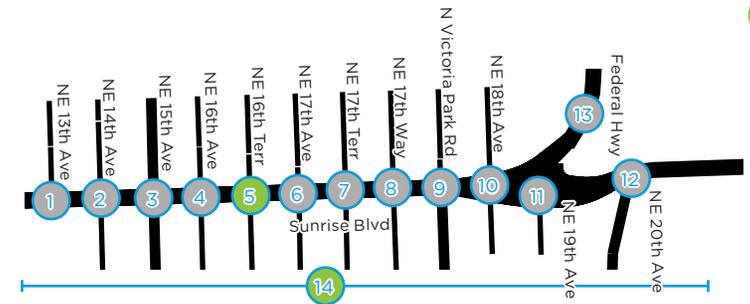
Issue: Signal Timing

- Signal times are long, which causes long wait times for pedestrians when crossing the street at intersections.
- It was observed that pedestrians cross the street against the signal even in crosswalks instead of waiting for the Walk signals.

- Consider retiming signals with a focus on pedestrian and bicycle mobility.
